Builders Defects Warranty Report

Builders Defects Warranty Inspection - Articon Standard Property Report

55 Liberty Drive Flagstone 4124 Queensland Australia

Report number:	ABI-03039
Inspection Date:	04 Mar 2026
Property Address	55 Liberty Drive Flagstone 4124 Queensland Australia
Special conditions or instructions	
Special conditions or instructions	There are no special conditions or instructions.
The parties	
Name of Client:	Brad wells

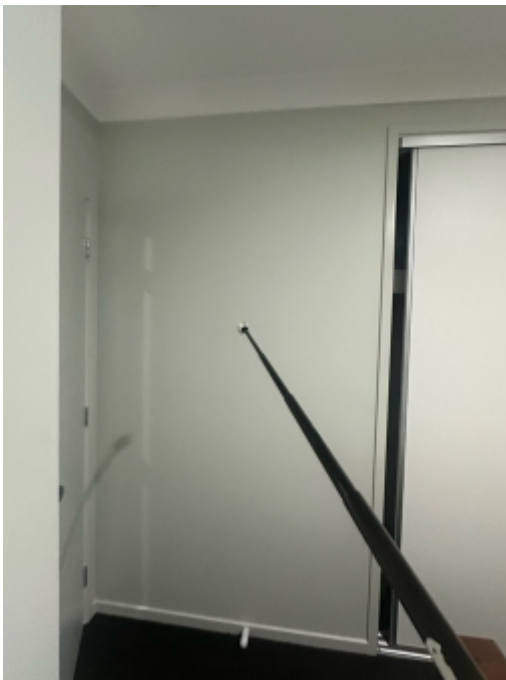
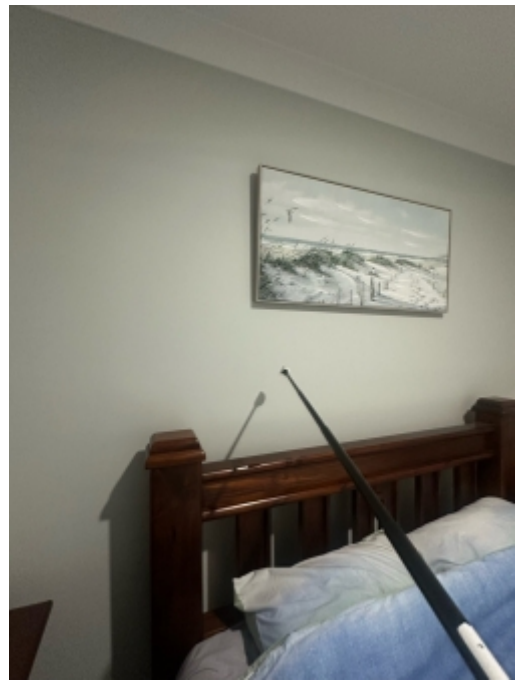
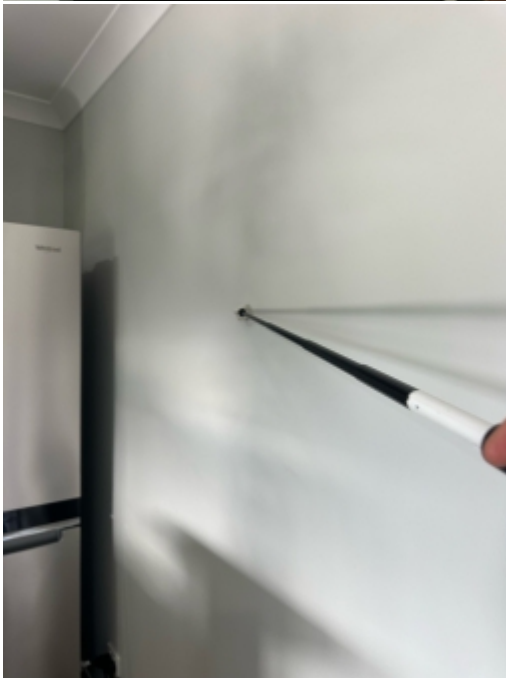
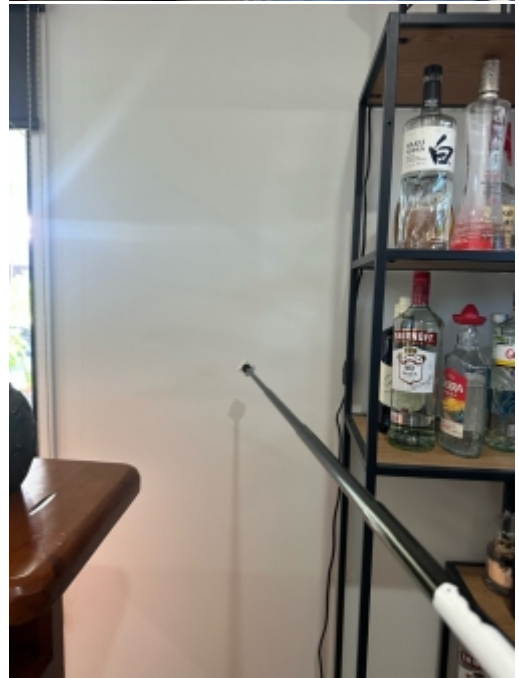
Internal Wall Defects

Detail of Major Defect	Wall plasterboards are wobbly and loose to parts of the living area, lounge, master bedroom walk in robe and bedrooms. likely due to poor installation and inadequate fixing to the framing. I recommend engaging a qualified builder or licensed plasterer to inspect the affected areas and provide advice on appropriate repairs to prevent further movement and deterioration.
------------------------	--

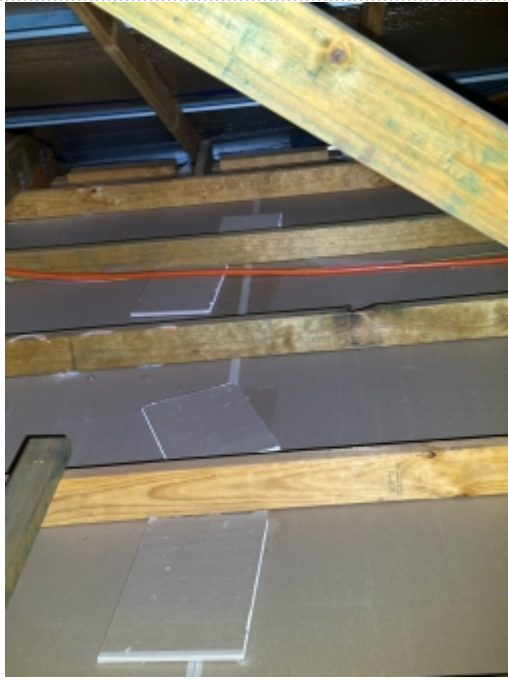
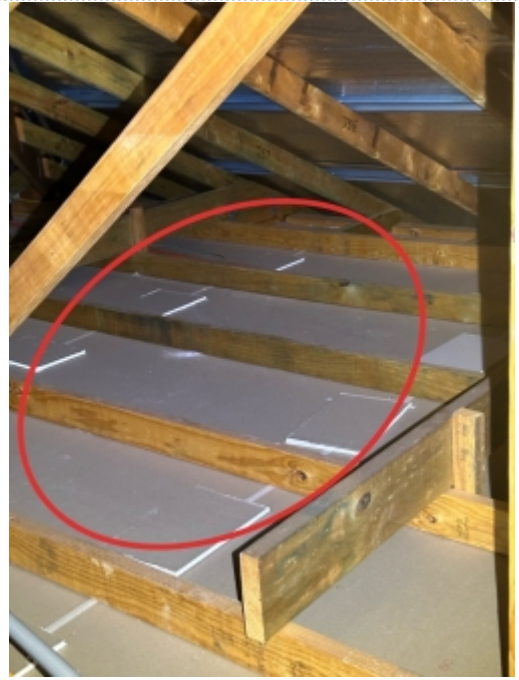
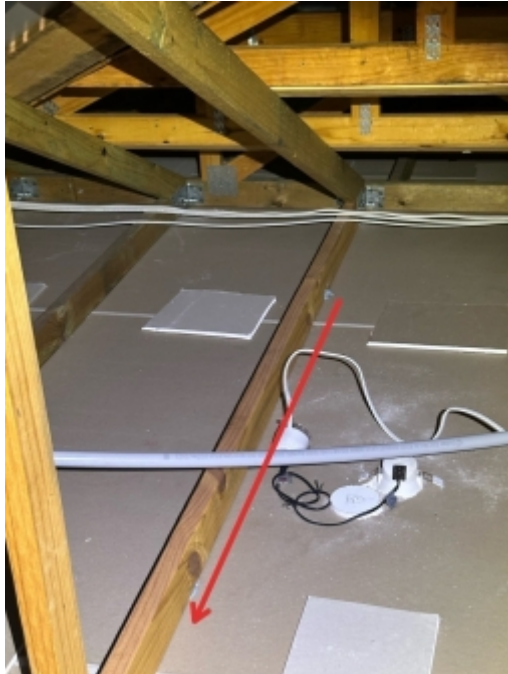
Roof space Defects

It appears the ceiling lining has inadequate adhesive and insufficient mechanical fixings, and the spacing between glue points and fixings exceeds the recommended requirements, there is a risk sagging ceiling.
It is recommended to engage a licensed builder or qualified plasterer to inspect and provide advice on appropriate rectification measures to prevent possible sagging and ensure the ceiling is properly secured.

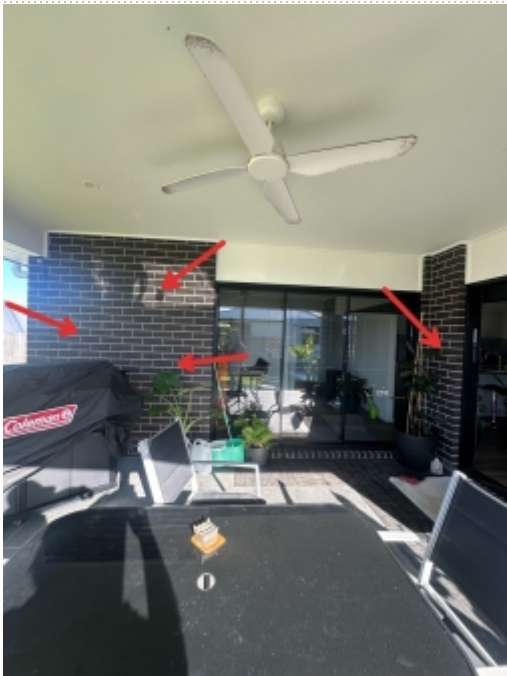
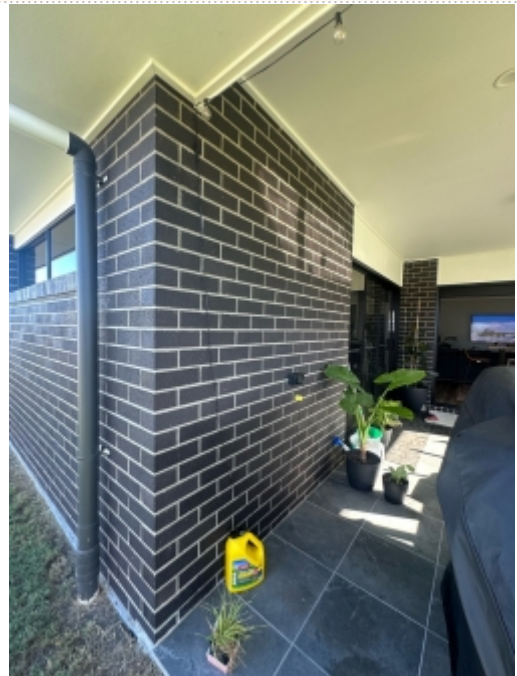
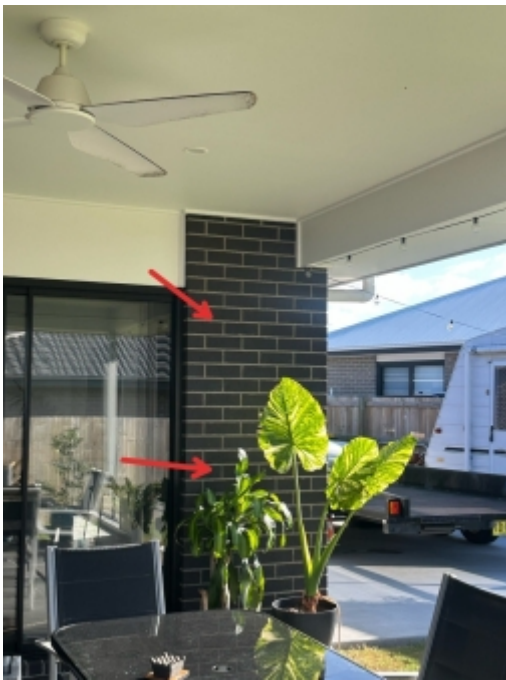
External Wall Defects

Parts of the external brickwork do not match and appear inconsistent in colour and/or texture. It looks like two different types of bricks may have been installed on the external wall.

I recommend engaging a qualified bricklayer/builder to inspect the installation and provide further advice regarding the quality and type of the bricks used.

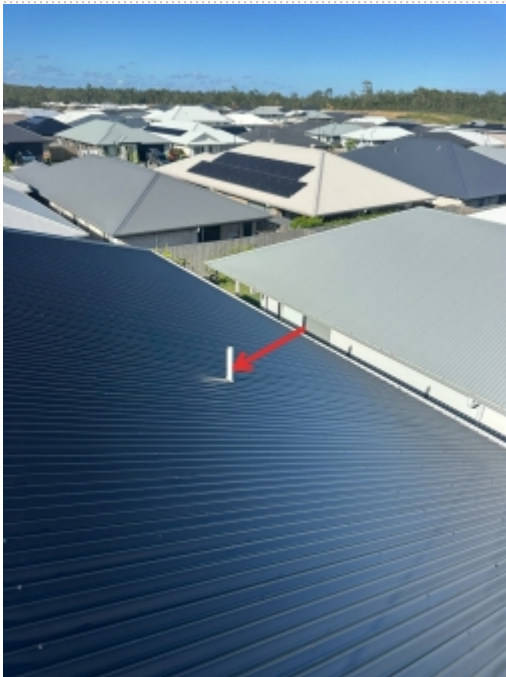
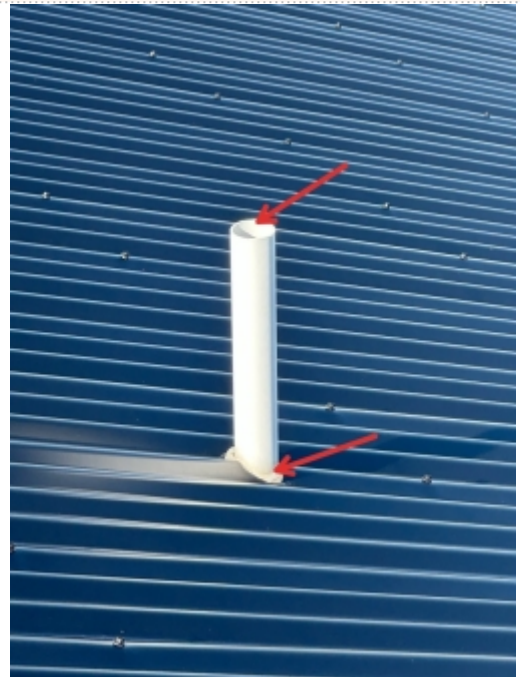
Roof Exterior Defects

Detail of Major Defect	Missing cap and boot flashing around the plumbing vent pipe. Recommend engaging a plumber/roofer to install it to reduce the risk of water penetration and damage.
------------------------	--

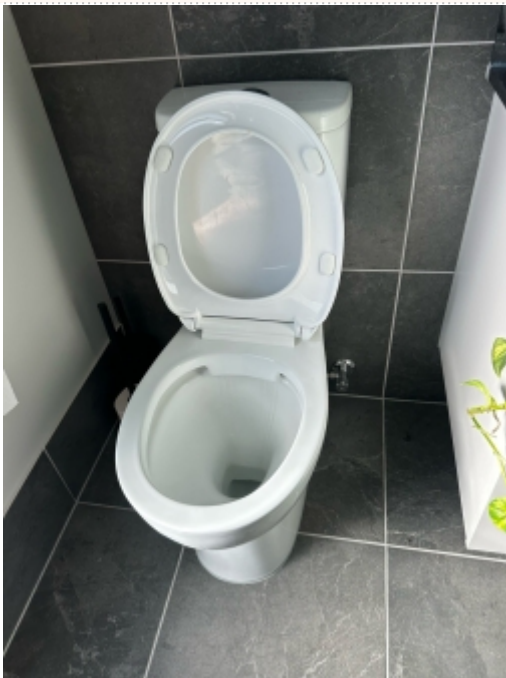
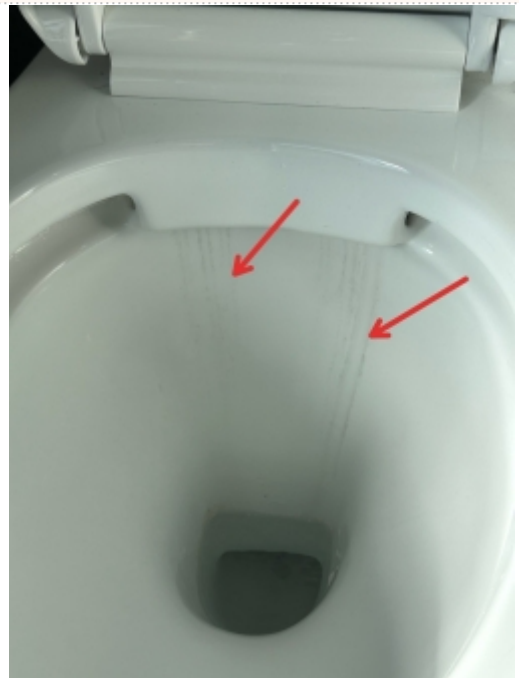
Comment on Minor Defects	Showing staining/marks to the toilet pan, recommend contacting a builder/supplier for further advice.
--------------------------	---

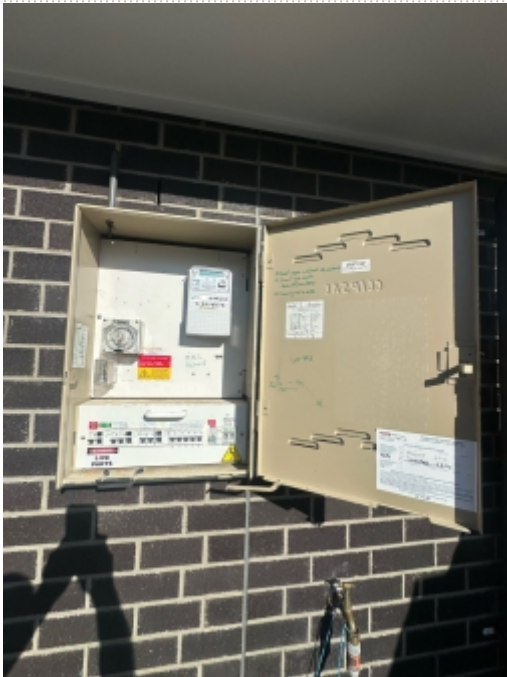
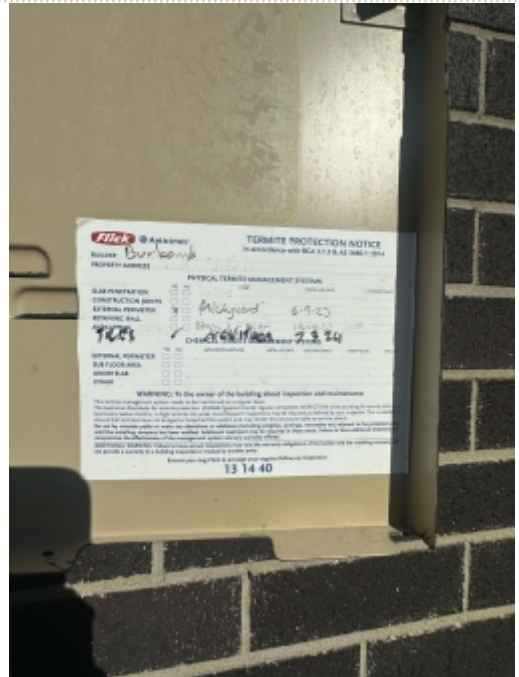
The Termite management notice was found in the meter box at the time of the inspection.
