Builders Defects Warranty Report

Builders Defects Warranty Inspection - Articon Standard Property Report

55 Liberty Drive Flagstone 4124 Queensland Australia

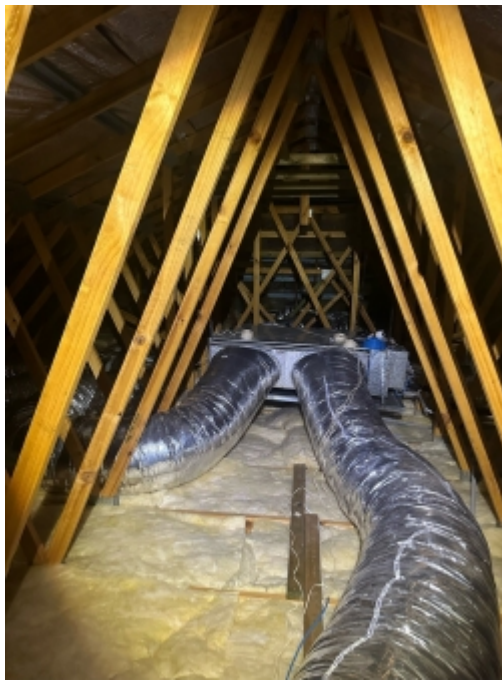
Comments of Obstructions:	Showing an example of ducted AC and insulation
Inaccessible areas	
Were there any normally accessible areas that did not permit entry?	All normally accessible areas permitted entry
Undetected defect risk assessment	
Due to the level of accessibility for inspection including the presence of obstructions, the overall degree of risk of undetected defects such as structural damage, conditions conducive to structural damage, timber pest attack and conditions conducive to timber pest attack was considered:	Low
Tick to add this comment into the report	<input type="checkbox"/> Recommend further inspection once the obstruction is moved. <input type="checkbox"/> Recommend further inspection when access is gained to all areas <input type="checkbox"/> Recommend further inspection once vacant and obstructions removed.

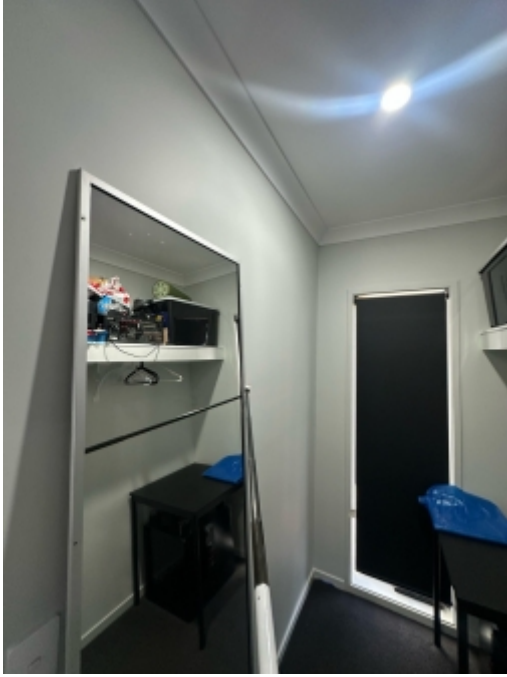
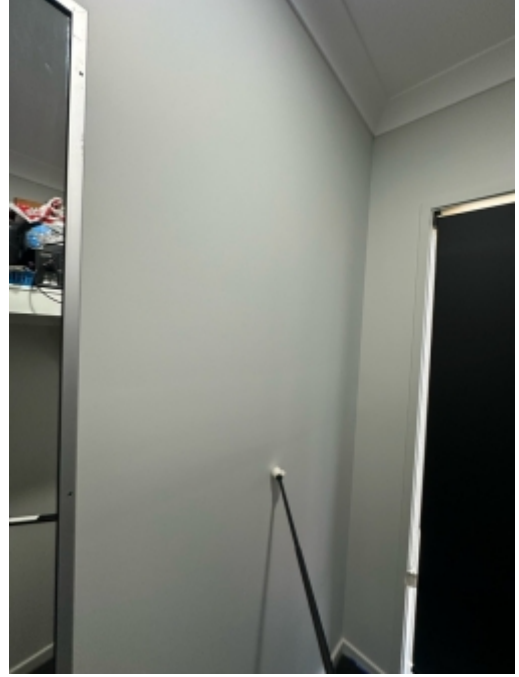
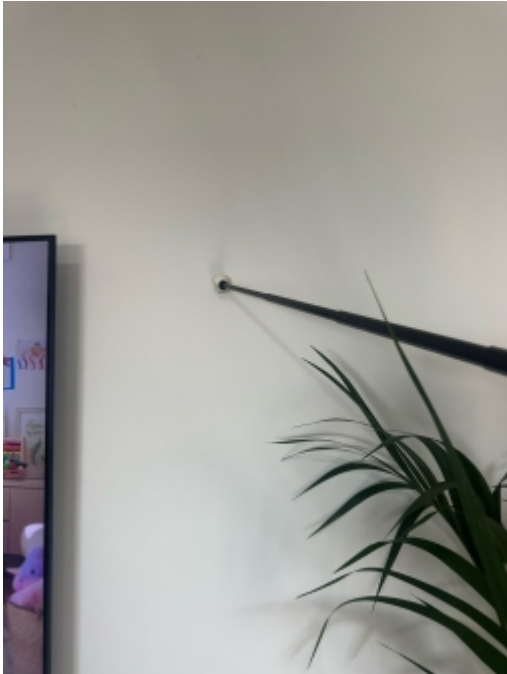
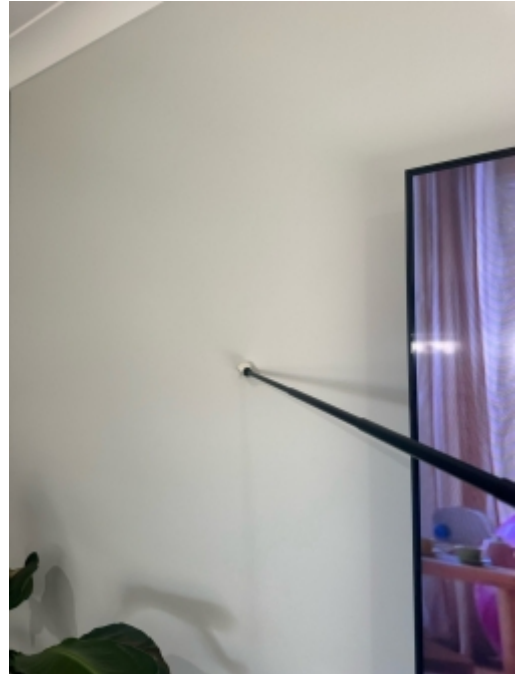
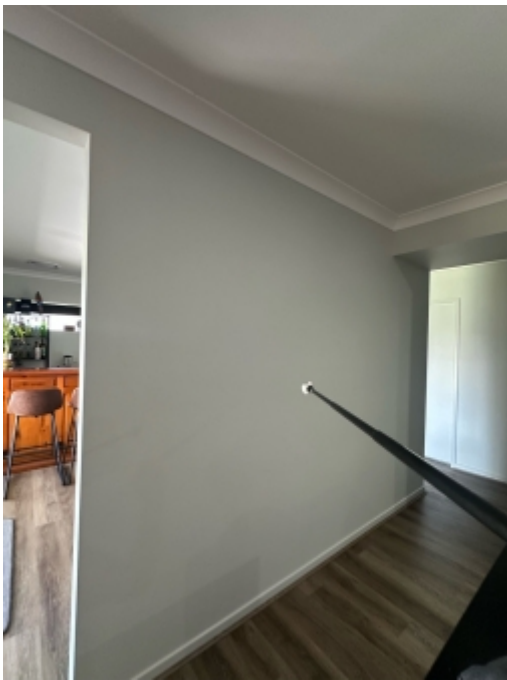
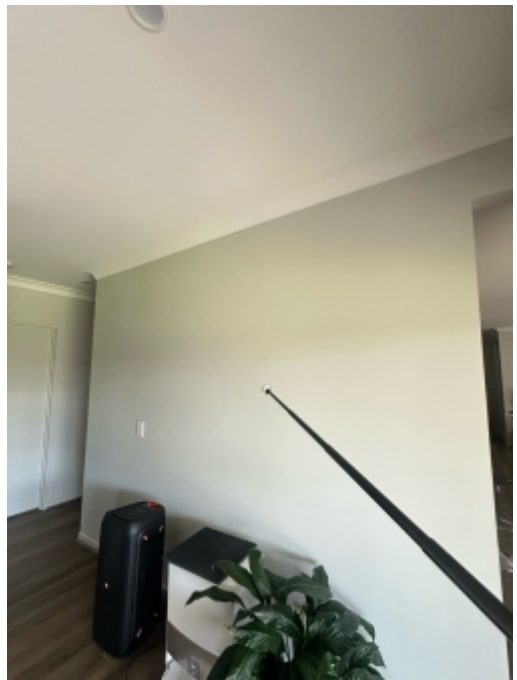
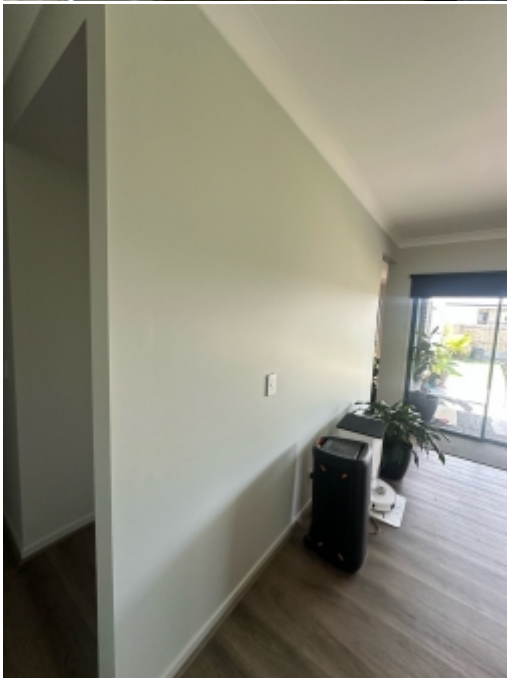
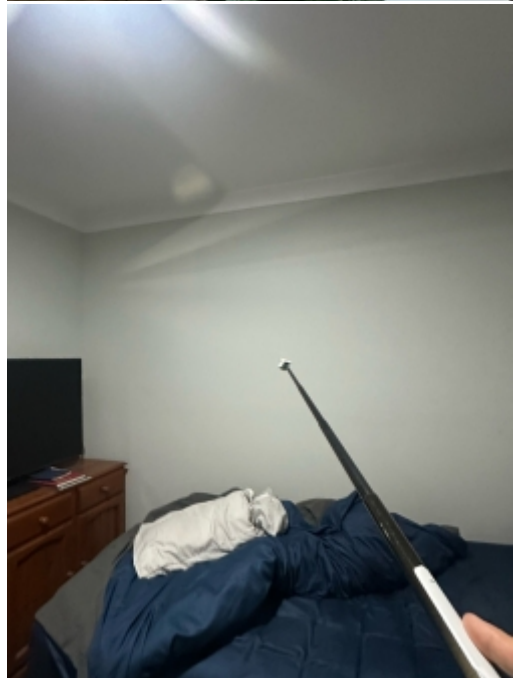
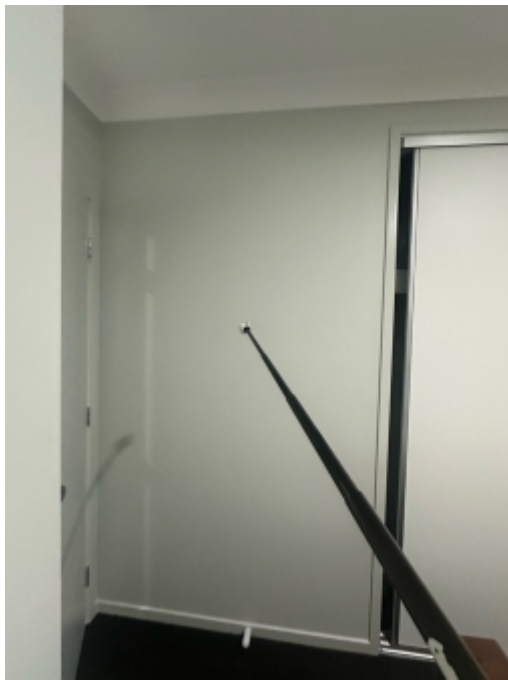
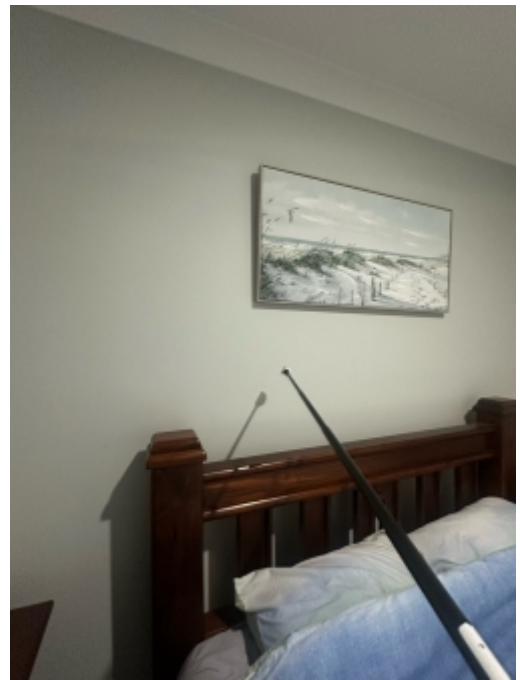
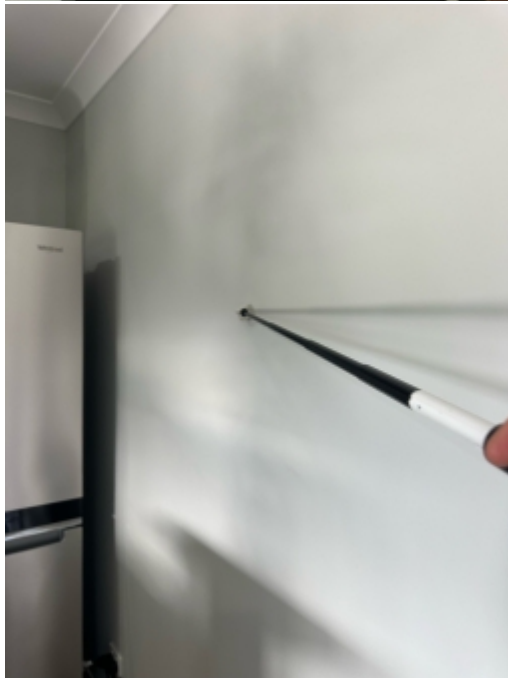
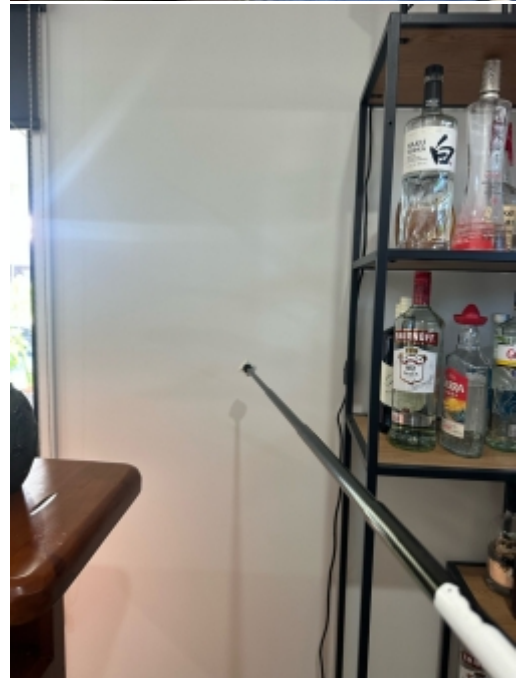
Detail of Major Defect	Wall plasterboards are wobbly and loose to parts of the living area, lounge, master bedroom walk in robe and bedrooms. likely due to poor installation and inadequate fixing to the framing. I recommend engaging a qualified builder or licensed plasterer to inspect the affected areas and provide advice on appropriate repairs to prevent further movement and deterioration.
------------------------	--

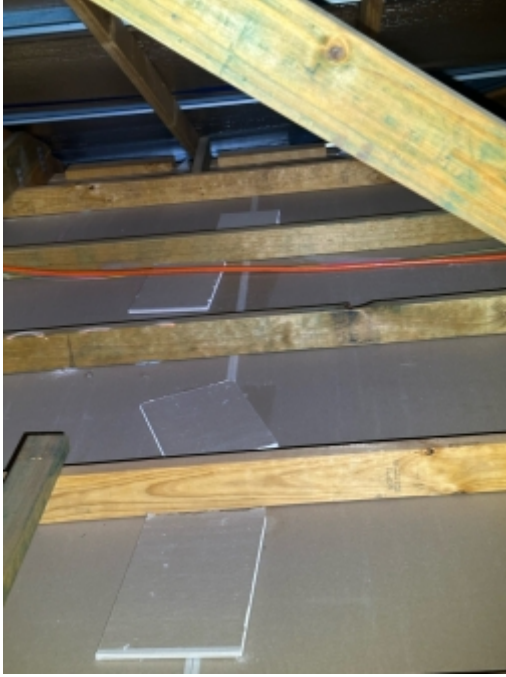
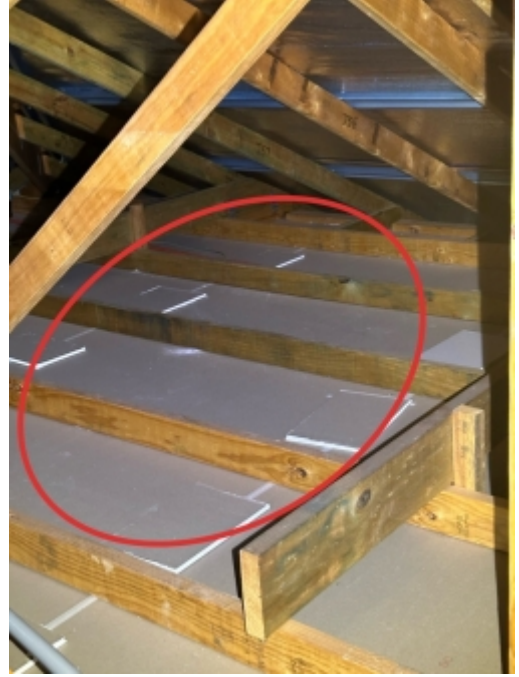
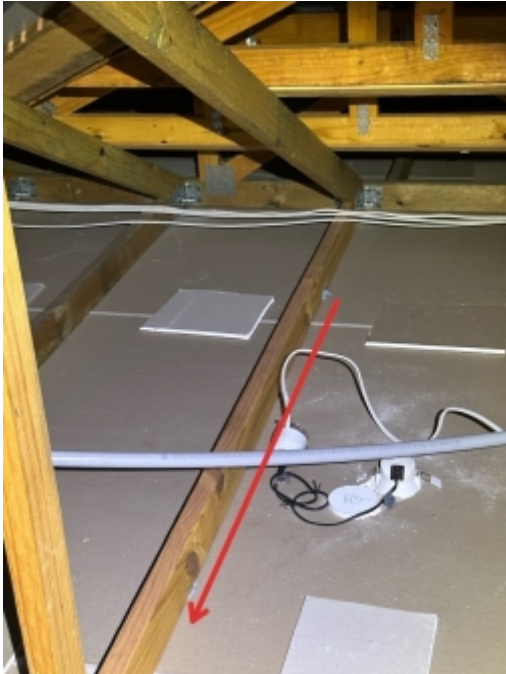
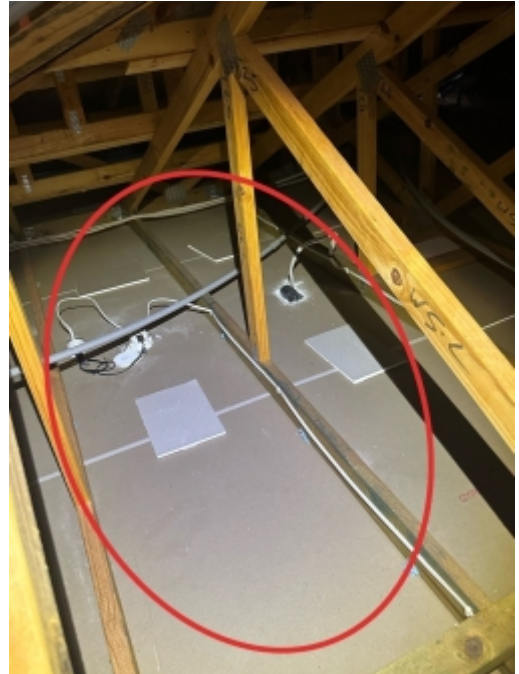
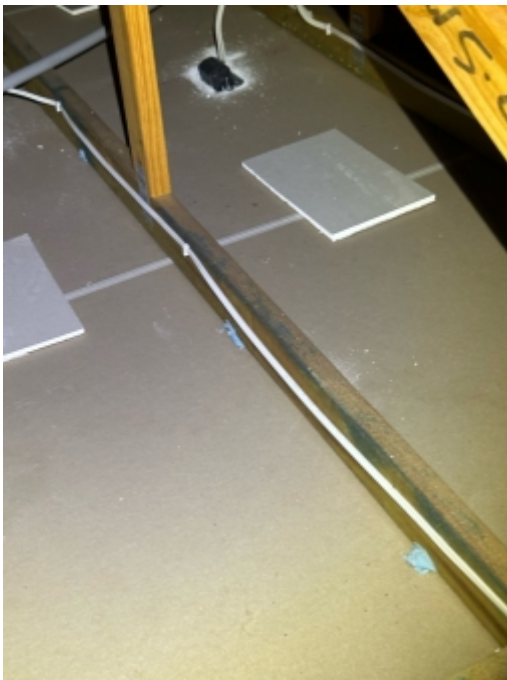
It appears the ceiling lining has inadequate adhesive and insufficient mechanical fixings, and the spacing between glue points and fixings exceeds the recommended requirements, there is a risk sagging ceiling.
It is recommended to engage a licensed builder or qualified plasterer to inspect and provide advice on appropriate rectification measures to prevent possible sagging and ensure the ceiling is properly secured.

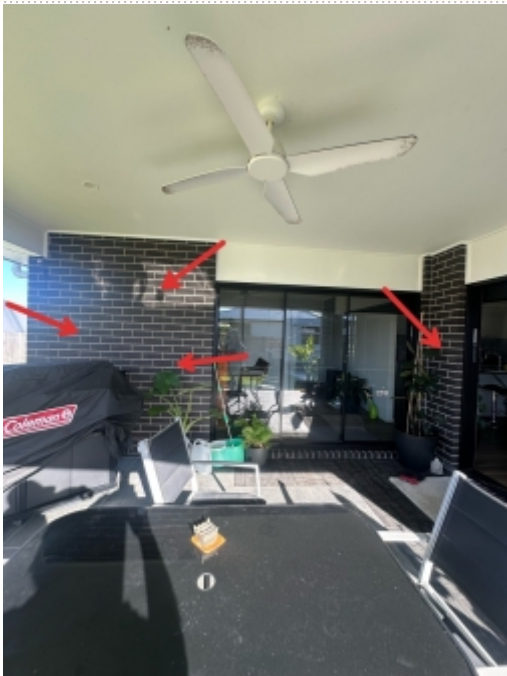
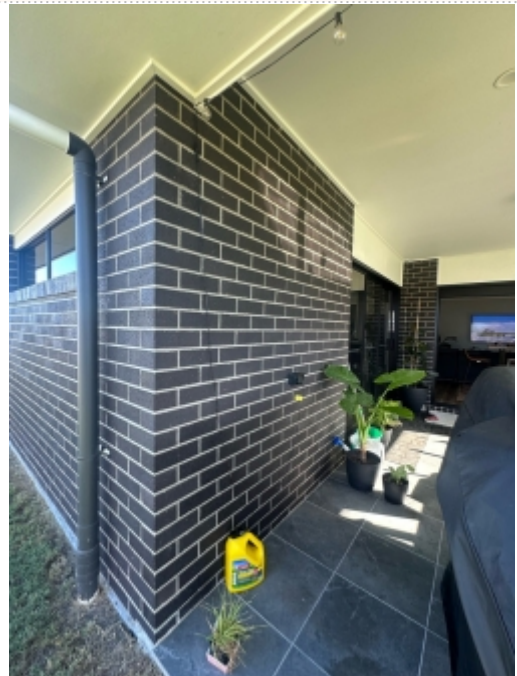
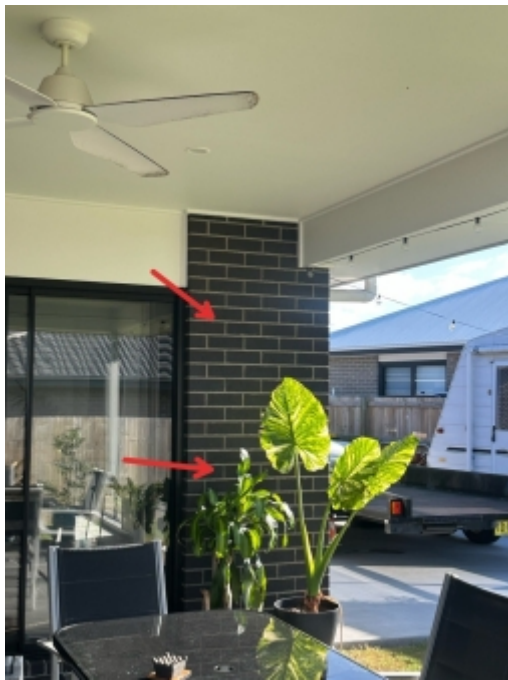
Parts of the external brickwork do not match and appear inconsistent in colour and/or texture. It looks like two different types of bricks may have been installed on the external wall.

I recommend engaging a qualified bricklayer/builder to inspect the installation and provide further advice regarding the quality and type of the bricks used.

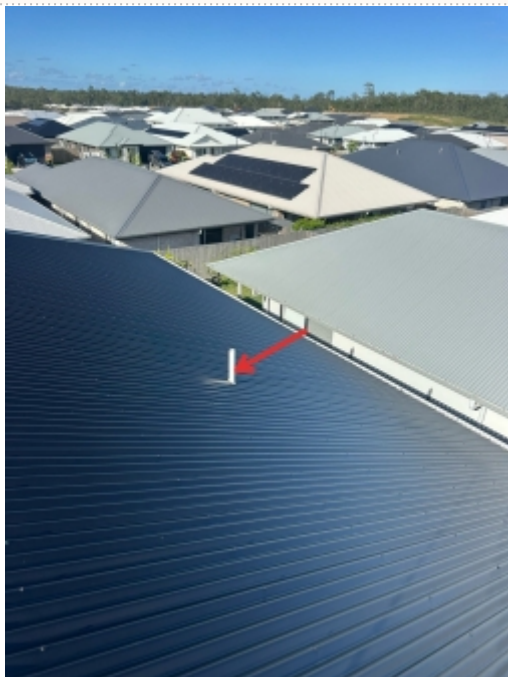
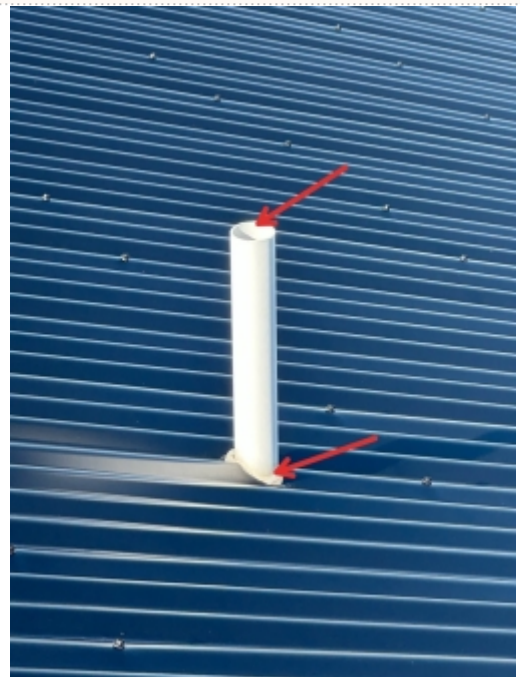
Missing cap and boot flashing around the plumbing vent pipe. Recommend engaging a plumber/roofer to install it to reduce the risk of water penetration and damage.

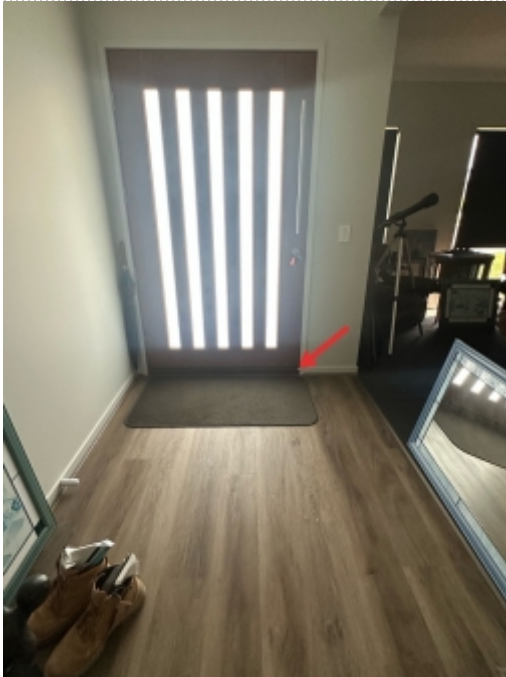
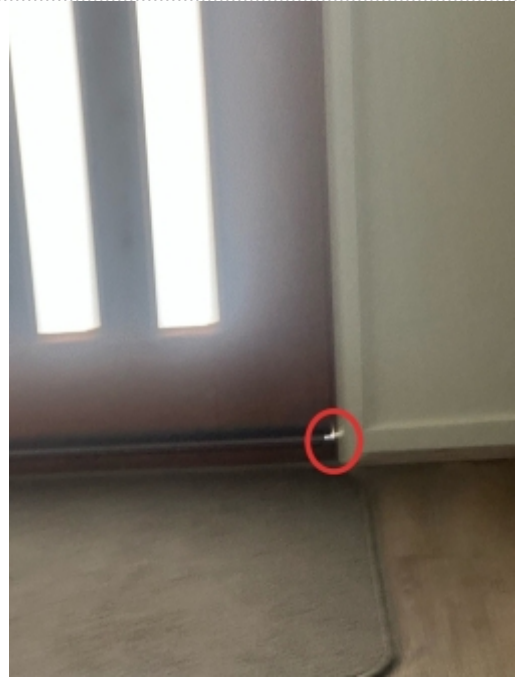
Comment on Minor Defects Showing gap under the entry door, needs weather seal.

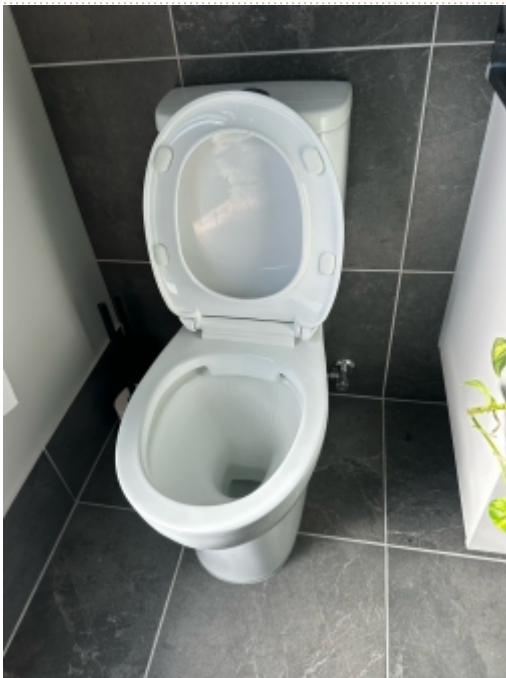
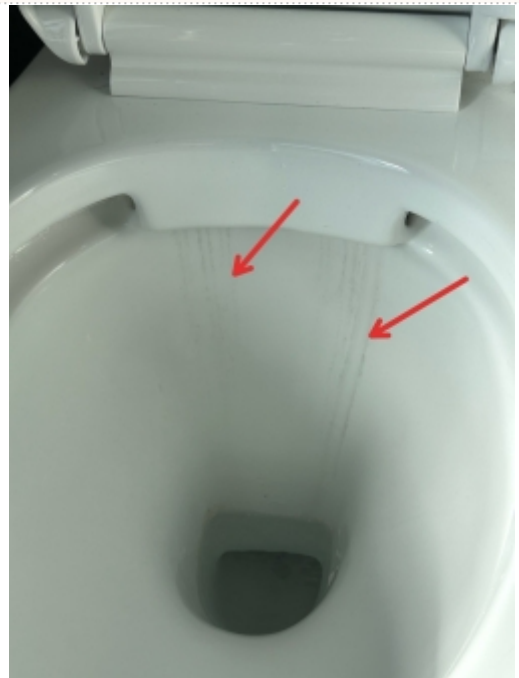
Comment on Minor Defects Showing staining/marks to the toilet pan, recommend contacting a builder/supplier for further advice.

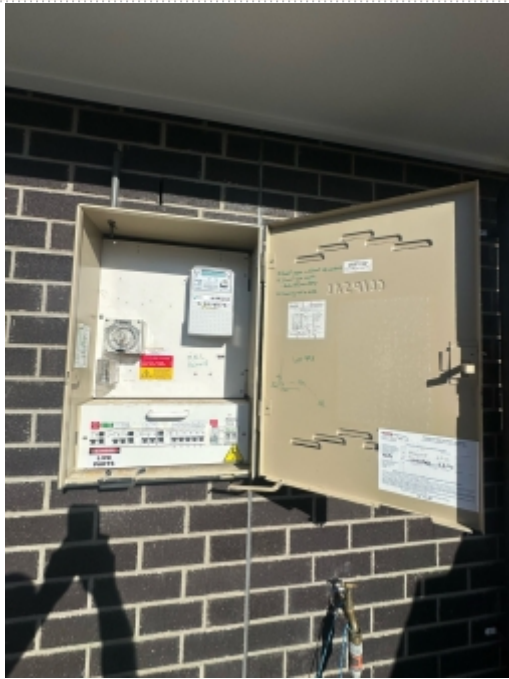
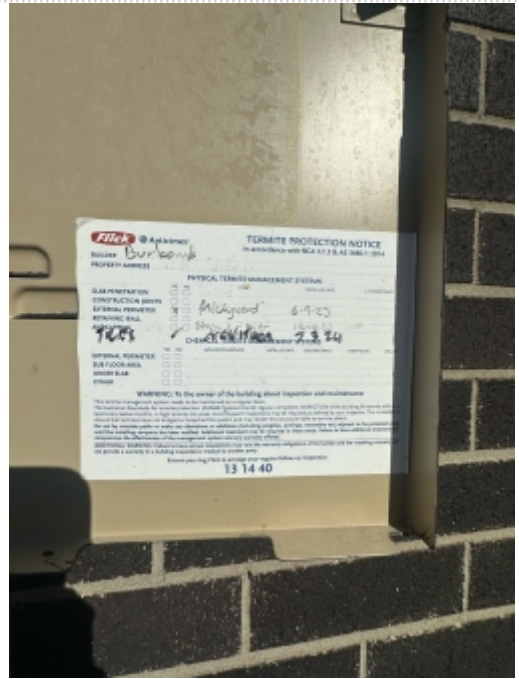
The Termite management notice was found in the meter box at the time of the inspection.
