Frame Stage Inspection Report

77 Guroman Drive, Greenbank, Queensland, 4124 Australia

Frame Stage Inspection Report - SDA STAGE - Frame Stage Inspection Report 22 Apr 2025

Email address:	info@articon.com.au
Report Number:	ABI-02472
Inspection Date:	22 Apr 2025
Address of the Property Inspected:	77 Guroman Drive, Greenbank, Queensland, 4124 Australia

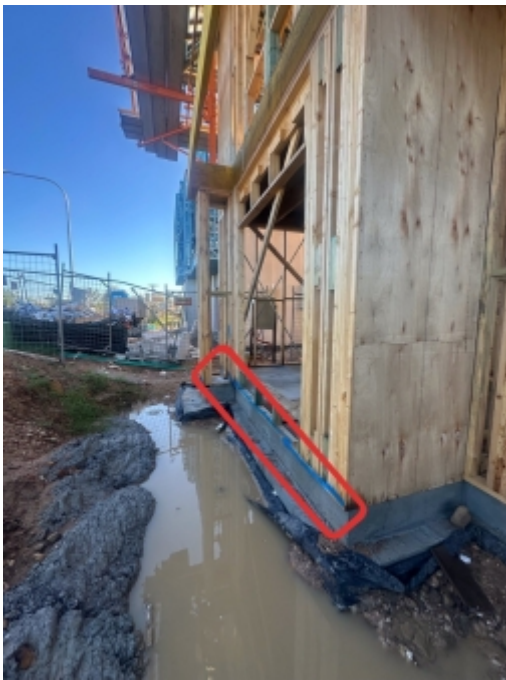
House Edge Rebate

Defect Details Timber frame bottom plates are overhung more than the maximum allowance of 10mm in one or more areas of the slab. Non-shrinkage cement-based material is to be applied to the side of the slab rebate to cover the bottom plate. Guide to Standards and Tolerances - 4.08: Bottom plates that are 90 mm wide or greater and overhang concrete slabs by more than 10 mm are defective.

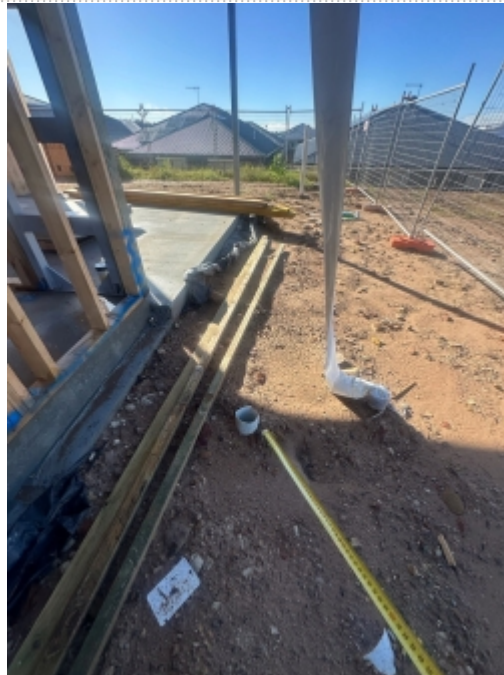
Stormwater Drainage Defects

Uncapped drainage pipe, needs rectifying.
Stormwater pipes are not capped which can cause future water blockage by entered construction work materials and debris.

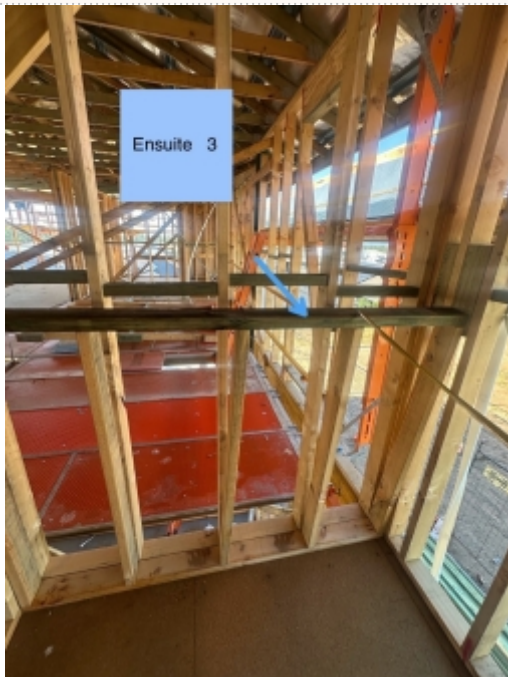
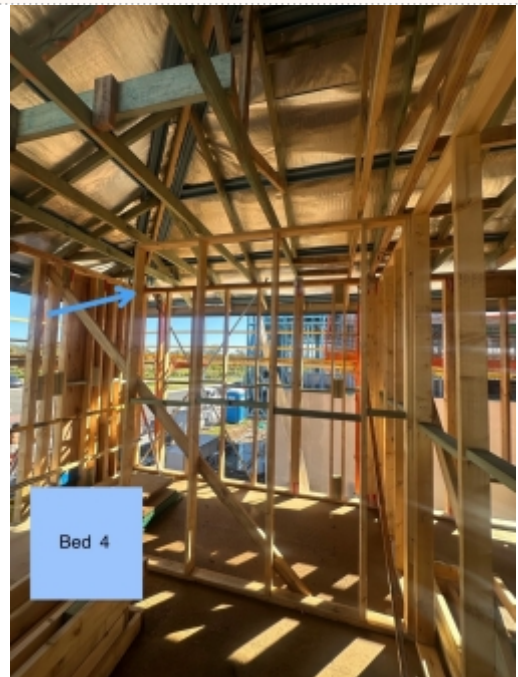
Wall Framing

Defects Details	Loose wall to the bedroom 4 and ensuite 3. Recommend engaging a qualified carpenter for future advice on rectification.
-----------------	---

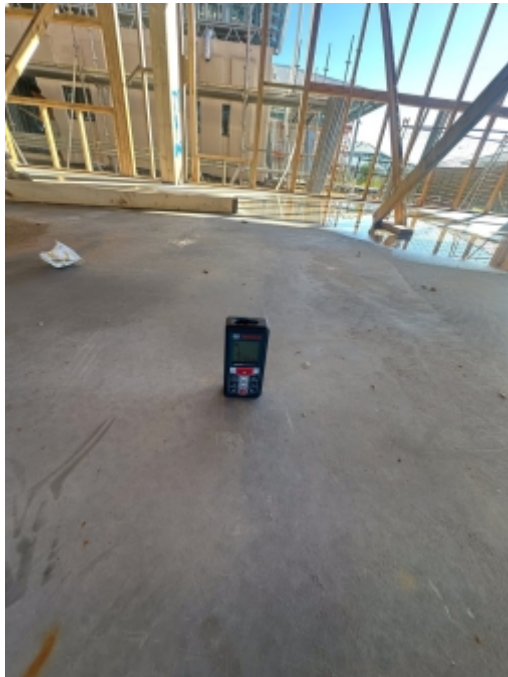
The height from the top of the concrete slab to the underside of the joists/trusses is:

2.71m

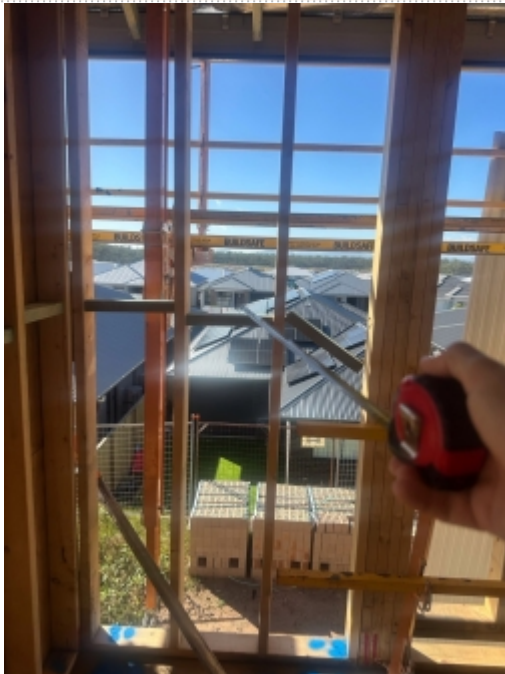
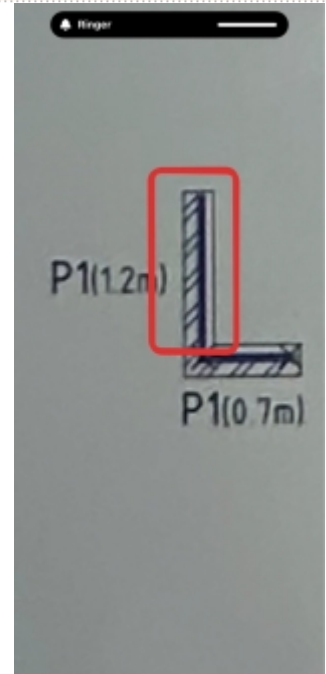
Missing playwood bracing to the master bedroom. Needs installing.

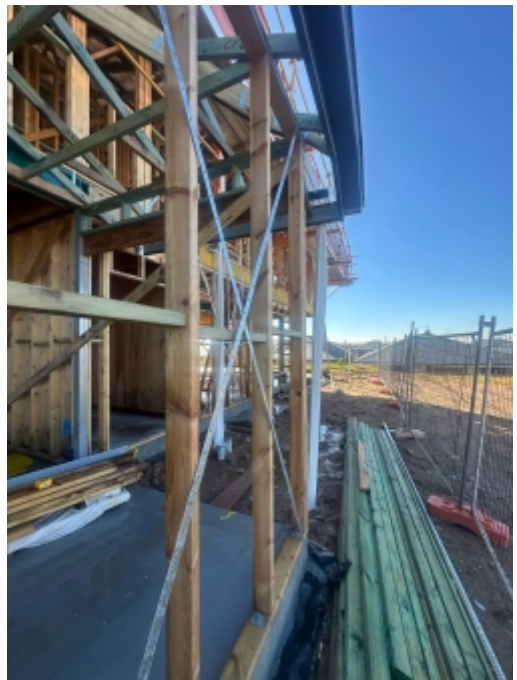
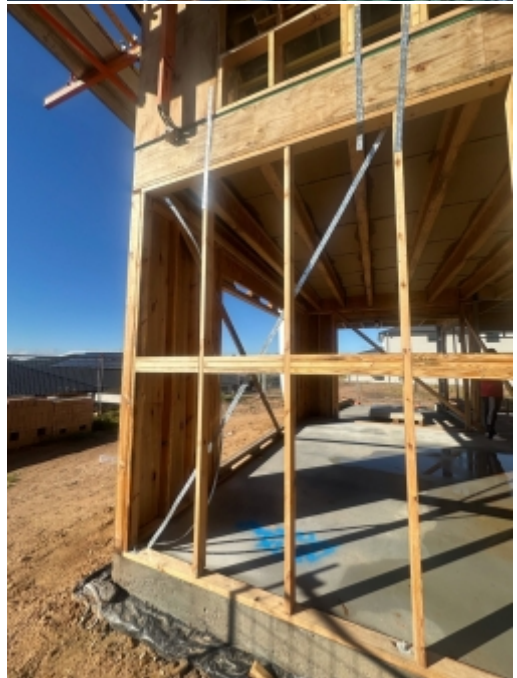
Missing nails/loose metal bracing to parts. Recommend engaging a qualified carpenter for further advice on repairs.

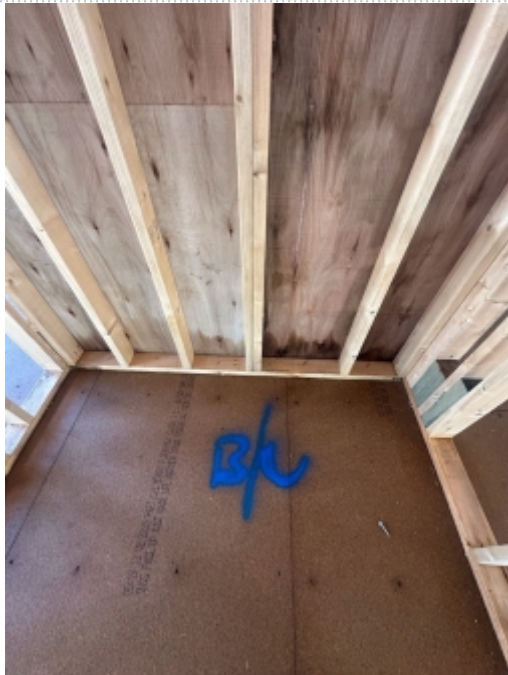
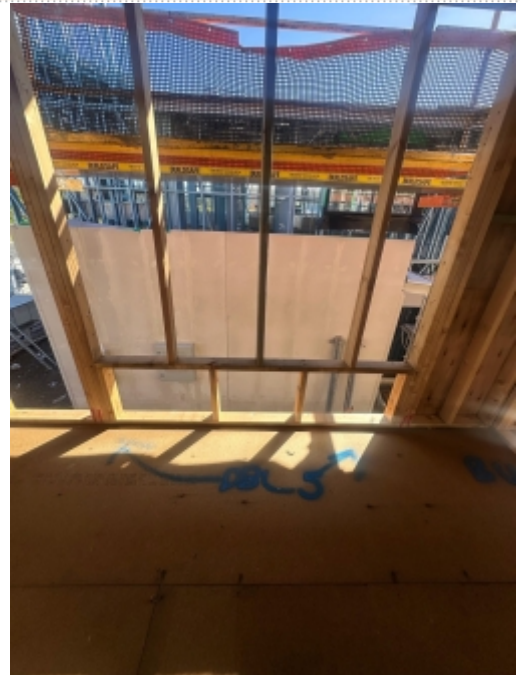
Missing Tie-Down:

Missing tie-down rod to parts. Recommend engaging a qualified carpenter for future advice on rectification.

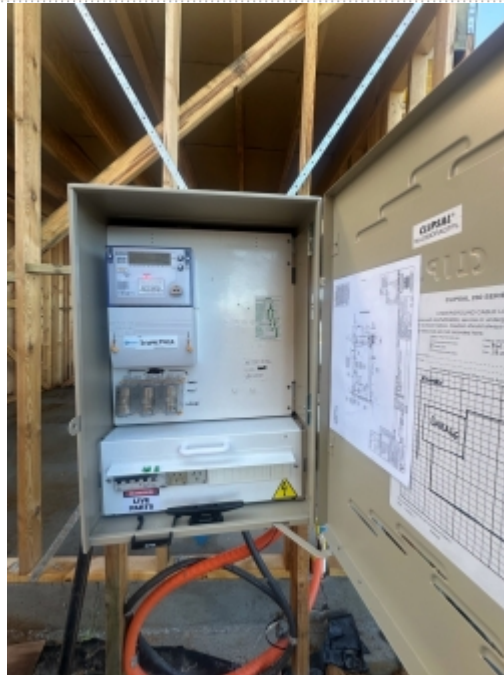
Termite Management Notice Termite Management Notice Not Found: The termite management notice was not found in the metre box at the time of inspection.
