# Frame Stage Inspection Report

77 Guroman Drive, Greenbank, Queensland, 4124 Australia

**Frame Stage Inspection Report - SDA STAGE - Frame Stage Inspection Report** 22 Apr 2025

| Report Number: | ABI-02472 |

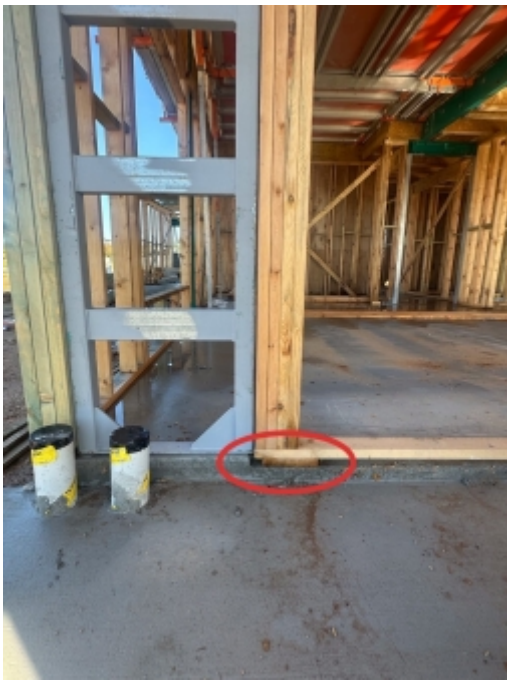
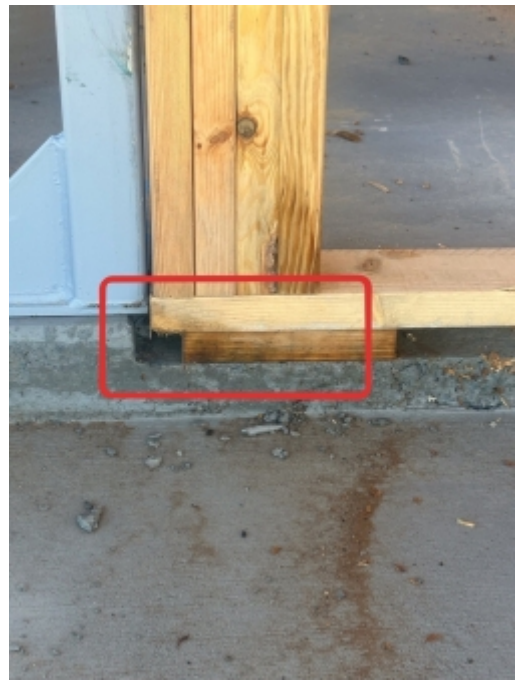
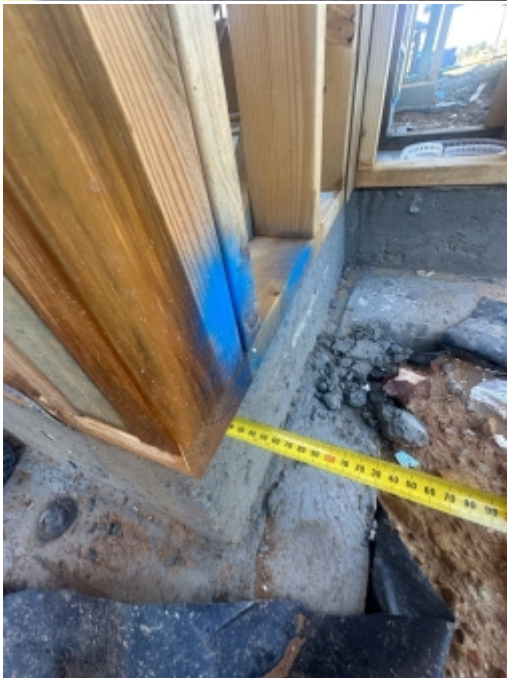
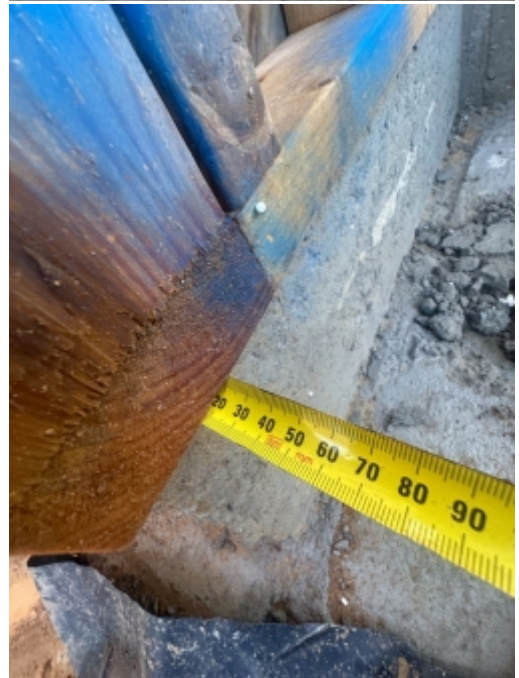
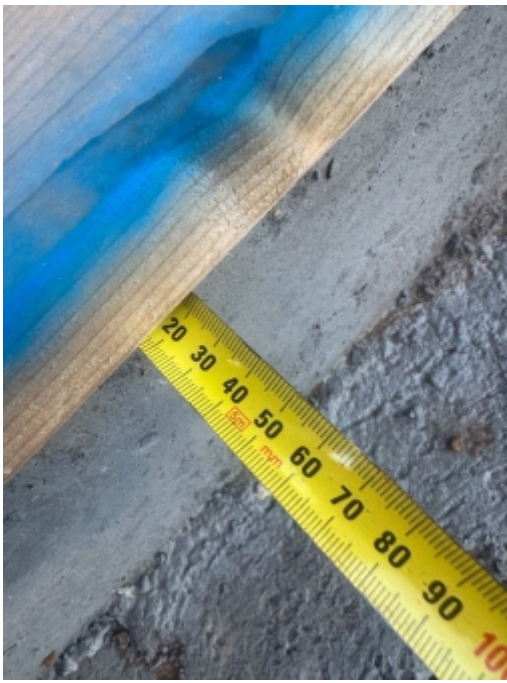
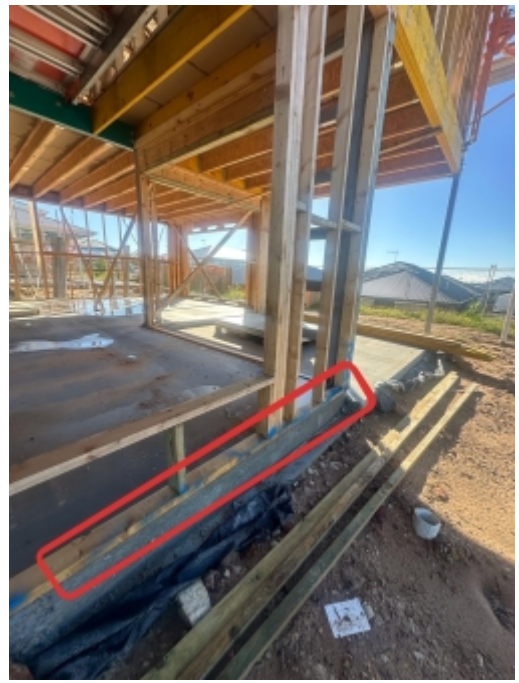
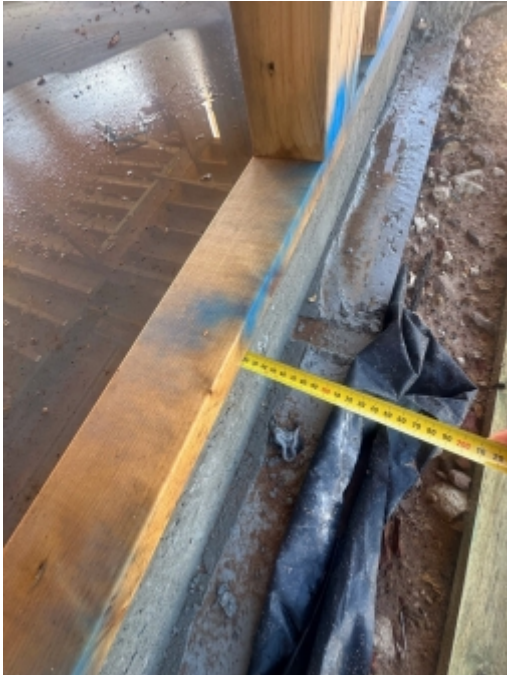
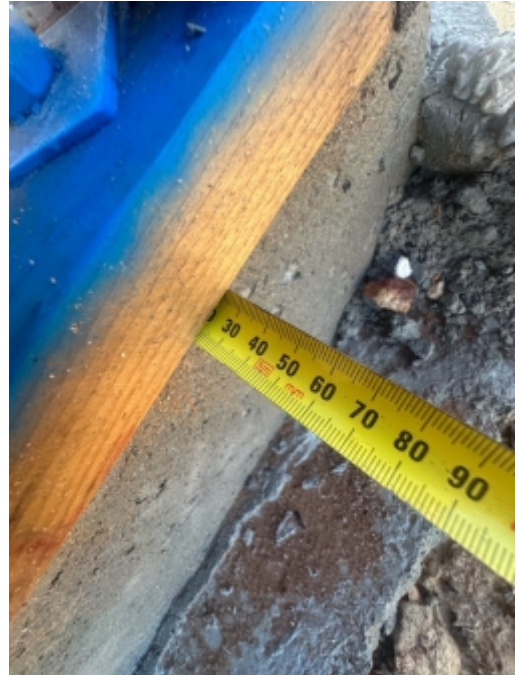
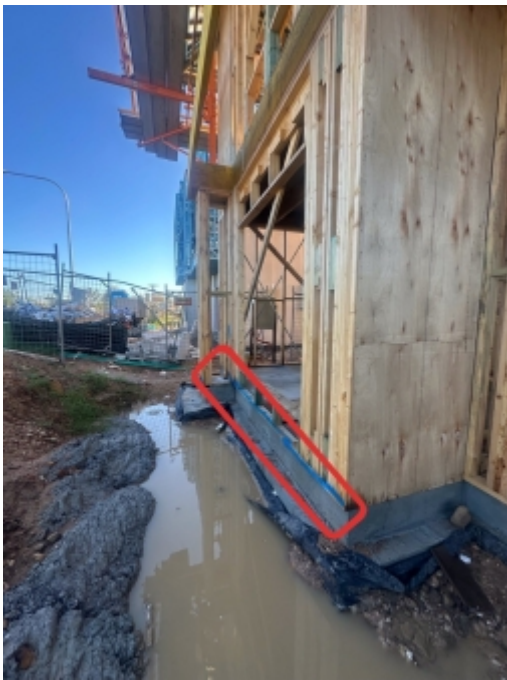
### House Edge Rebate

Defect Details Timber frame bottom plates are overhung more than the maximum allowance of 10mm in one or more areas of the slab. Non-shrinkage cement-based material is to be applied to the side of the slab rebate to cover the bottom plate. Guide to Standards and Tolerances - 4.08: Bottom plates that are 90 mm wide or greater and overhang concrete slabs by more than 10 mm are defective.

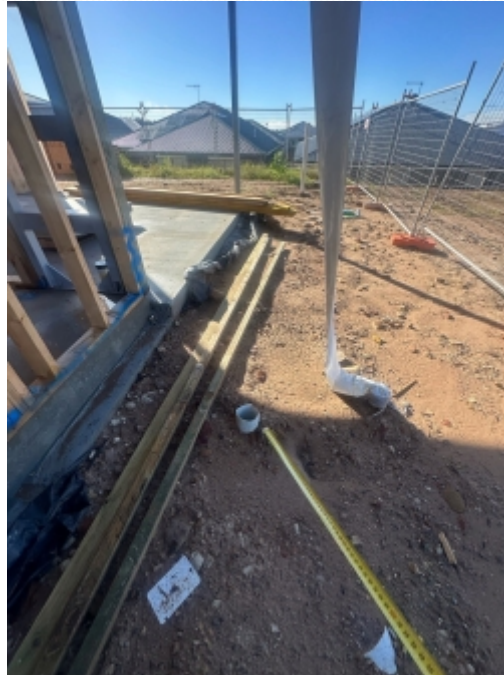
**Stormwater Drainage Defects**

Uncapped drainage pipe, needs rectifying.  
Stormwater pipes are not capped which can cause future water blockage by entered construction work materials and debris.

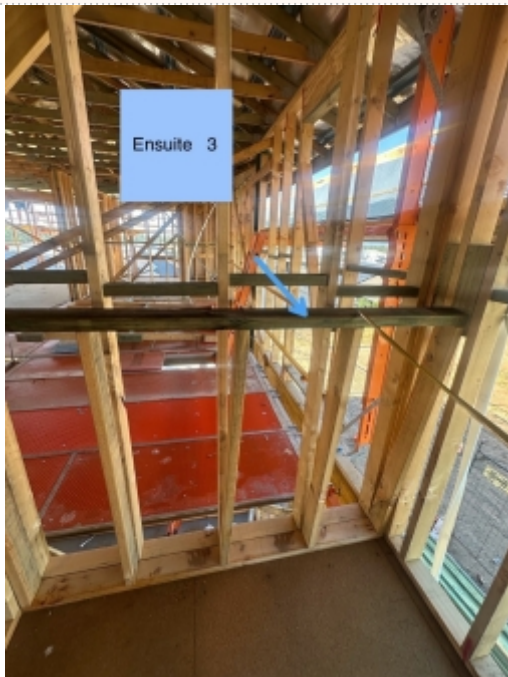
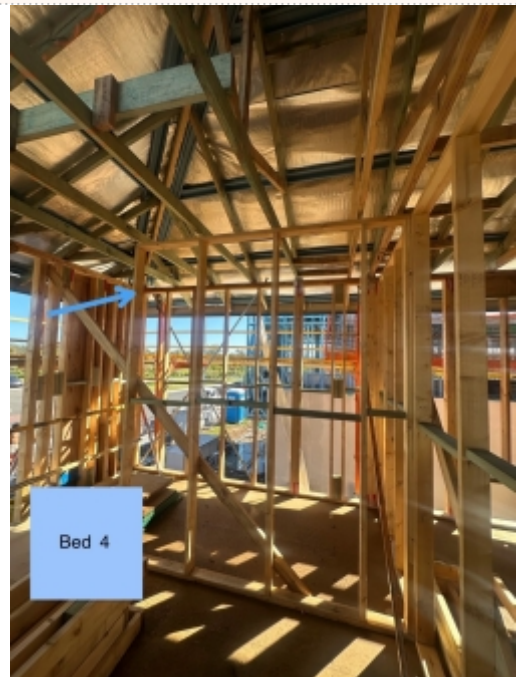
### Wall Framing

| Defects Details | Loose wall to the bedroom 4 and ensuite 3. Recommend engaging a qualified carpenter for future advice on rectification. |

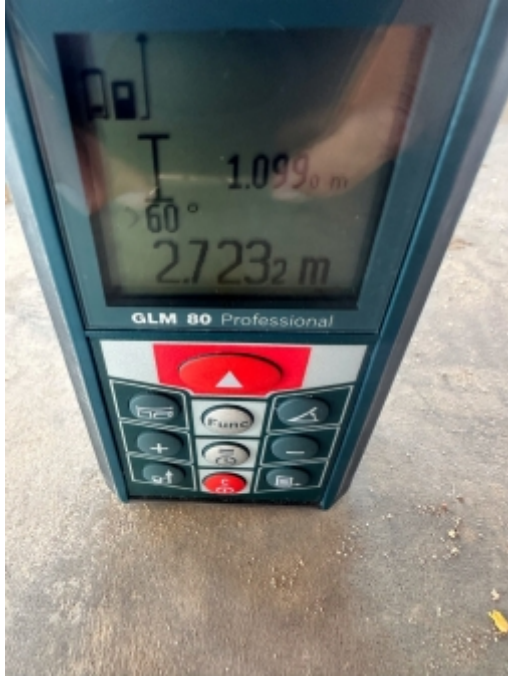
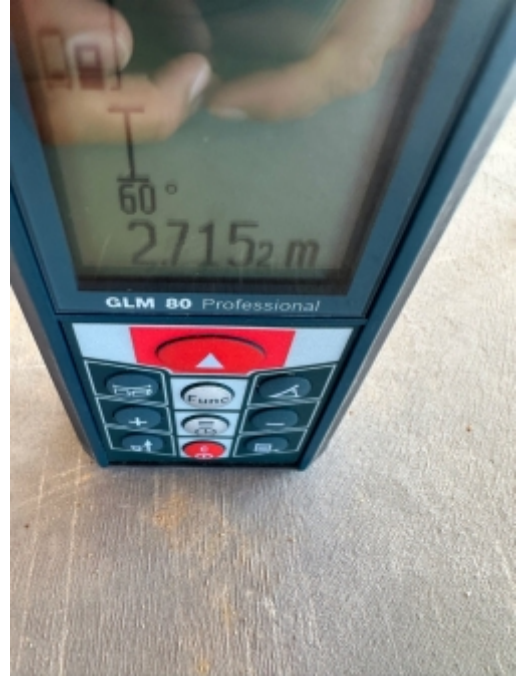
The height from the top of the concrete slab to the underside of the joists/trusses is:

2.71m

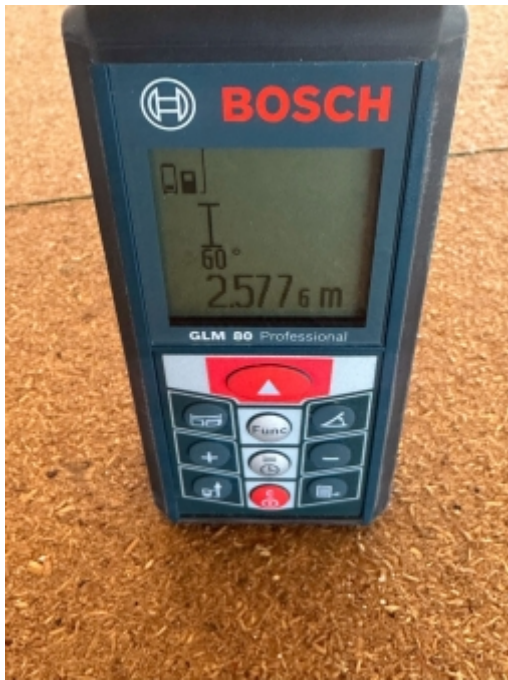
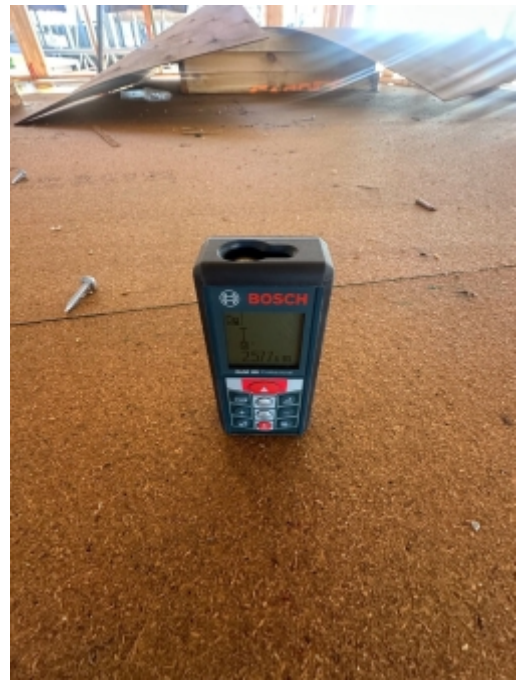
The height between the top of the timber/hebel floor to the underneath of the trusses is:

2.57m

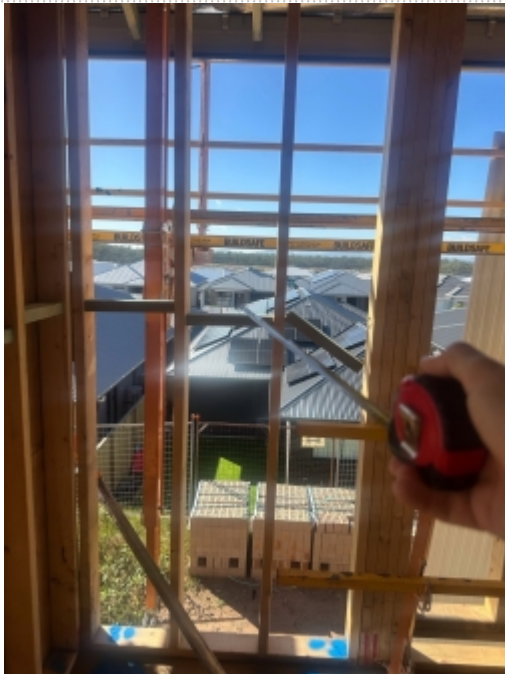
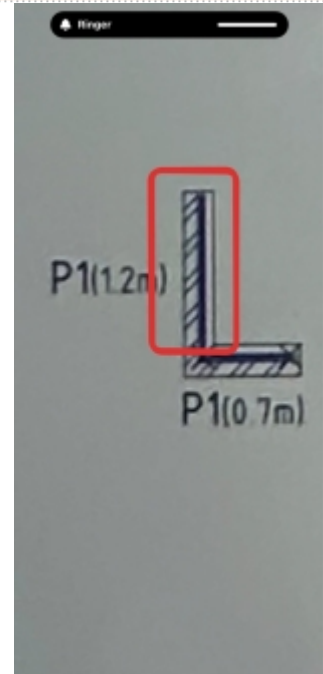
Enter question... Missing playwood bracing to the master bedroom. Needs installing.

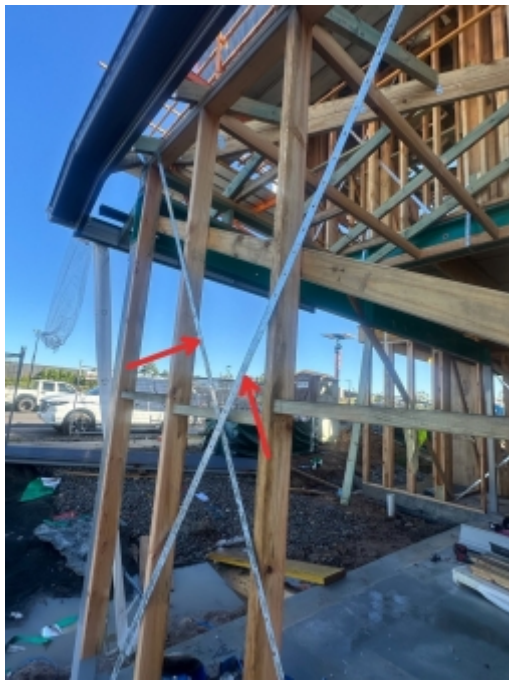
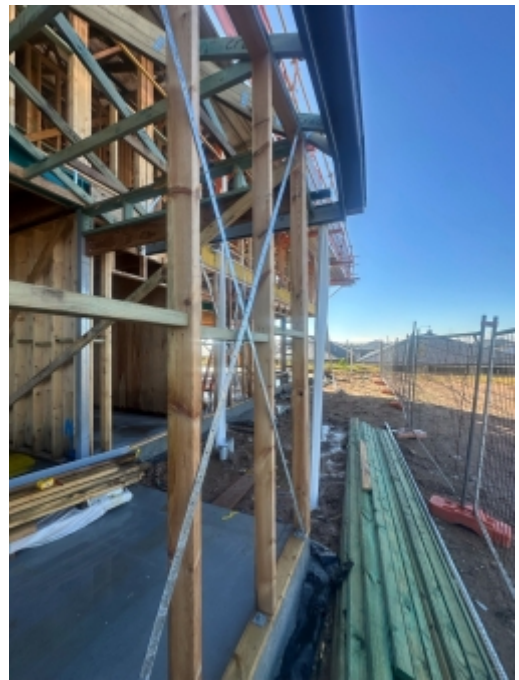
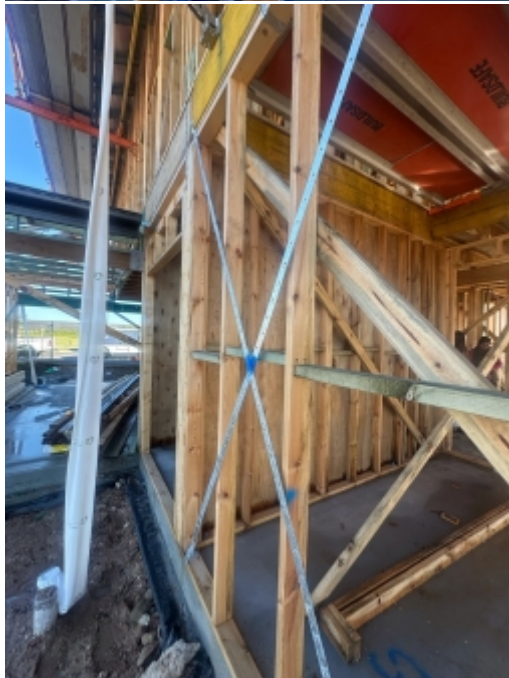
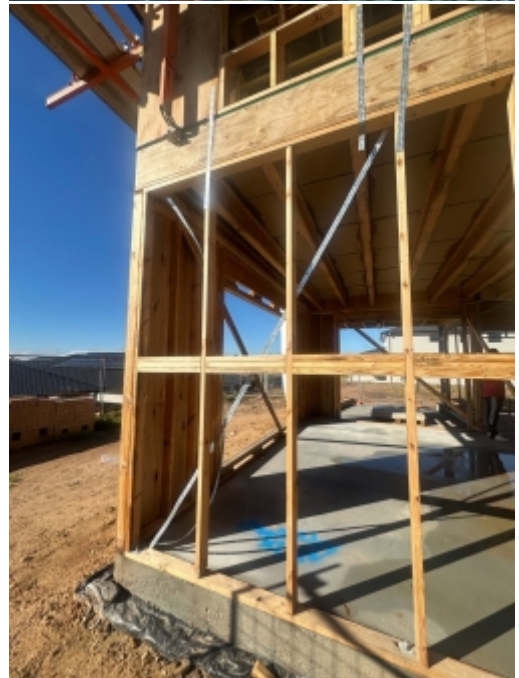
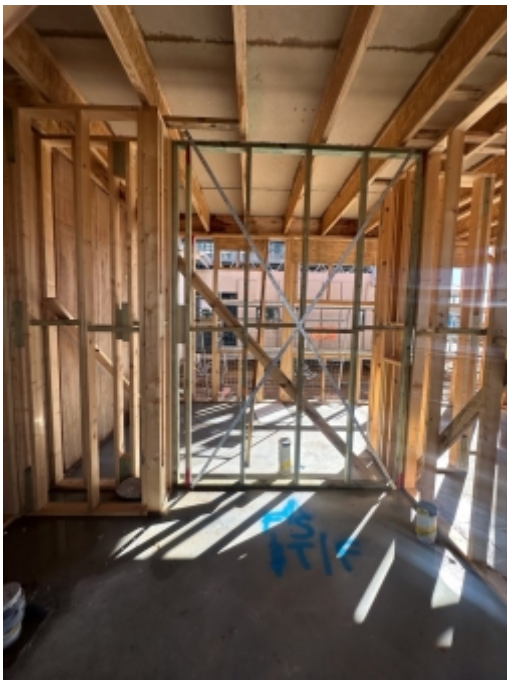
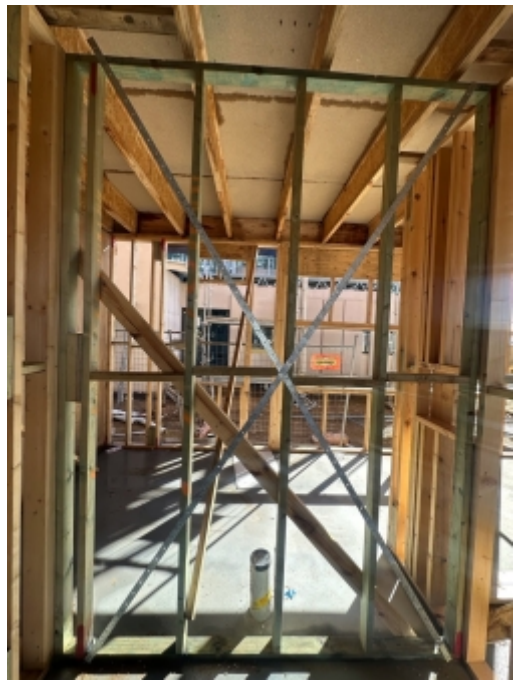
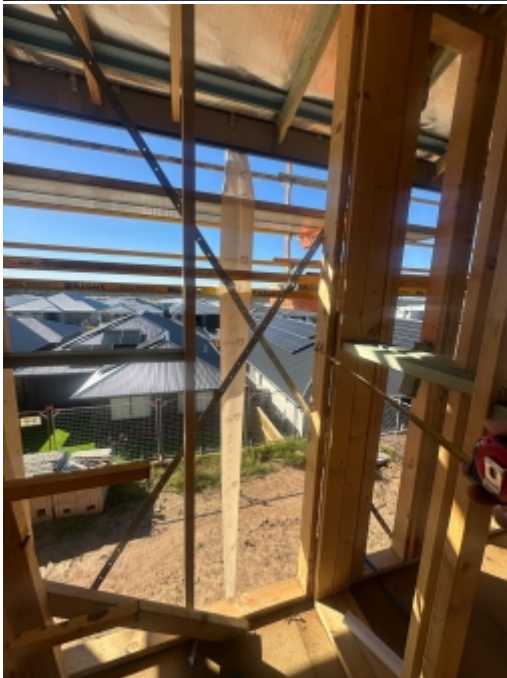
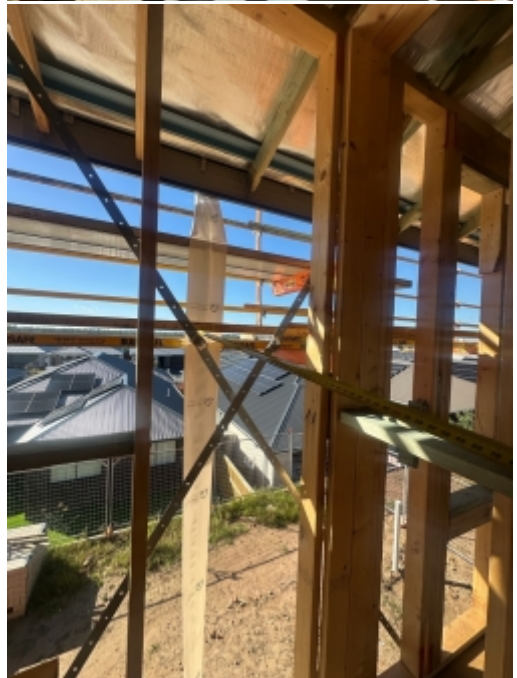
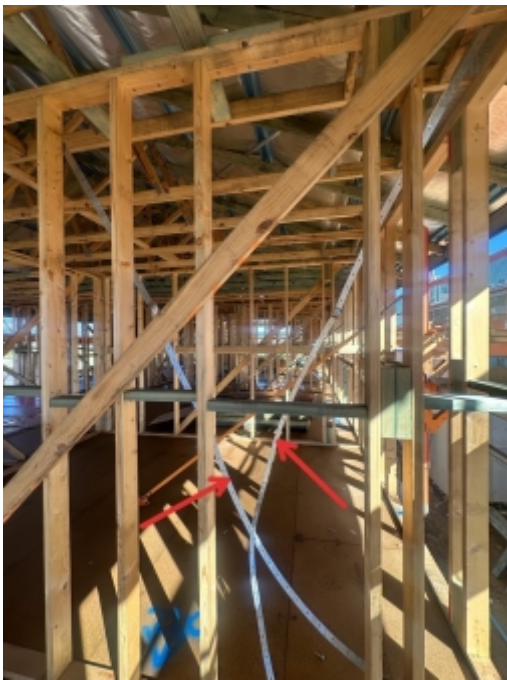
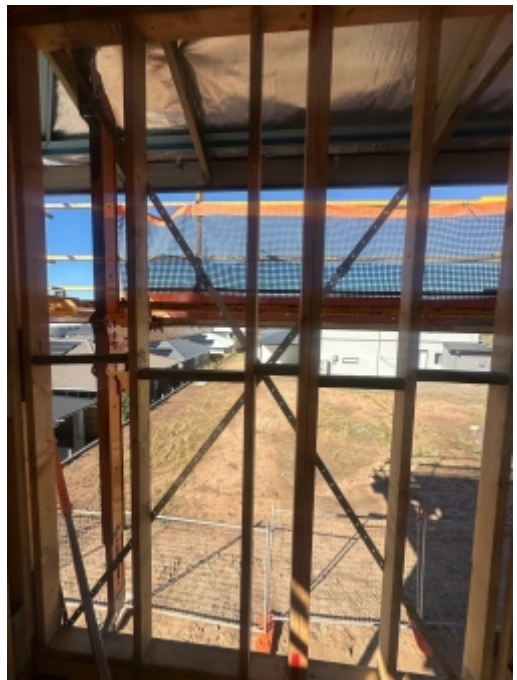
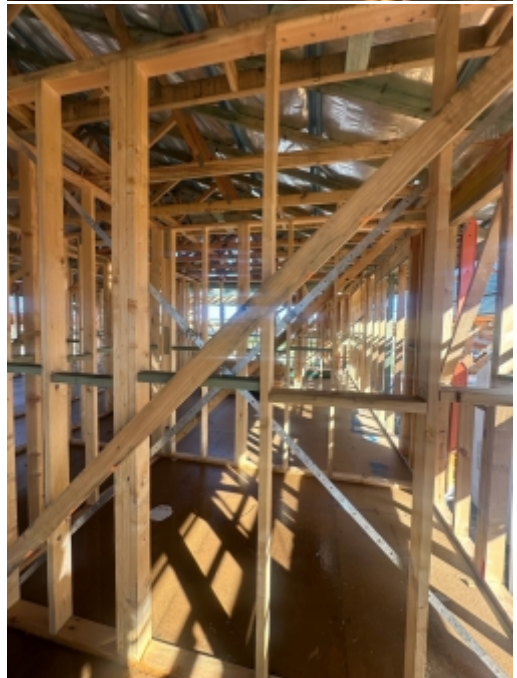
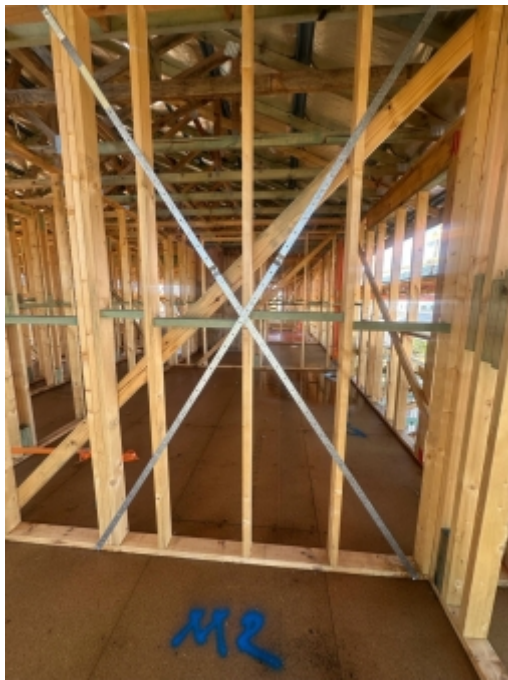
Enter question... Missing nails/loose metal bracing to parts. Recommend engaging a qualified carpenter for further advice on repairs.

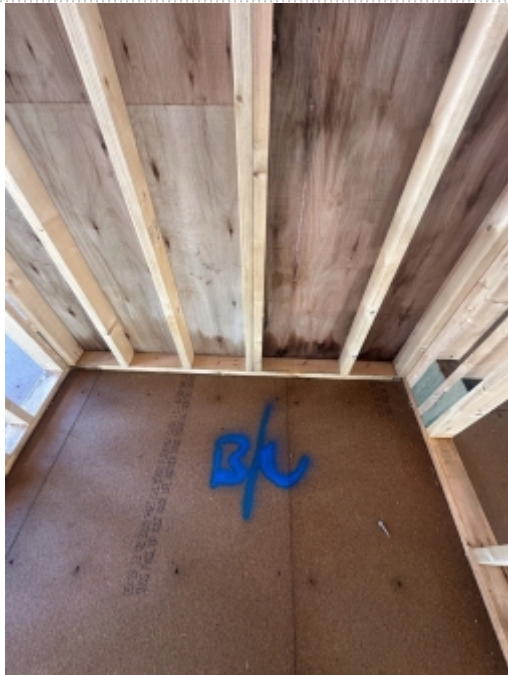
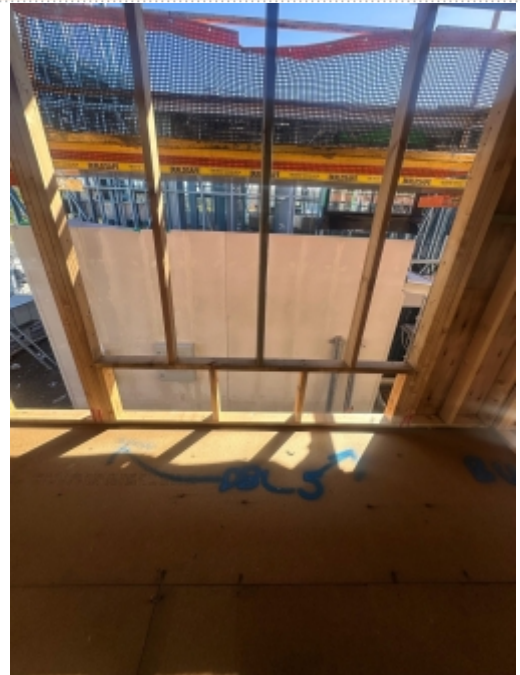
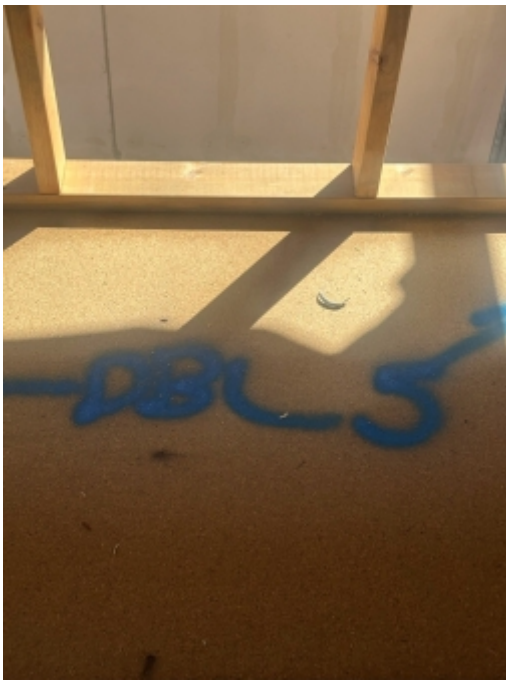
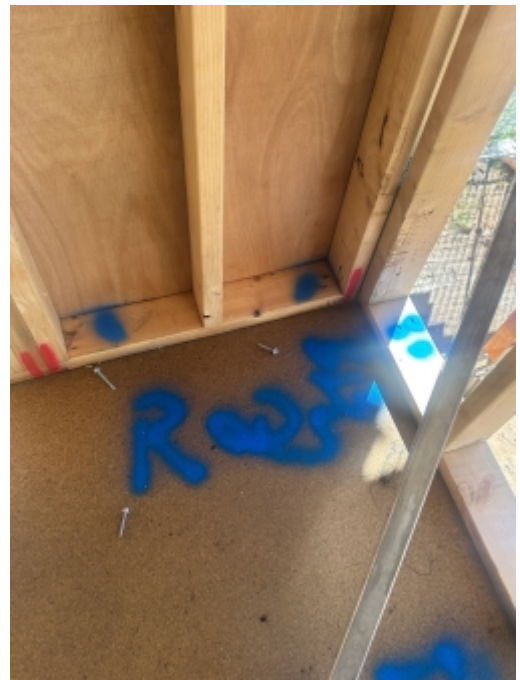
Missing Tie-Down:

Missing tie-down rod to parts. Recommend engaging a qualified carpenter for future advice on rectification.

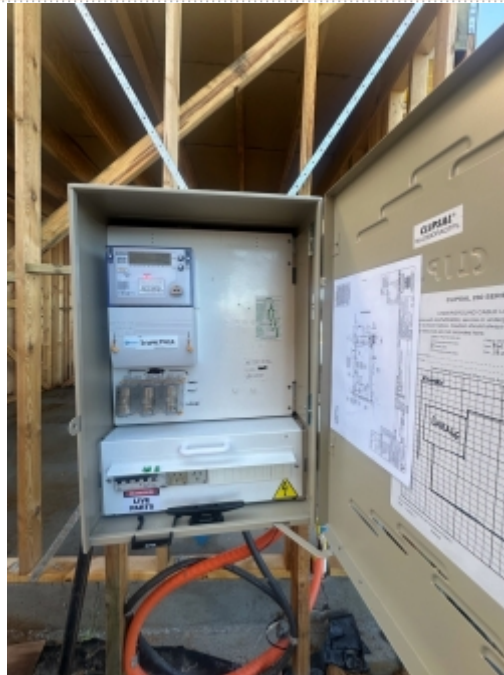
| Termite Management Notice | Termite Management Notice Not Found: The termite management notice was not found in the metre box at the time of inspection. |
