PCI (Practical Completion Inspection) Report

lot 4308/30 Peach Avenue Greenbank 4124 Queensland Australia

Report number:	ABI-03079
Inspection Date:	01 Apr 2026
Property Address	lot 4308/30 Peach Avenue Greenbank 4124 Queensland Australia
Special conditions or instructions	
Special conditions or instructions	There are no special conditions or instructions.
The parties	
Name of Client:	Shane Chand

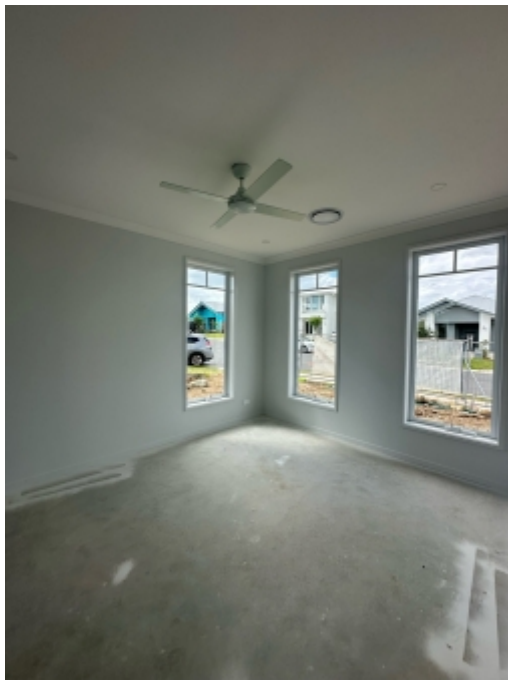
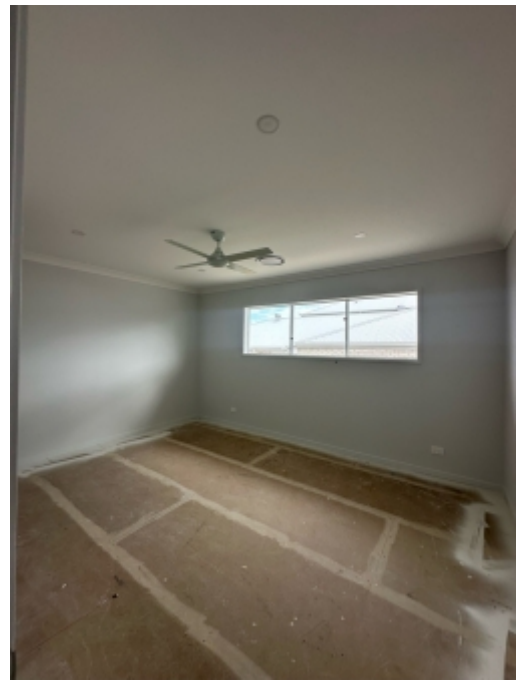
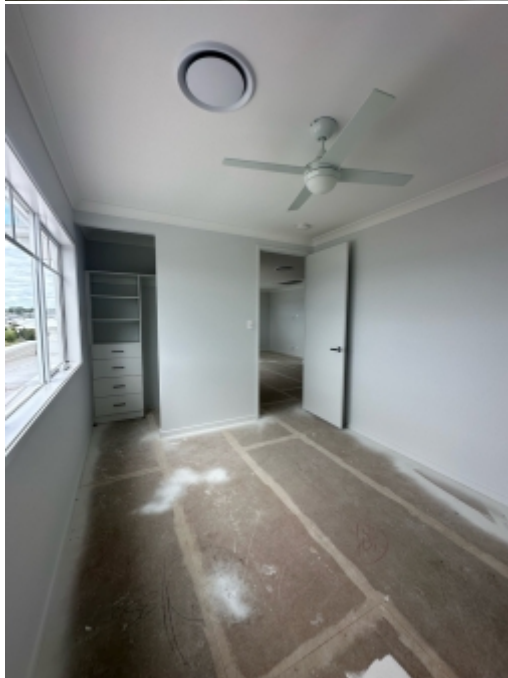
The floor carpet was not installed at the time of the inspection.

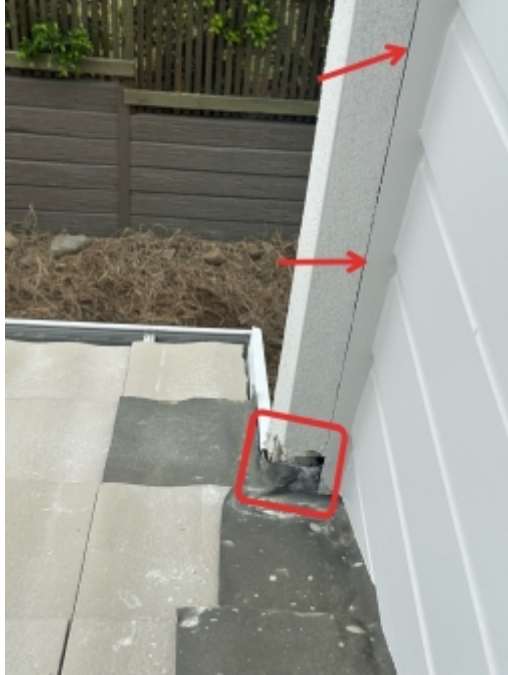
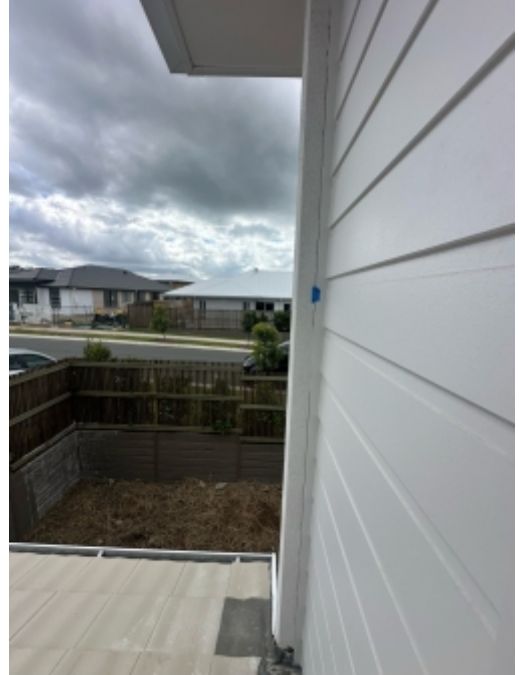
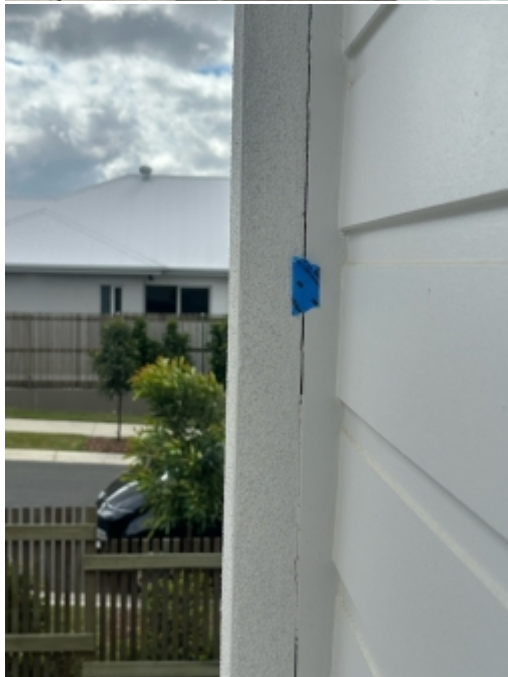
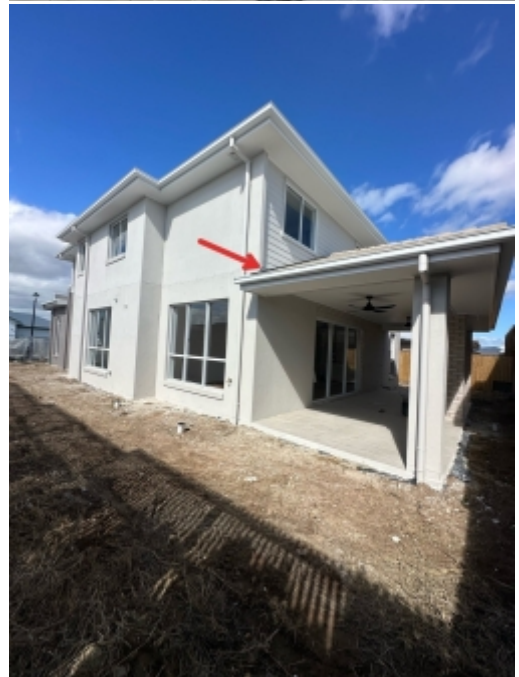
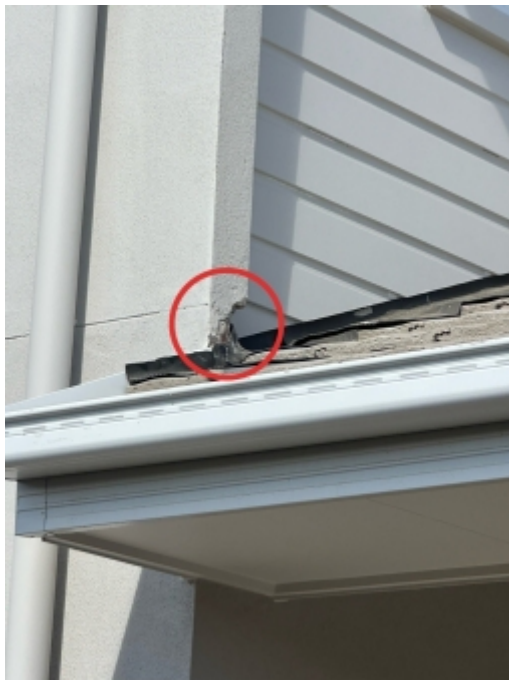
It appears some of the cladding is poorly installed without the proper use of flashing, inadequate fixings, and poor workmanship. Recommend engaging a builder to rectify to reduce the risk of water penetration and further deterioration. Recommend undertaking the above as soon as practical.

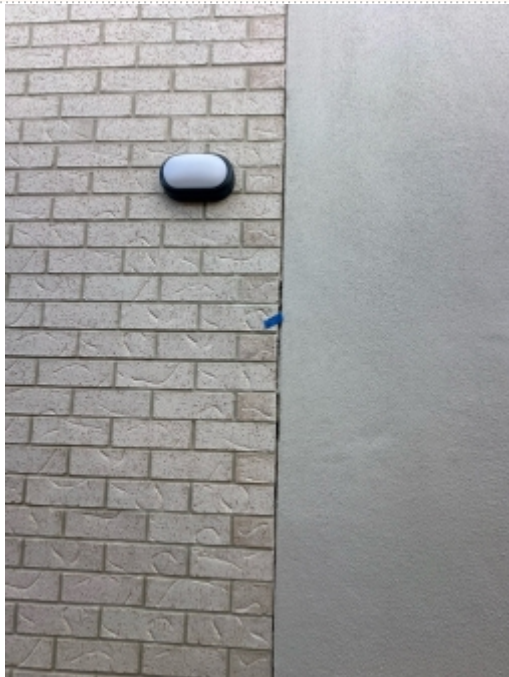
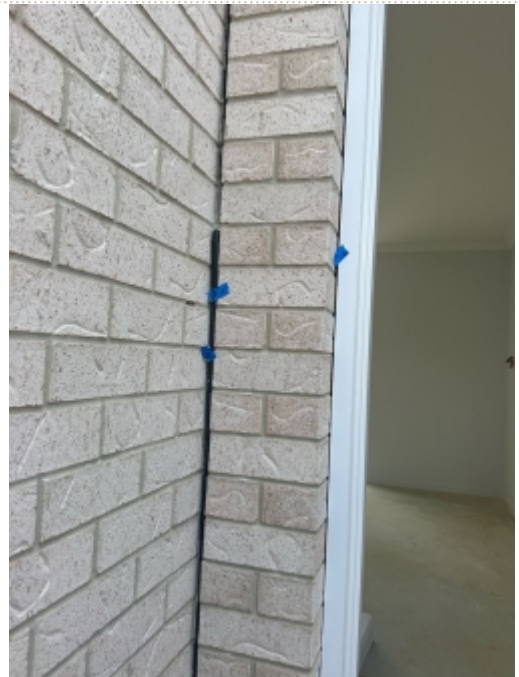
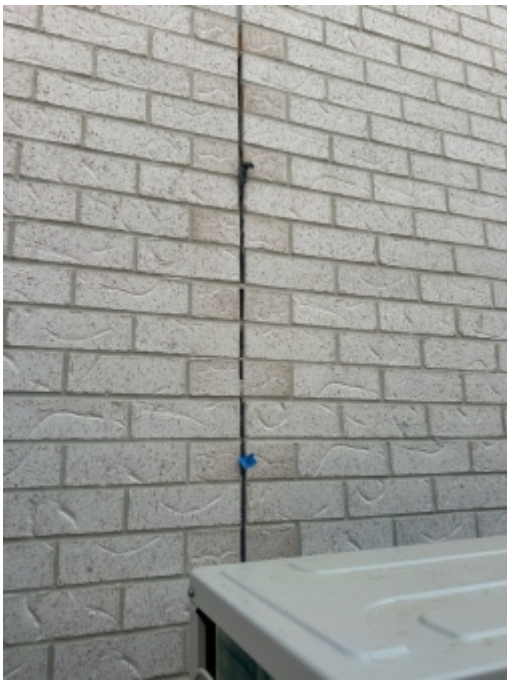
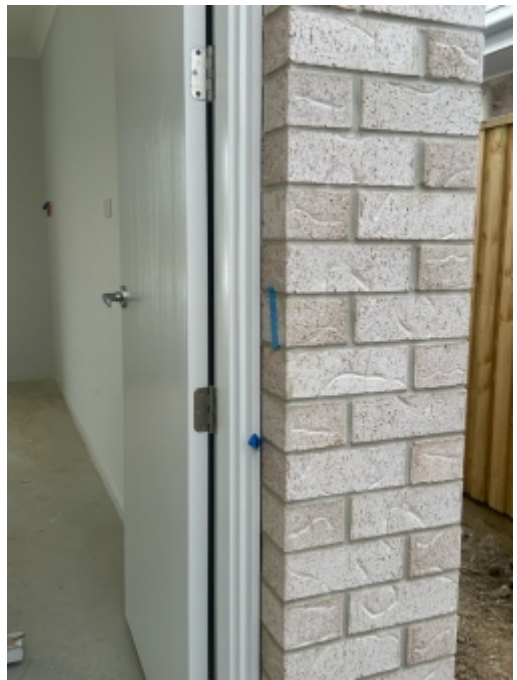
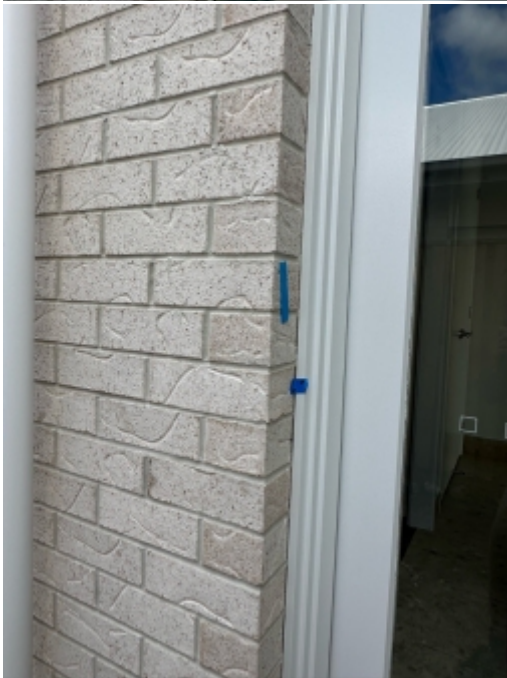
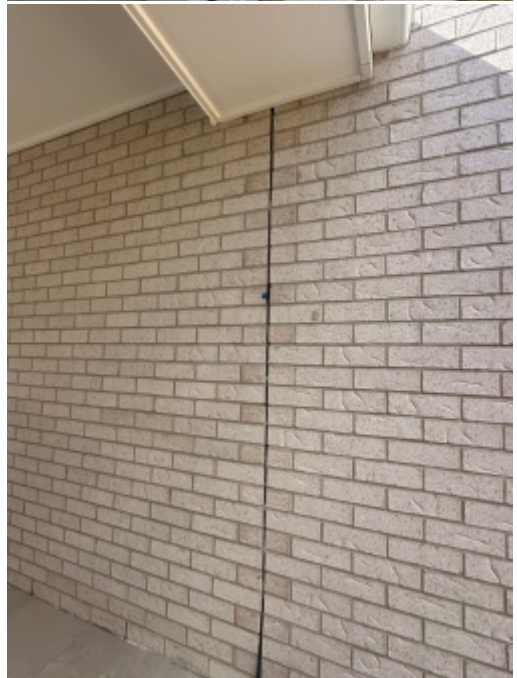
It appears the expansion joints to the brickwork may require re-sealing. This presents a risk of water penetration and vermin-related issues. Recommend engaging a bricklayer to rectify. Recommend undertaking the above as soon as practical.

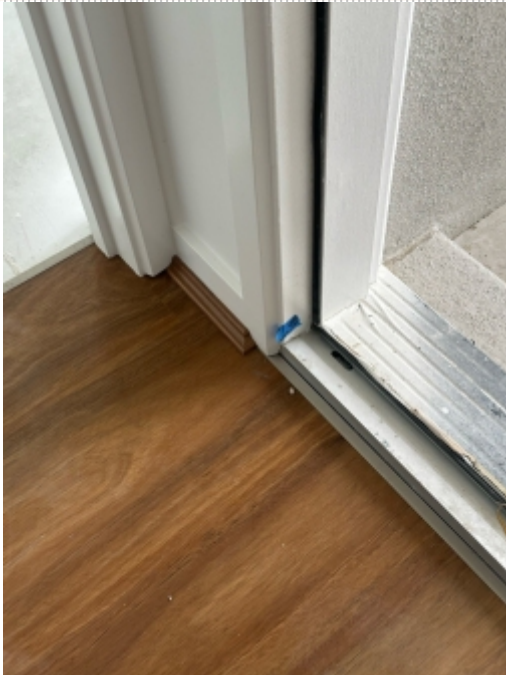
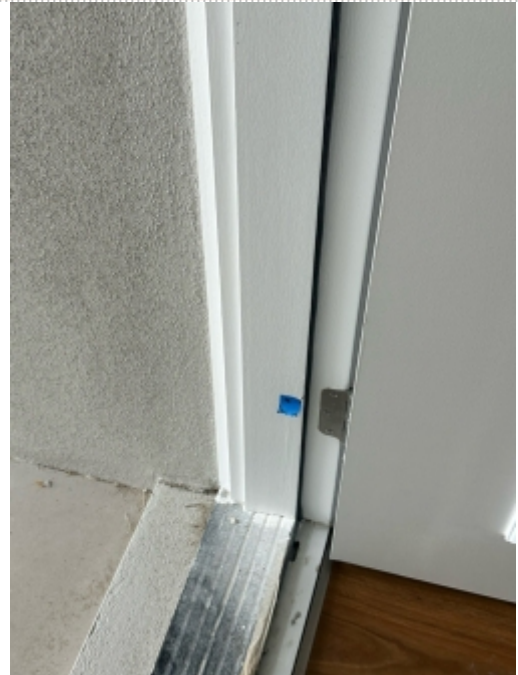
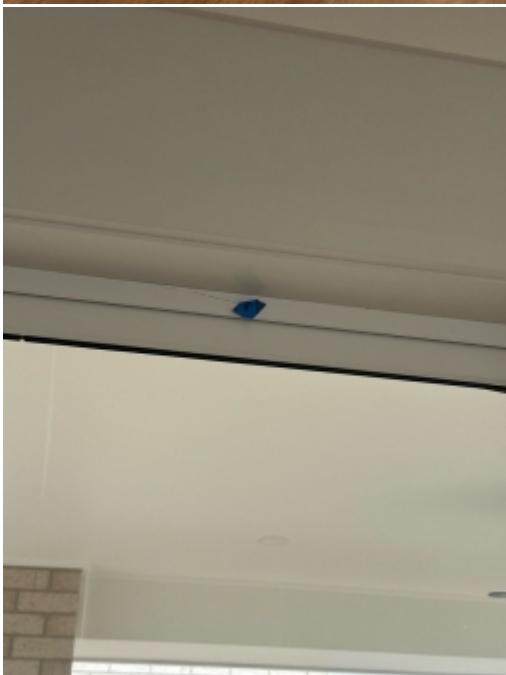
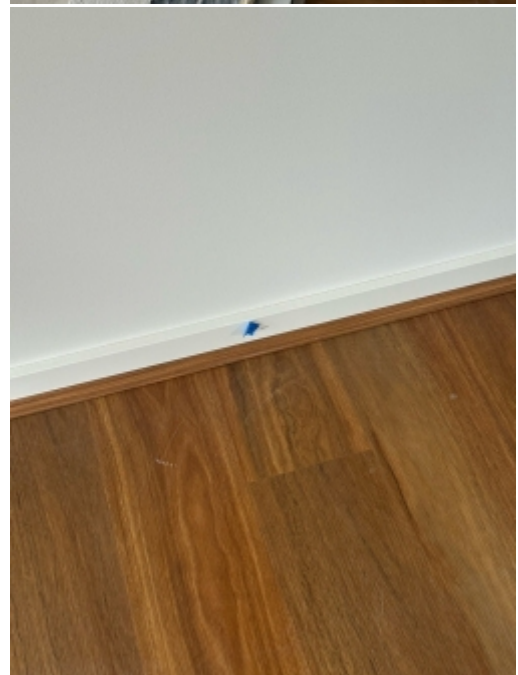
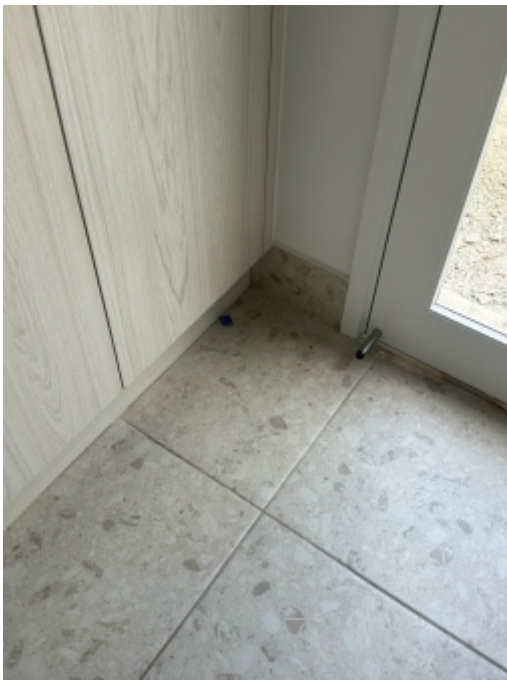
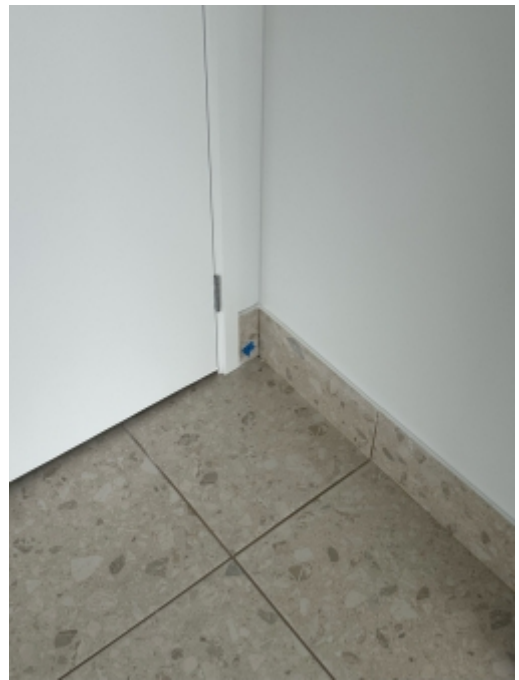
Comments on Minor Defects Showing examples of defective paintwork to parts of the common areas.

Comments on Minor Defects Showing examples of missing/loose silicone to parts.

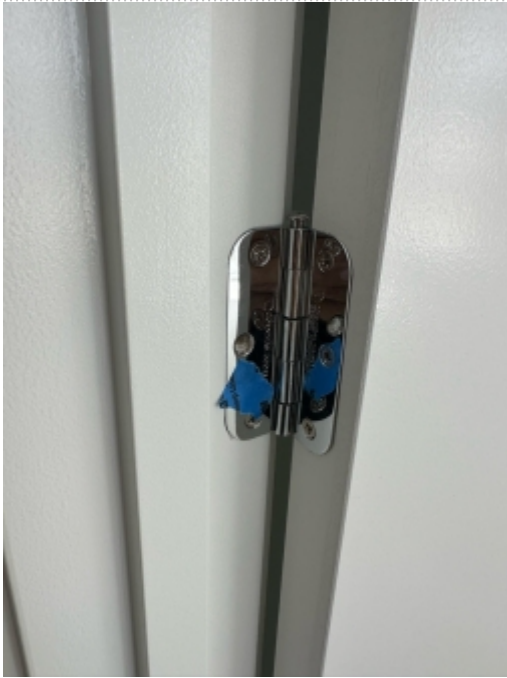
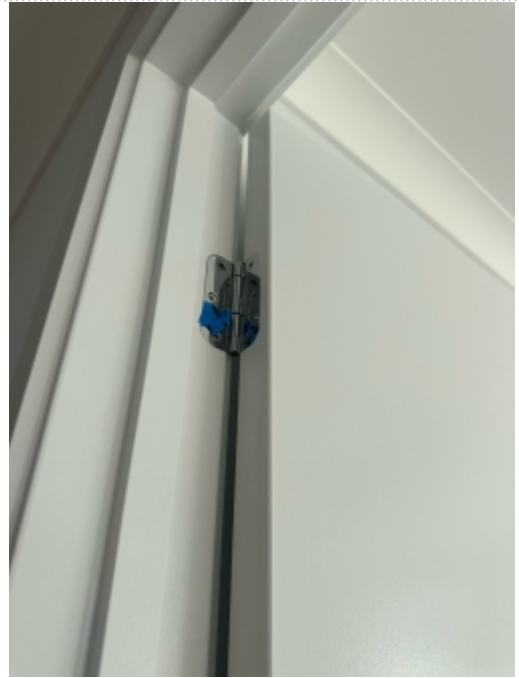
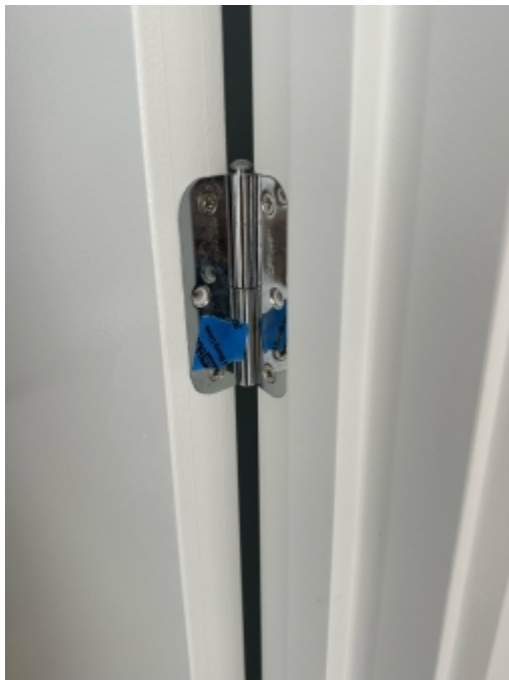
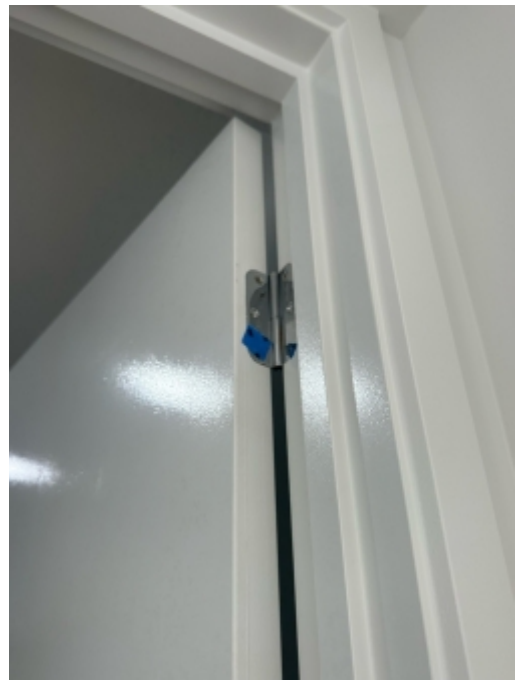
Showing examples of missing screws to the hinges.

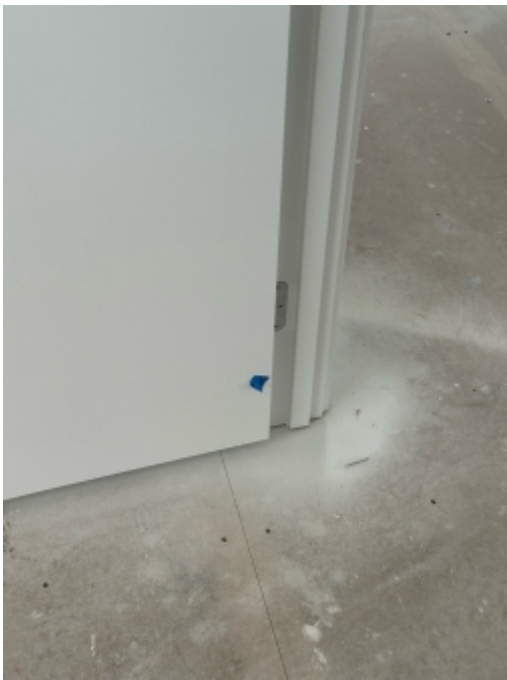
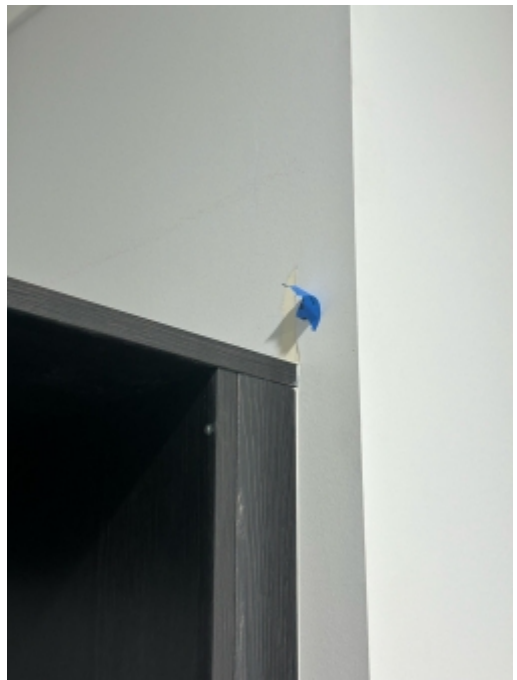
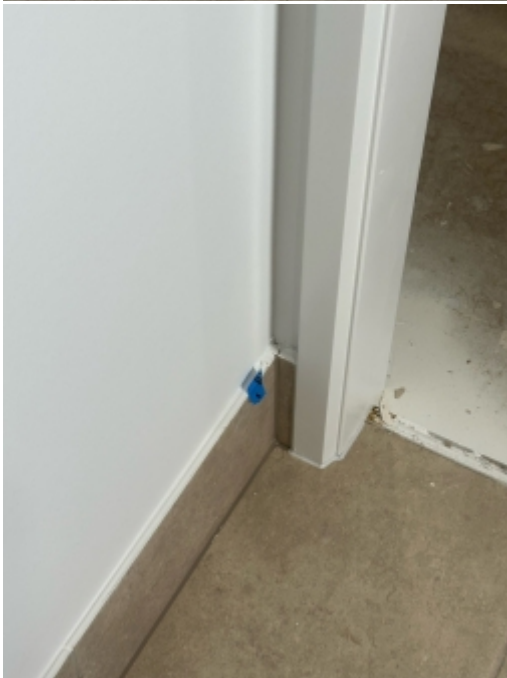
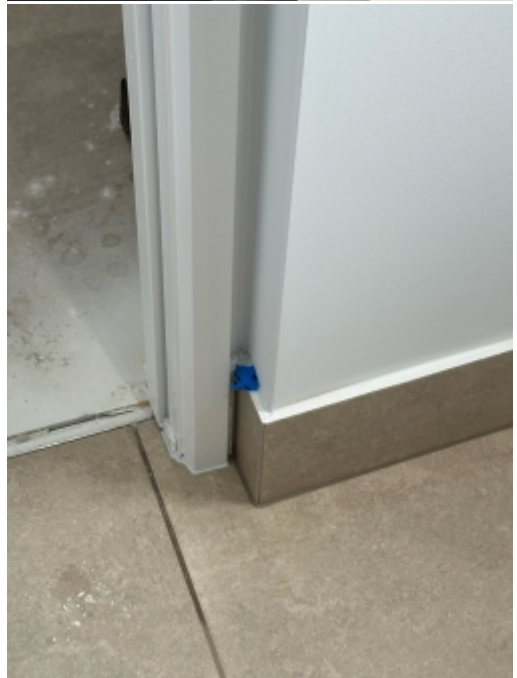
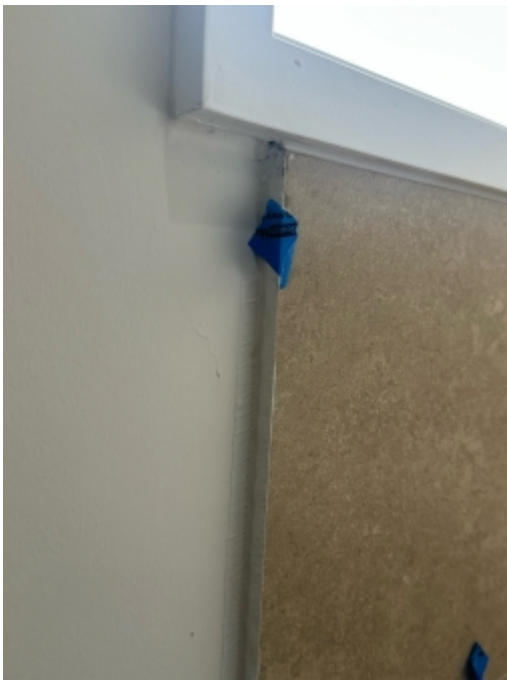
Showing examples of defective paintwork to parts of the Master Bedroom.

Showing examples of defective paintwork to parts of the Ensuite.

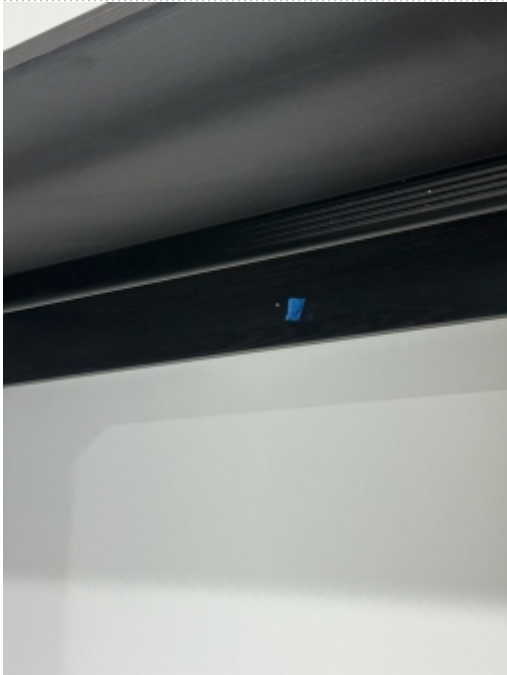
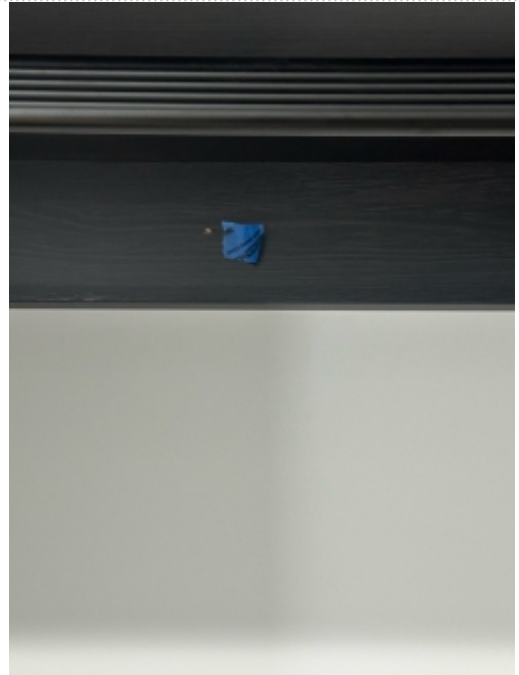
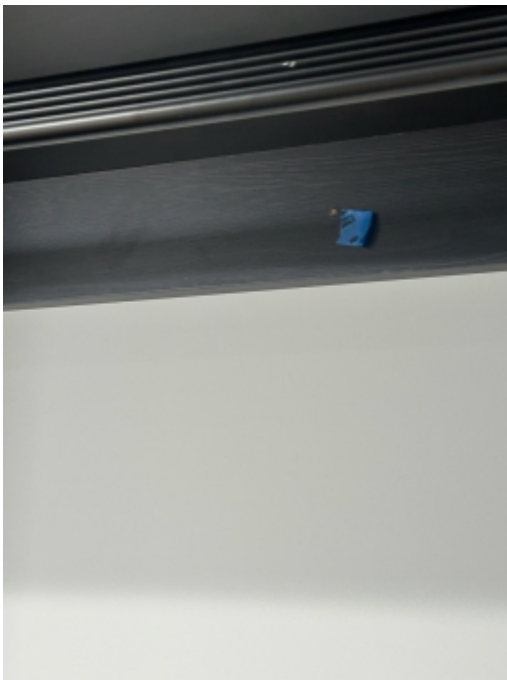
Showing missing screw caps to Walk in robe.

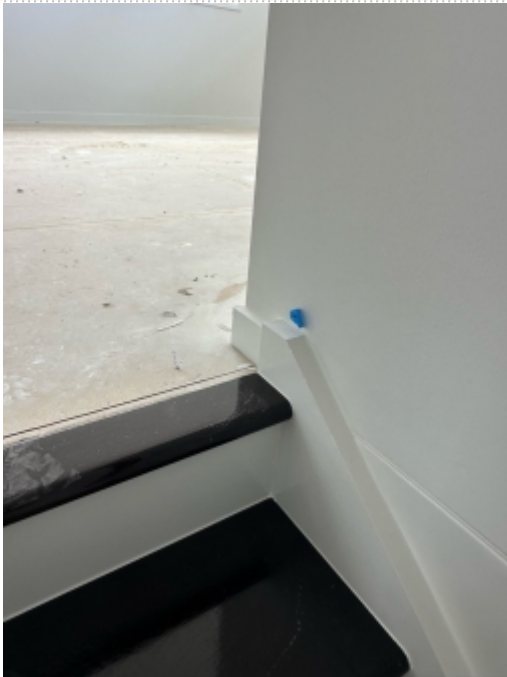
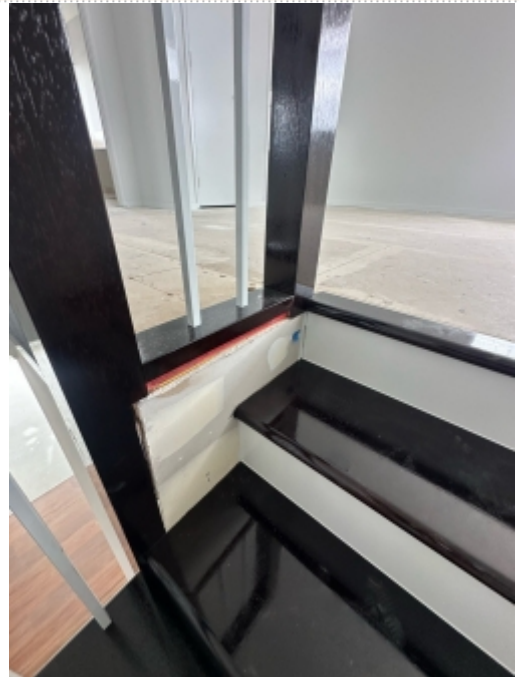
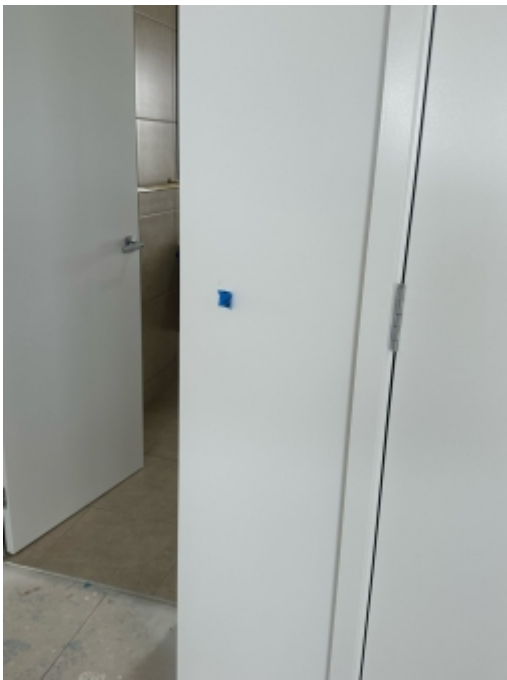
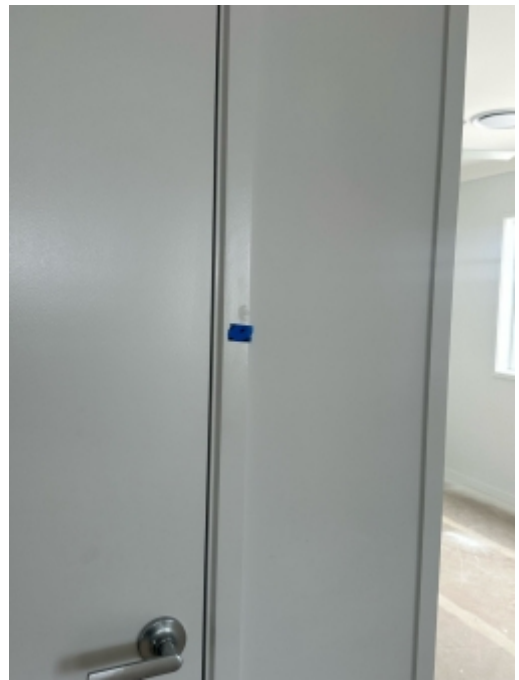
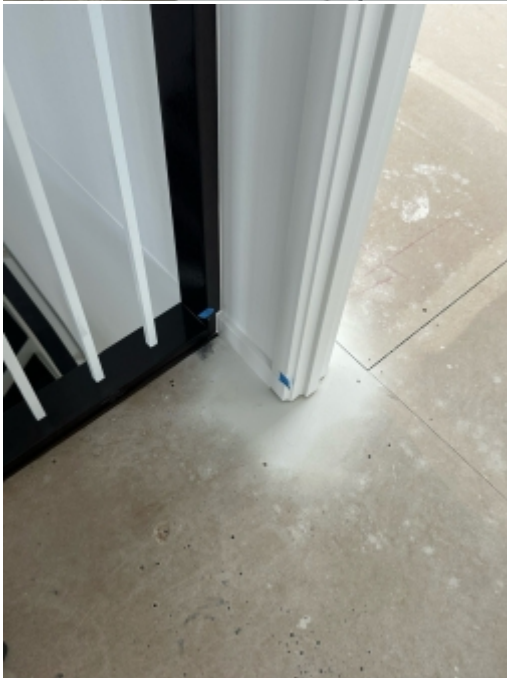
Showing examples of defective paintwork to parts of the common areas.

Showing examples of scratches and defective paintworks to the staircase.

To the upstairs area.

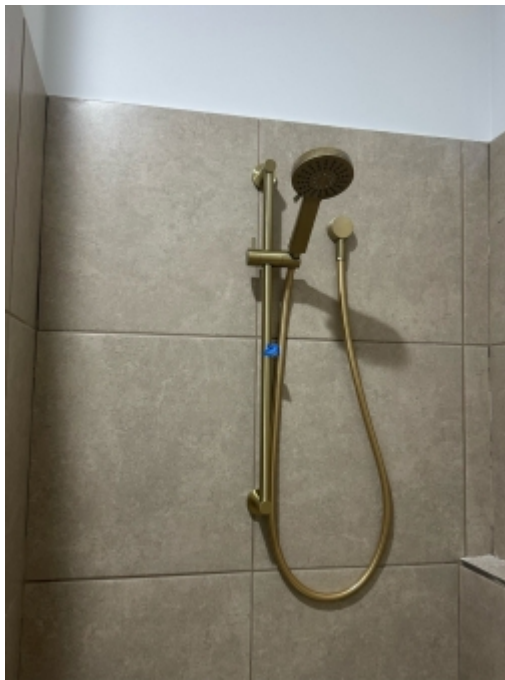
Comments on Minor Defects Showing loose shower head rail to the downstairs powder room.

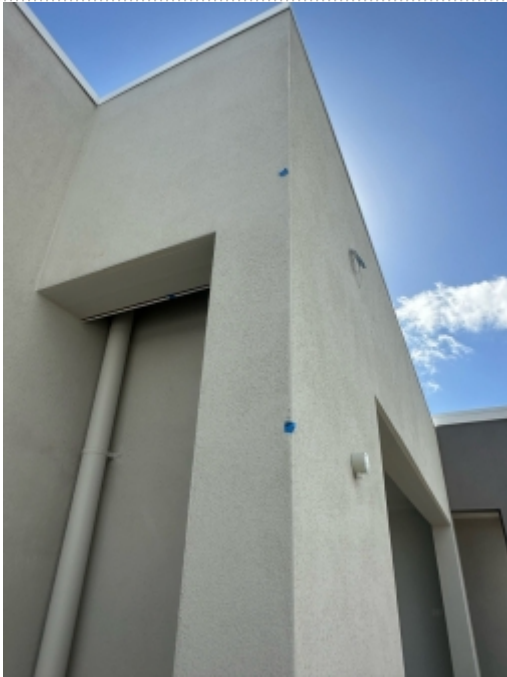
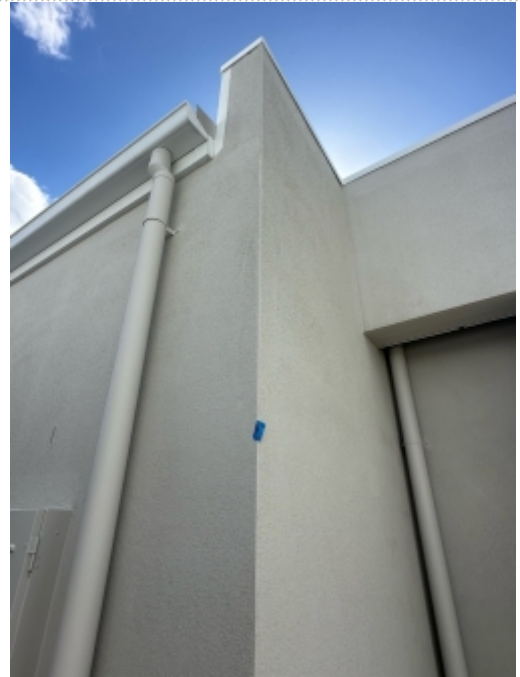
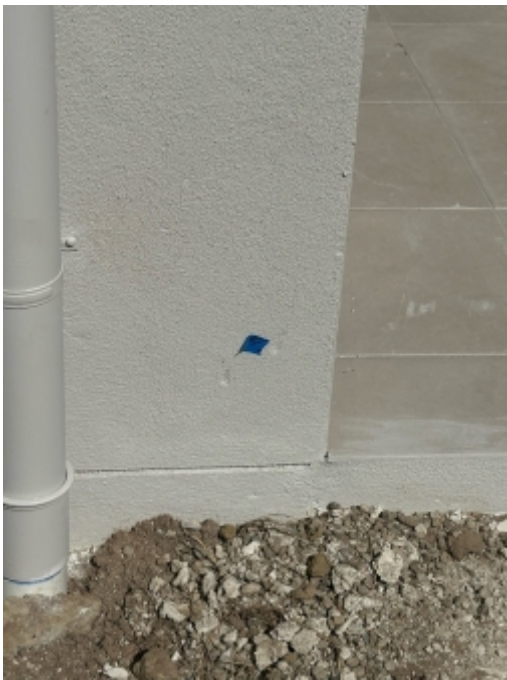
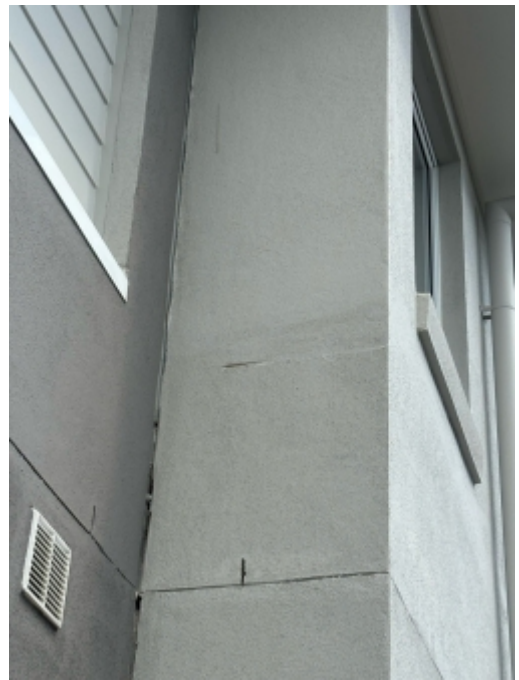
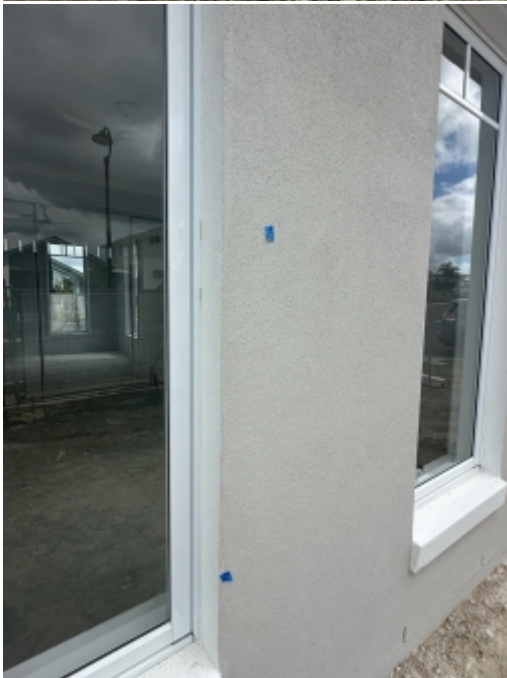
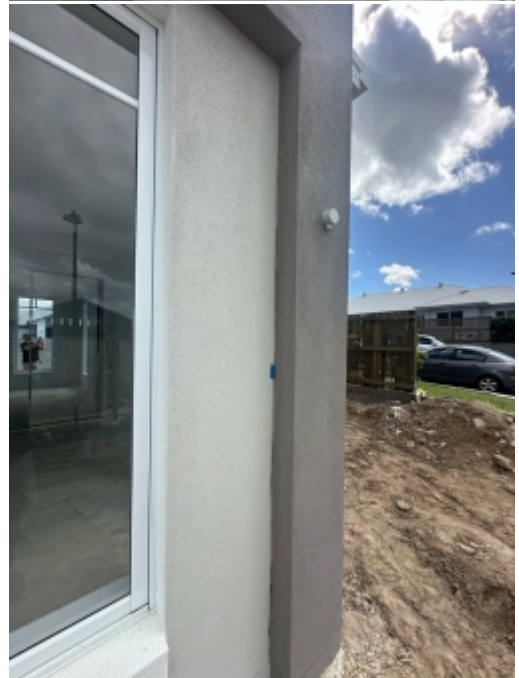
Showing examples of defective paintwork to parts of the House External.

Showing examples of defective rendering to parts of the House External.

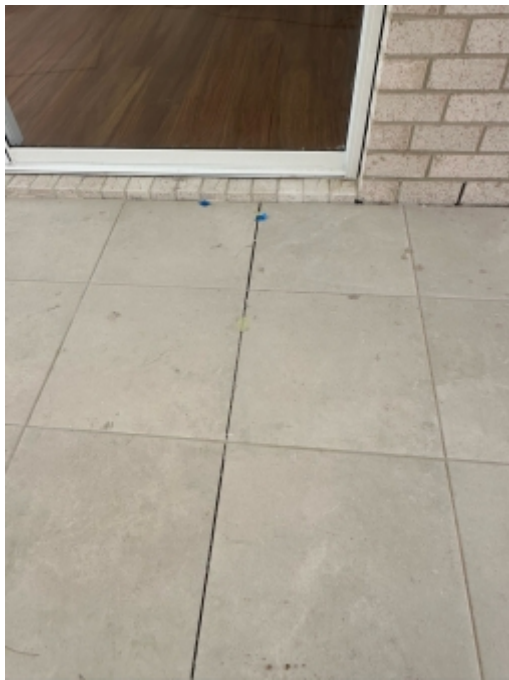
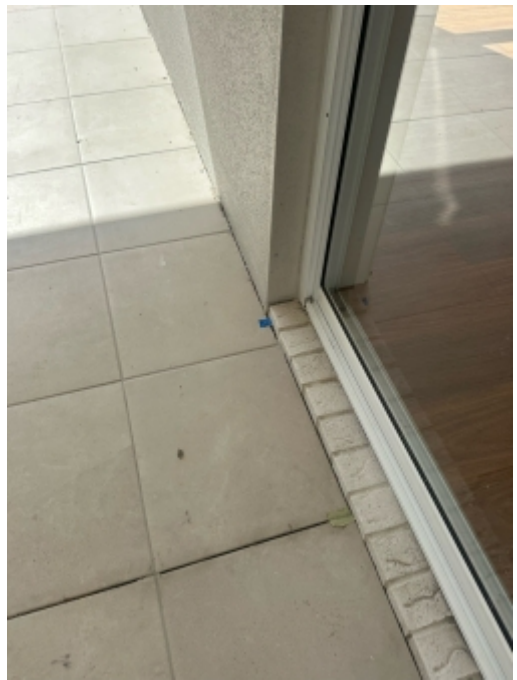
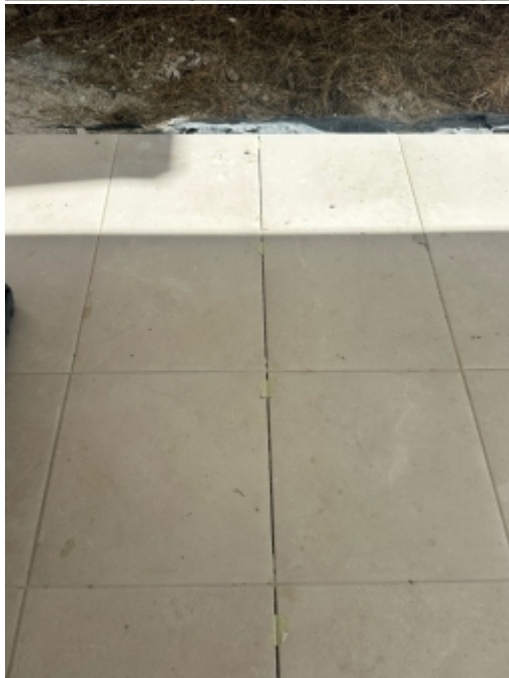
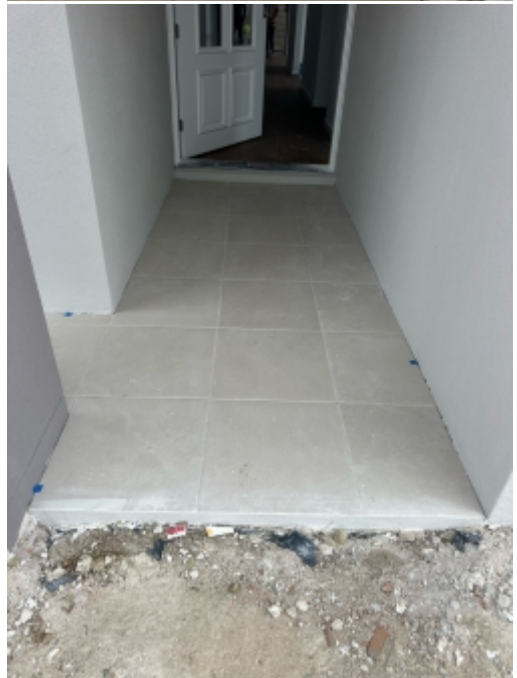
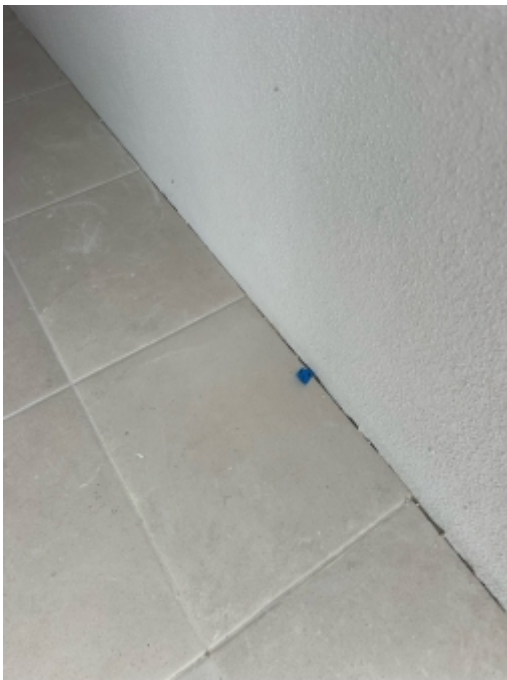
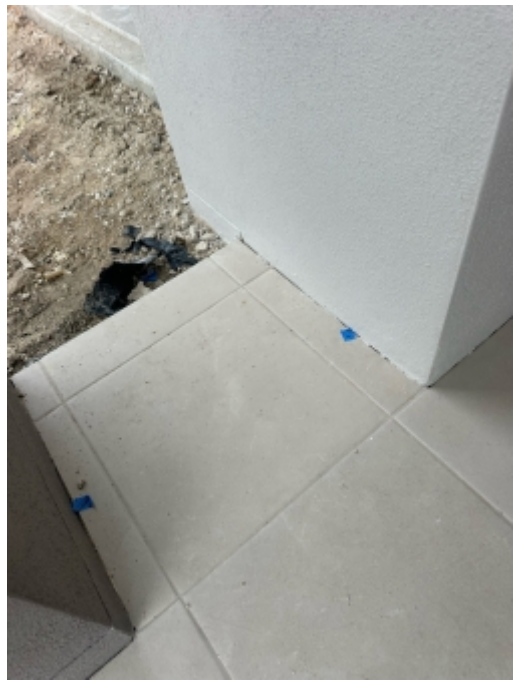
Showing examples of missing/loose silicone to parts of the external floor tiles.

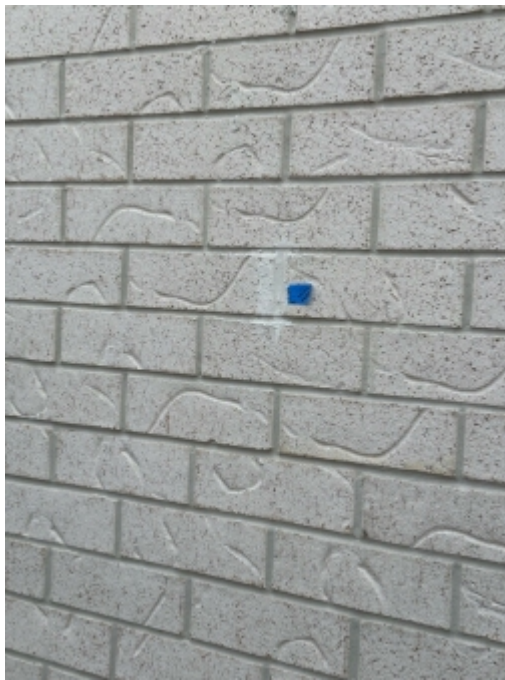
Showing examples of excess mortar to parts of external wall bricks.

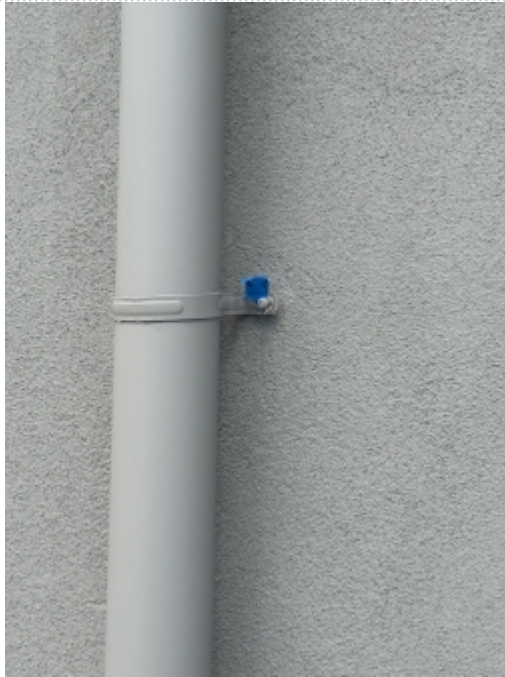
Showing loose downpipe clips.

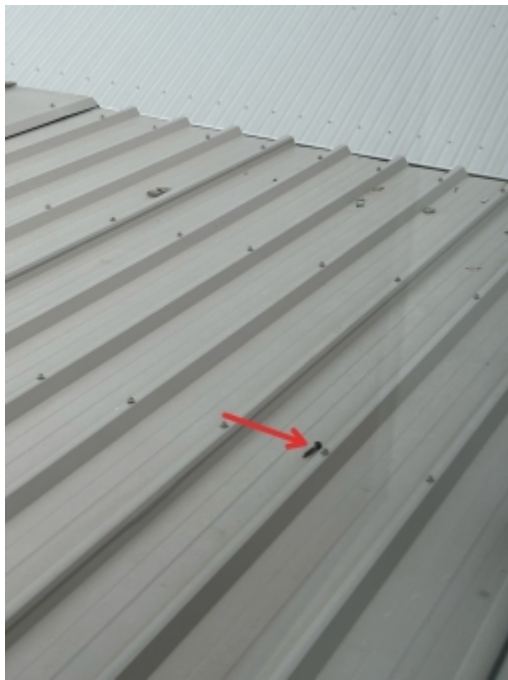
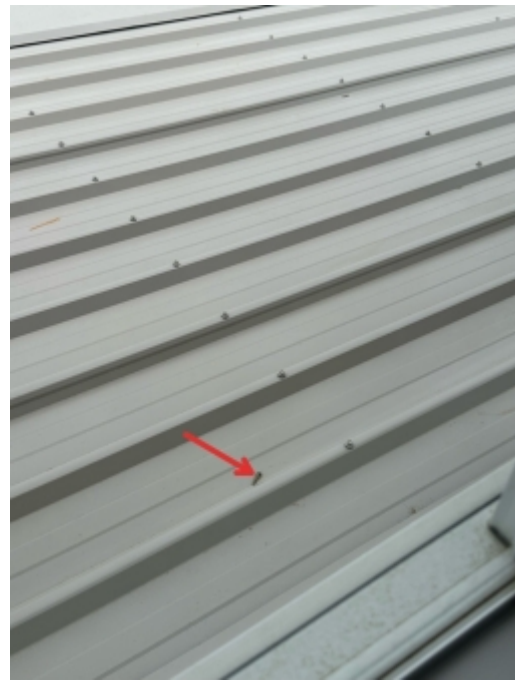
Showing examples of screws/nails to parts of roof covering, needs removing.

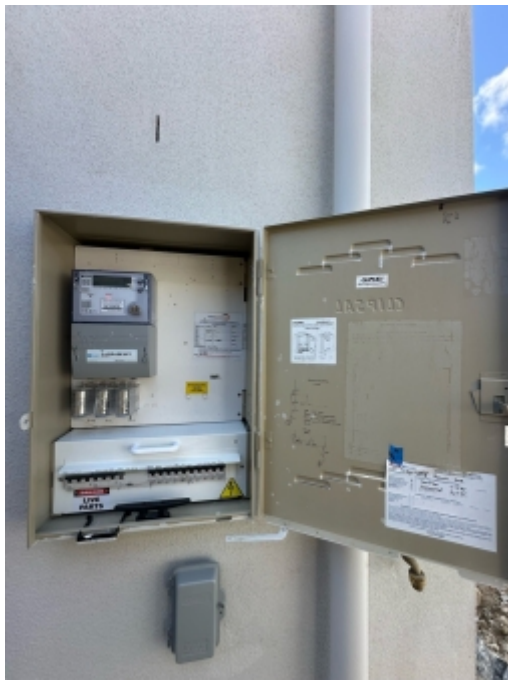
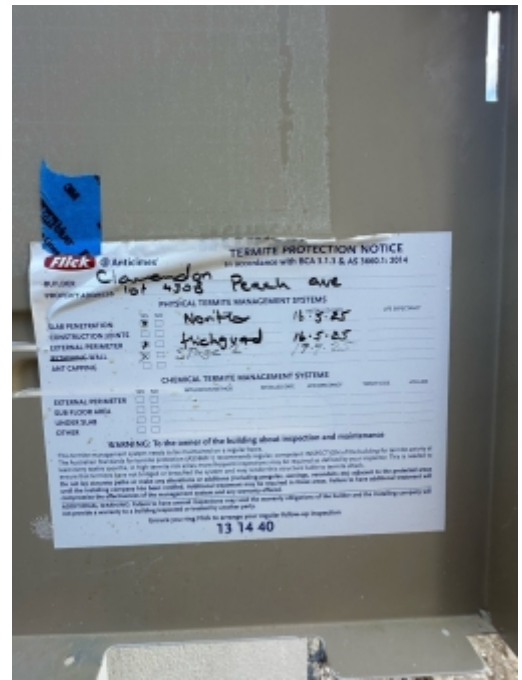
Photo Comments	The Termite management notice was found in the meter box at the time of the inspection.
Photo
