Pre-Purchase Standard Property & Timber Pest Combined Report

43 Clausen Street Mount Gravatt East 4122 Queensland Australia

Report number:	ABI-03083
Inspection Date:	03 Apr 2026
Property Address	43 Clausen Street Mount Gravatt East 4122 Queensland Australia

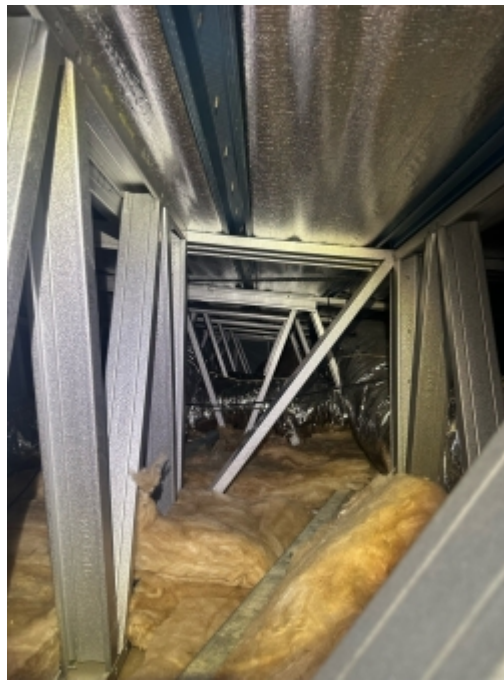
Comments on Obstructions:	Showing an example of ducted AC and insulation to the ceiling space
Inaccessible areas	
Were there any normally accessible areas that did not permit entry?	All normally accessible areas permitted entry
Undetected defect risk assessment	
Due to the level of accessibility for inspection including the presence of obstructions, the overall degree of risk of undetected defects such as structural damage, conditions conducive to structural damage, timber pest attack and conditions conducive to timber pest attack was considered:	Moderate
Tick to add this comment into the report	<input type="checkbox"/> Recommend further inspection once the obstruction is moved. <input type="checkbox"/> Recommend further inspection when access is gained to all areas <input type="checkbox"/> Recommend further inspection once vacant and obstructions removed.

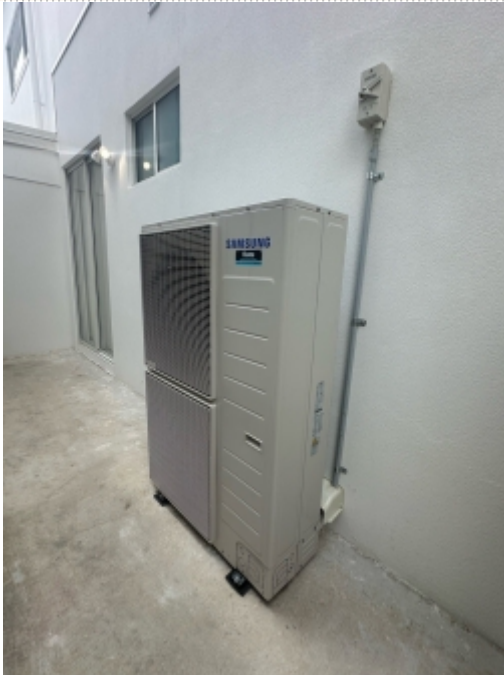
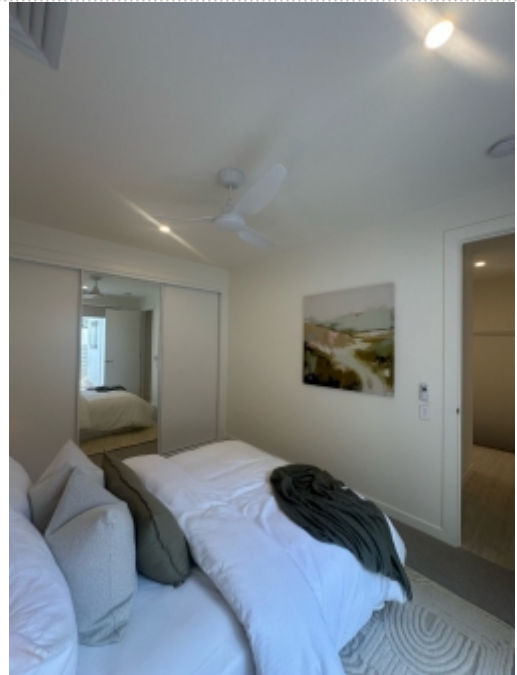
Finishing Element Defects

Details of Major Defect	<p>The air conditioning unit is generating excessive noise, which is noticeable within the downstairs bedroom. Additionally, when the wall lining is accessed, the wall exhibits movement (wobbling) during operation of the unit, indicating possible vibration transfer.</p> <p>It is recommended to engage a qualified builder to assess and rectify the issue. This may include improving wall linings and/or installing appropriate acoustic insulation to the internal wall to reduce noise.</p>
-------------------------	--

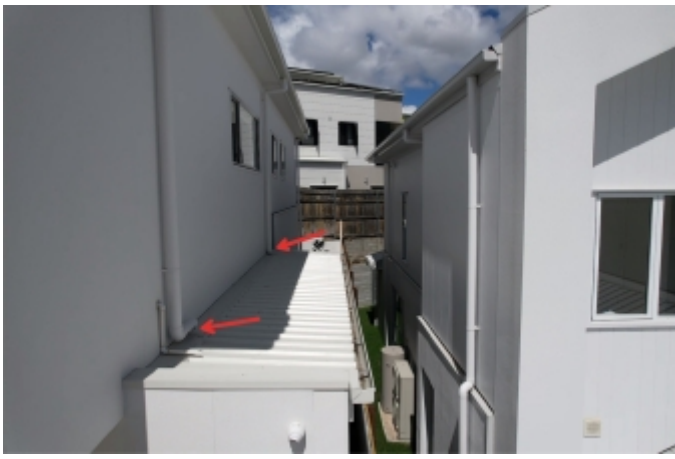
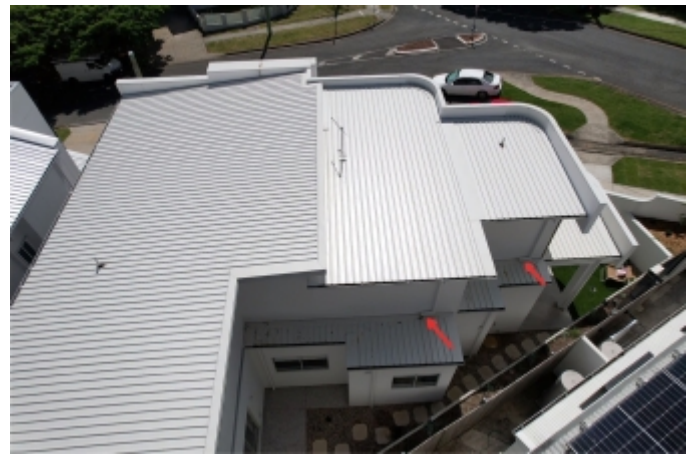
Rainwater Defects

Details of Major Defect	The downpipe spreaders are installed on top of roof flashing. Recommend engaging a plumber for further advice on rectifying to reduce the risk of water ingress under the flashing.
-------------------------	---

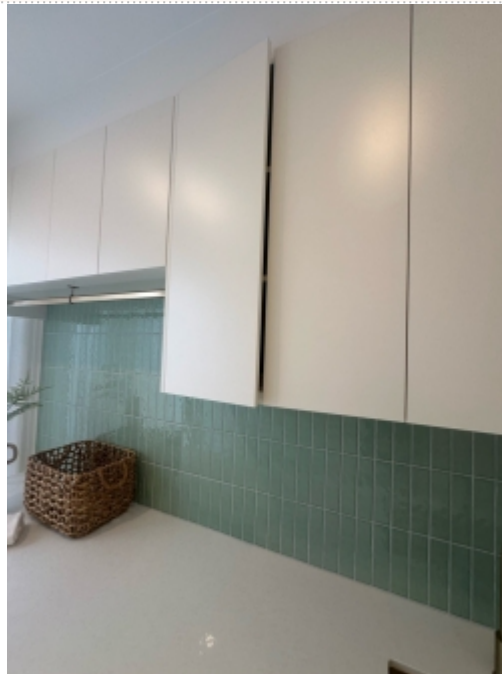
Comments on Minor Defects Showing loose cabinet door hinge to the laundry.

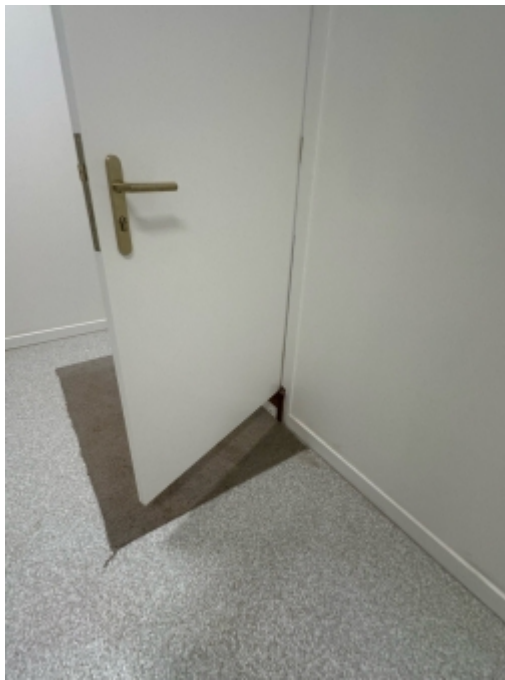
Comments on Minor Defects Showing examples of broken/missing door stoppers.

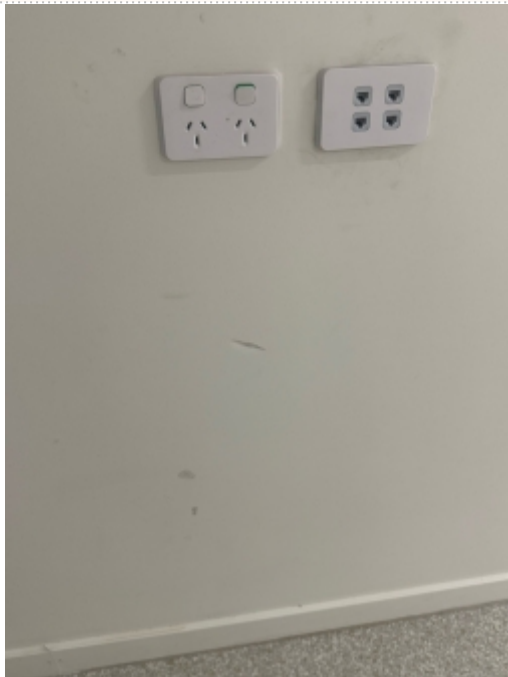
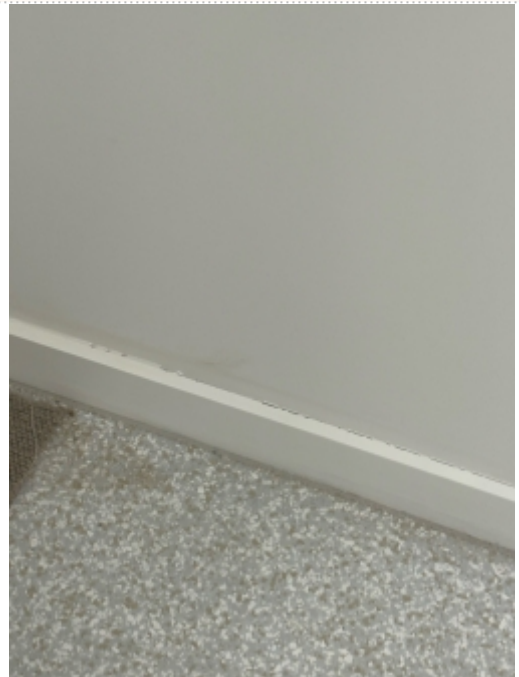
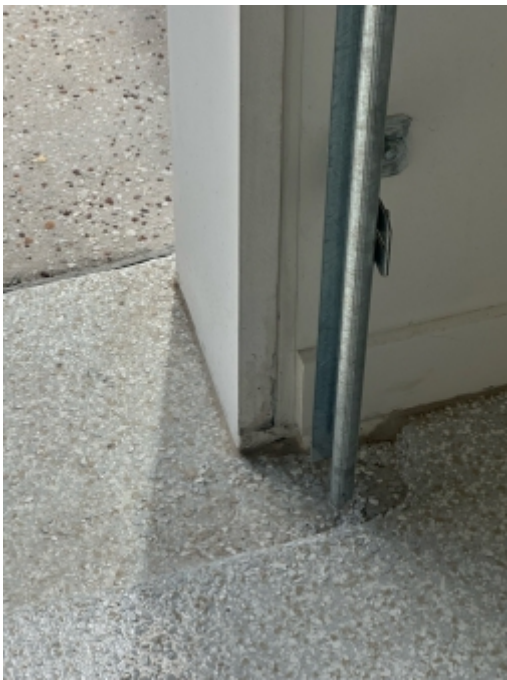
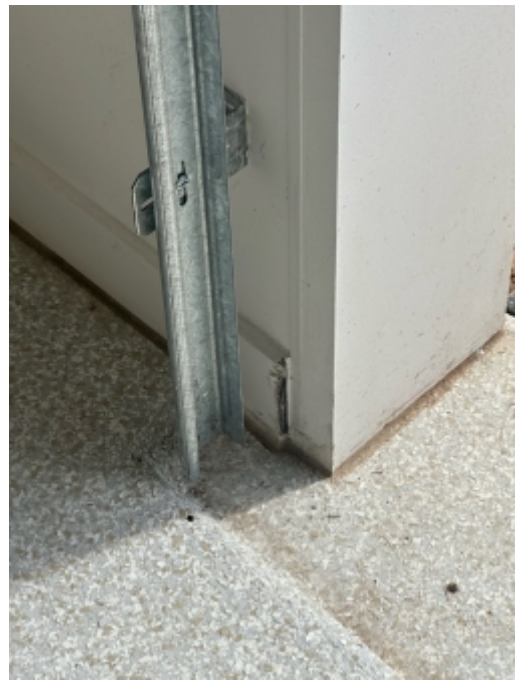
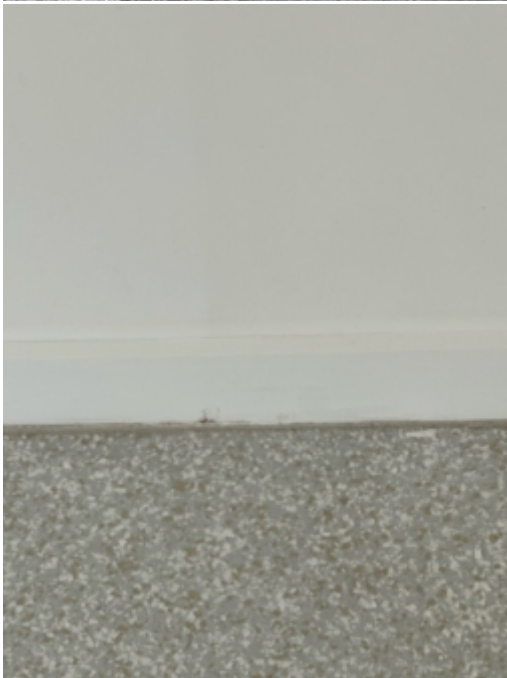
Showing examples of defective paintwork/finishing to parts of the building.

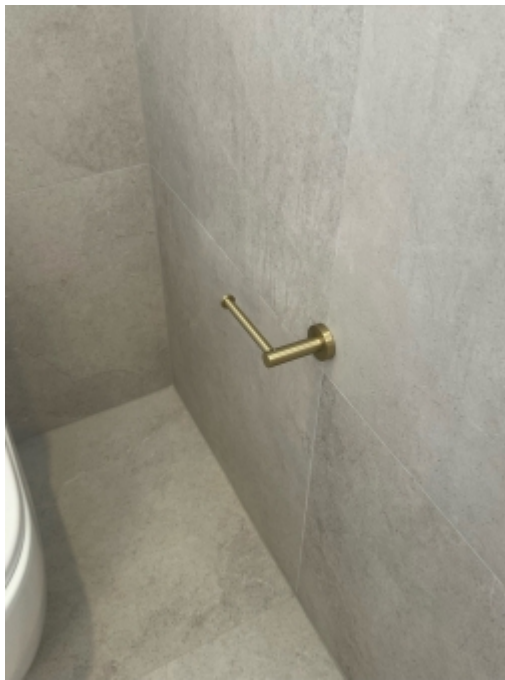
Showing loose toilet paper holder to the bathroom.

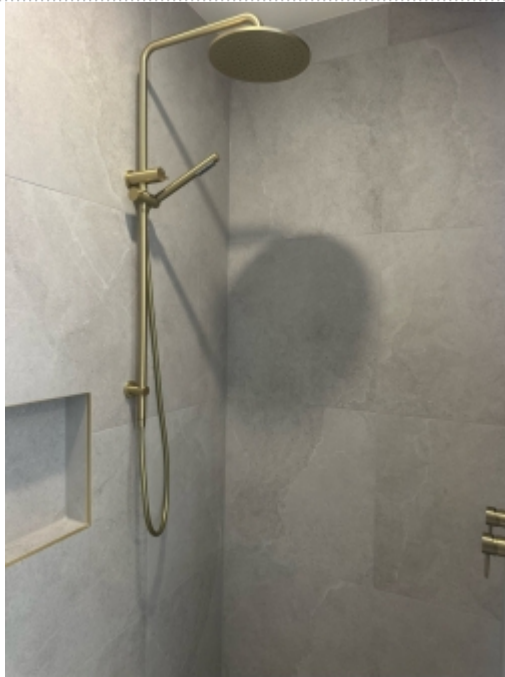
Showing loose shower head rail to the bathroom.

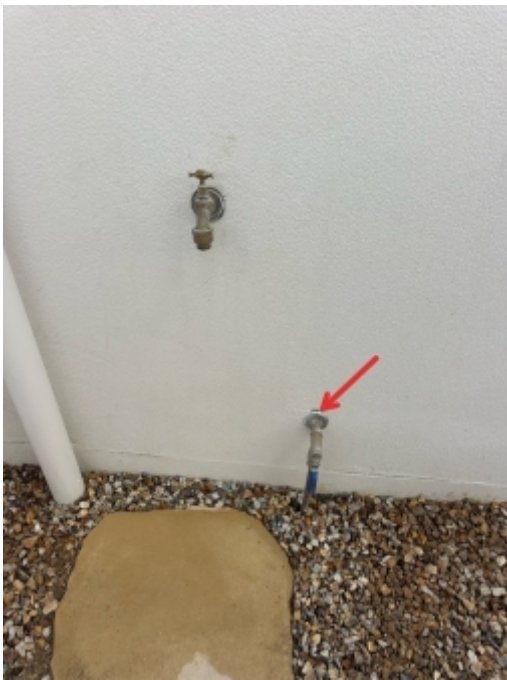
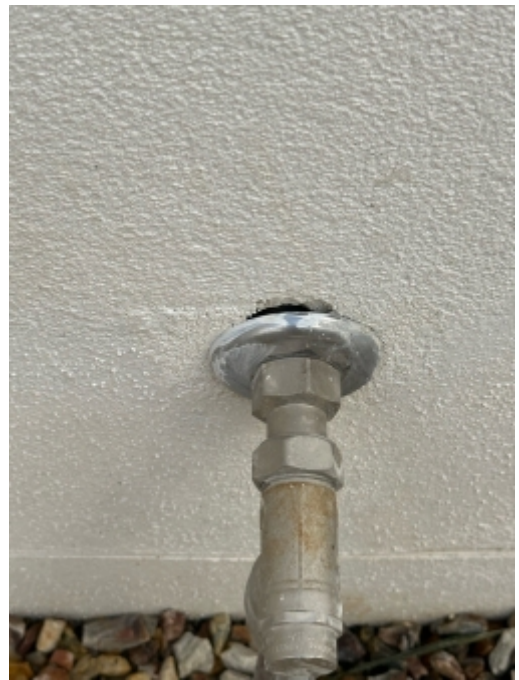
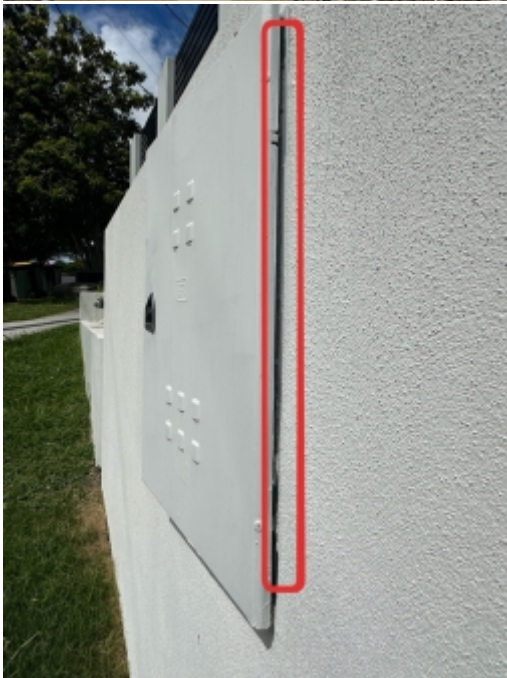
Showing examples of the gaps/holes to parts of the external walls, needs sealed to reduce the risk of water leaks and penetration into the building.

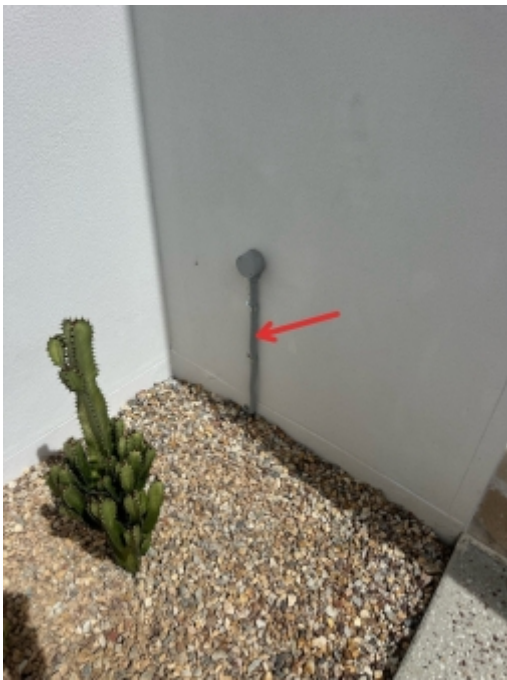
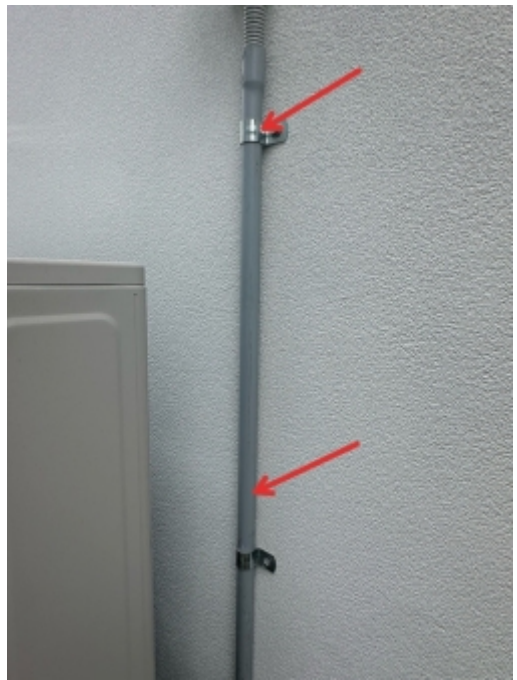
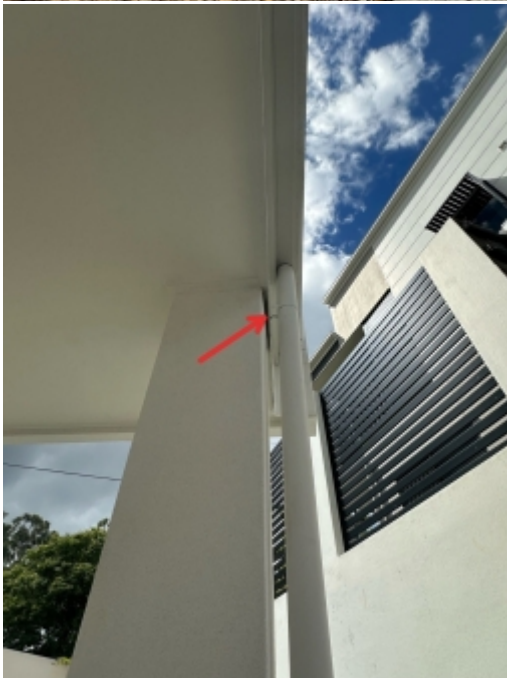
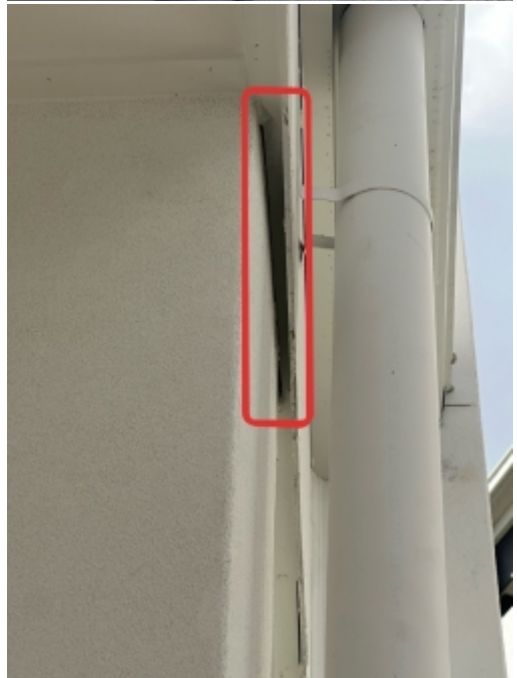
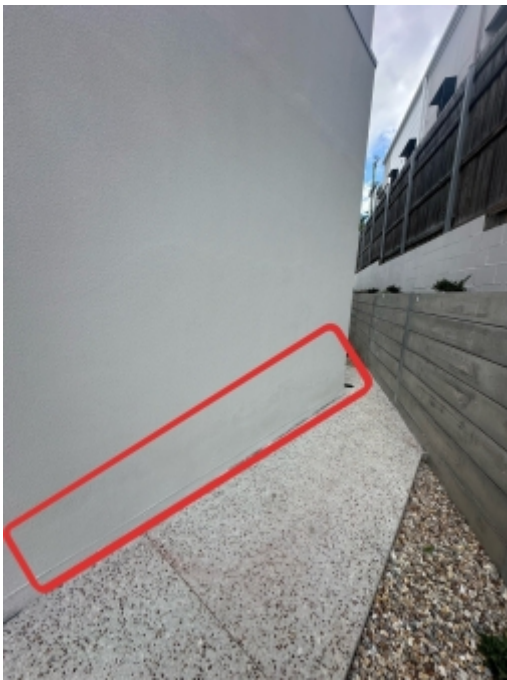
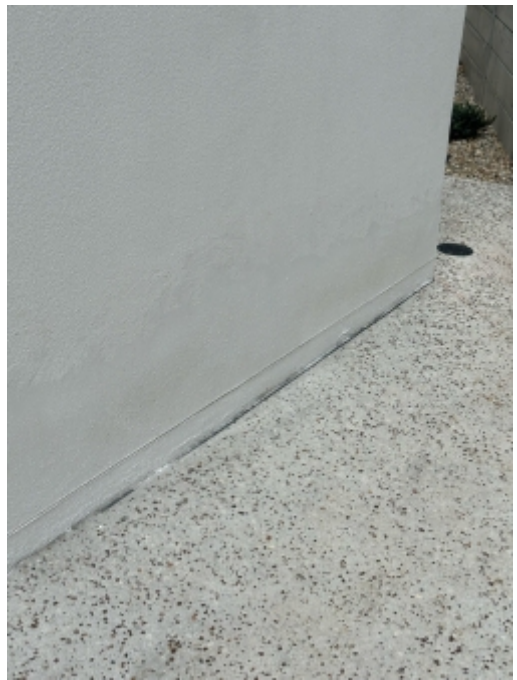
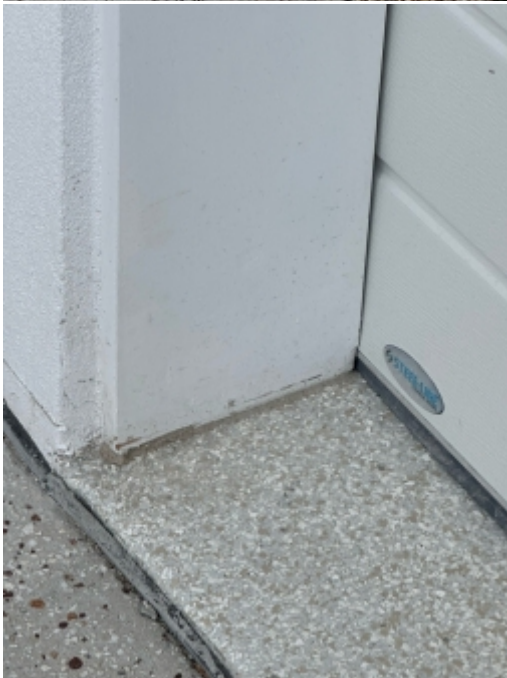
Showing examples of defective paintwork/finishing to parts of the building.

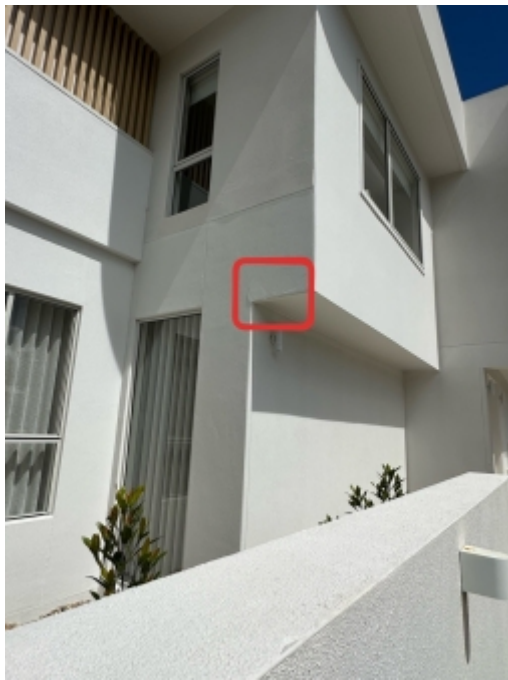
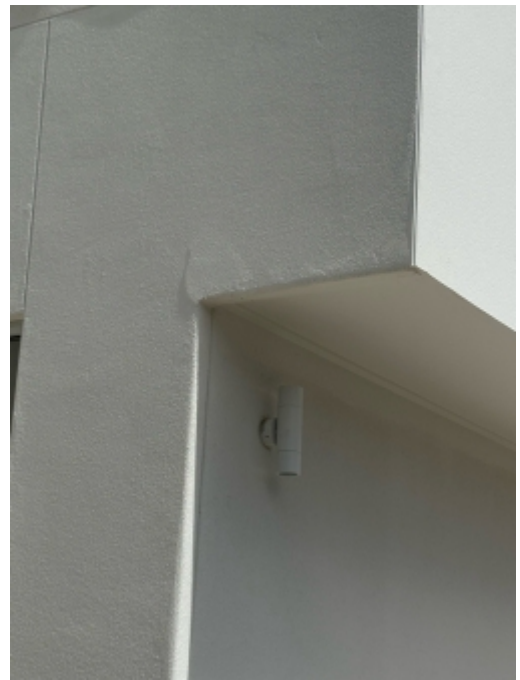
Showing defective rendering to parts, needs repairing.

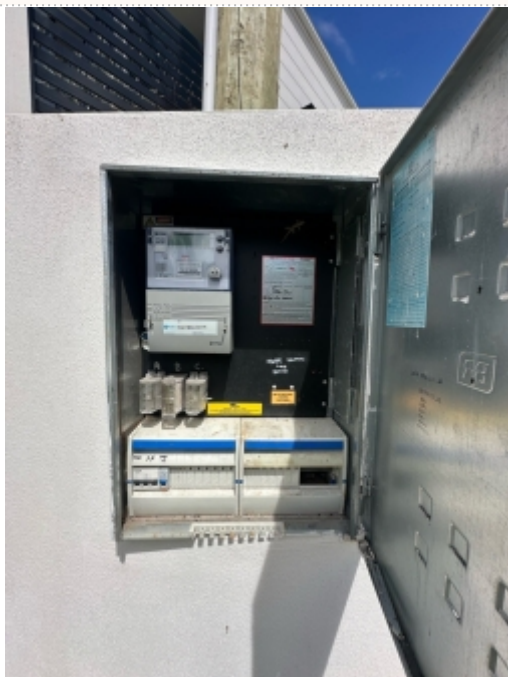
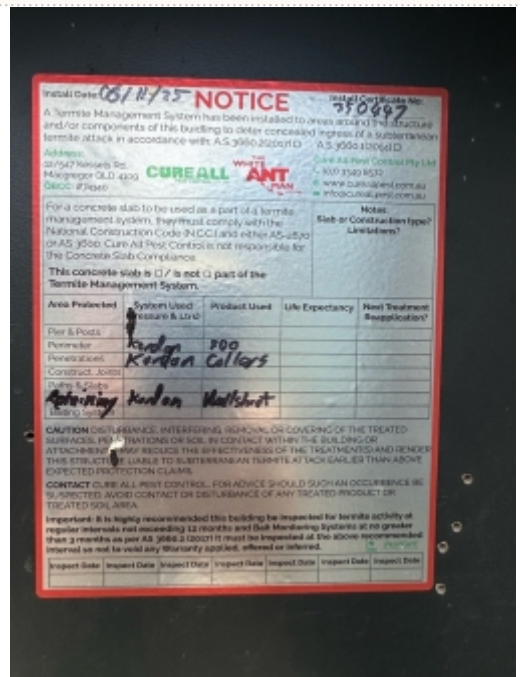
Previous Treatment Photos

E1 Active (live) Termites	No evidence was found
E2 Subterranean Termite Management Proposal	A Proposal is not recommended
E3 Termite Workings and/or Damage	No evidence was found
E4 Previous Termite Management Program	The following evidence was found:
Evidence of previous program:	Treatment sticker in meter box

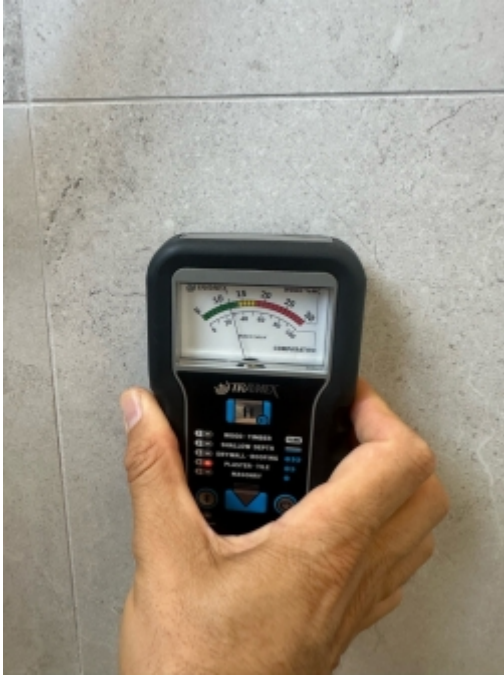
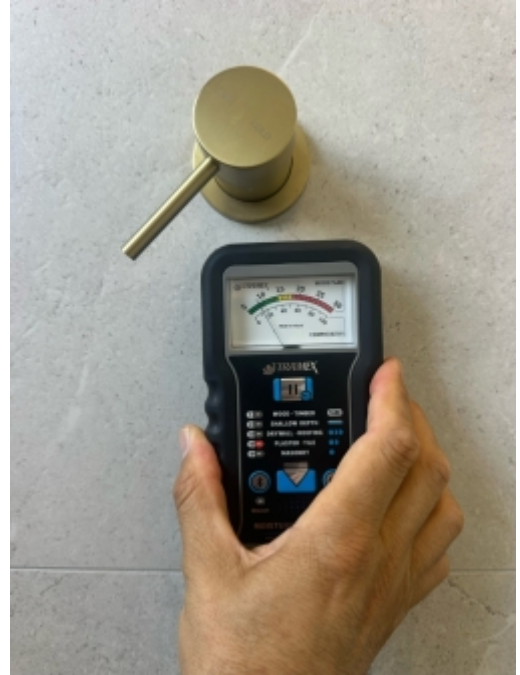
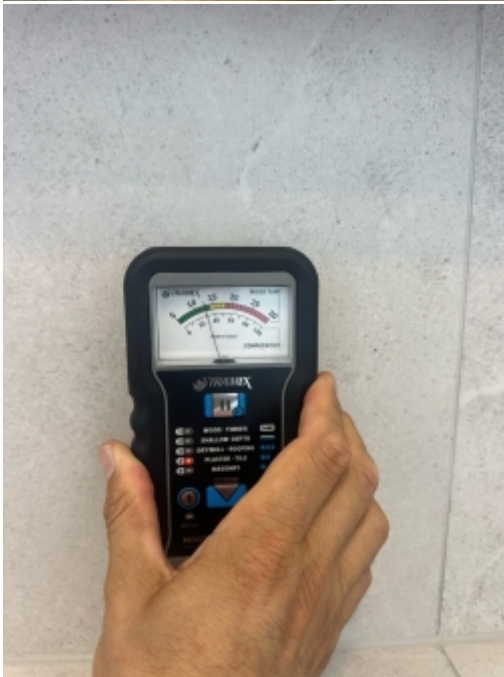
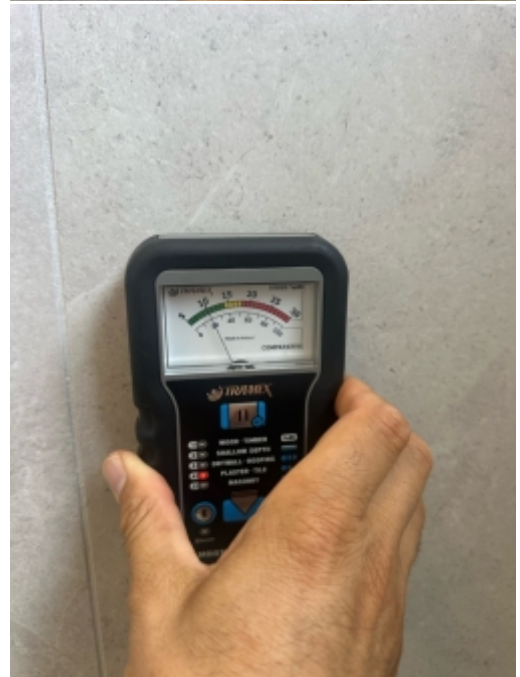
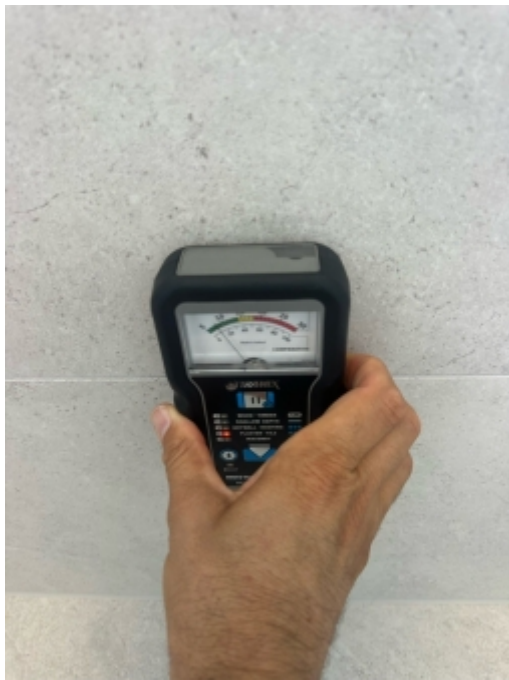
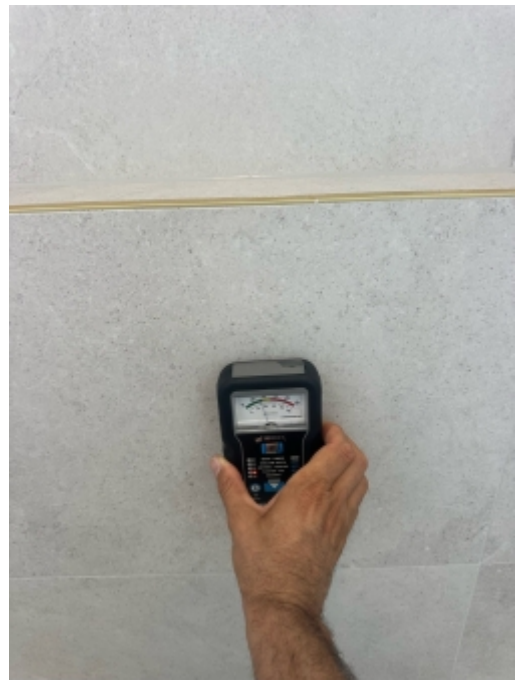
Showing examples of moisture meter displaying normal reading in various areas of the property
