# Frame Stage Inspection Report

77 Guroman Drive, Greenbank, Queensland, 4124 Australia

**Frame Stage Inspection Report - SDA STAGE - Frame Stage Inspection Report** 22 Apr 2025

| Report Number: | ABI-02472 |

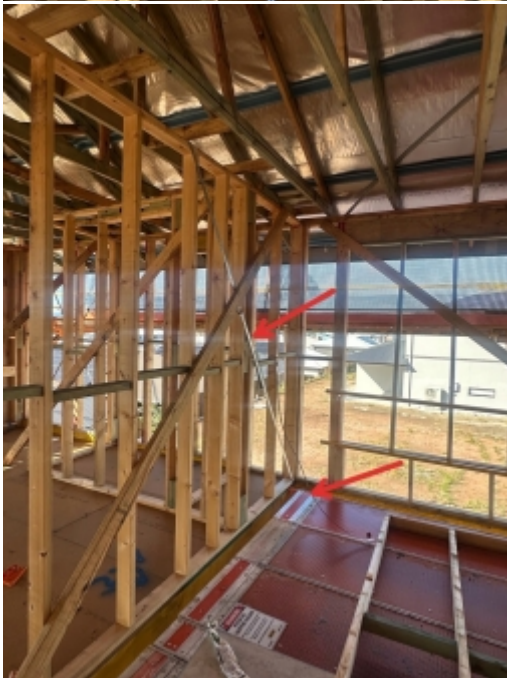
Photos of Defects

Enter question... Missing nails/loose metal bracing to parts. Recommend engaging a qualified carpenter for further advice on repairs.

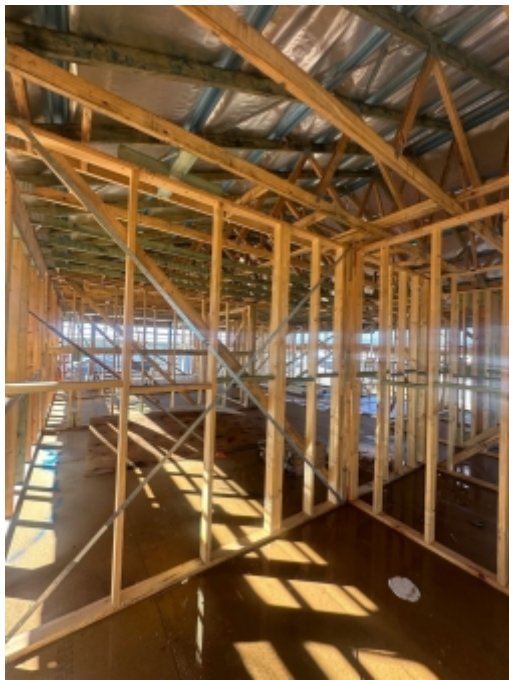
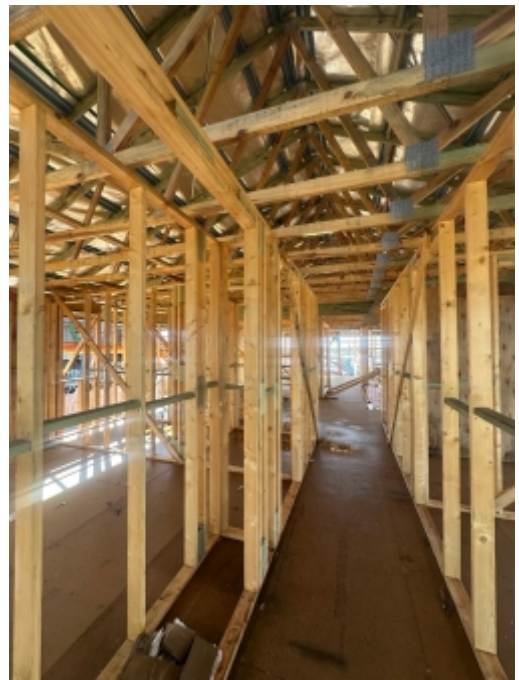
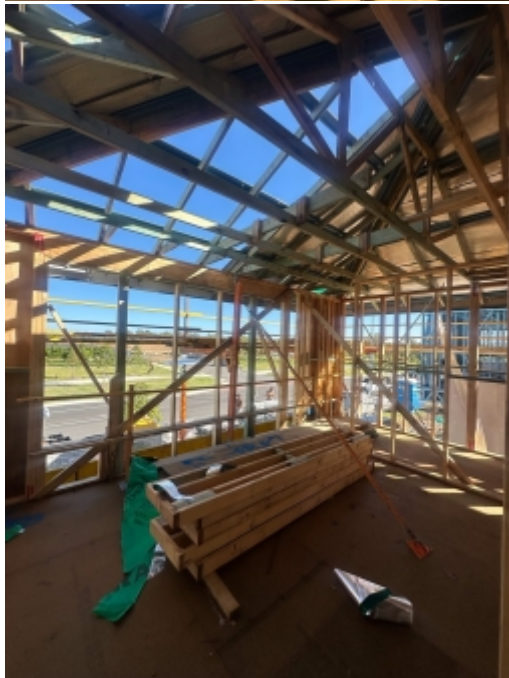
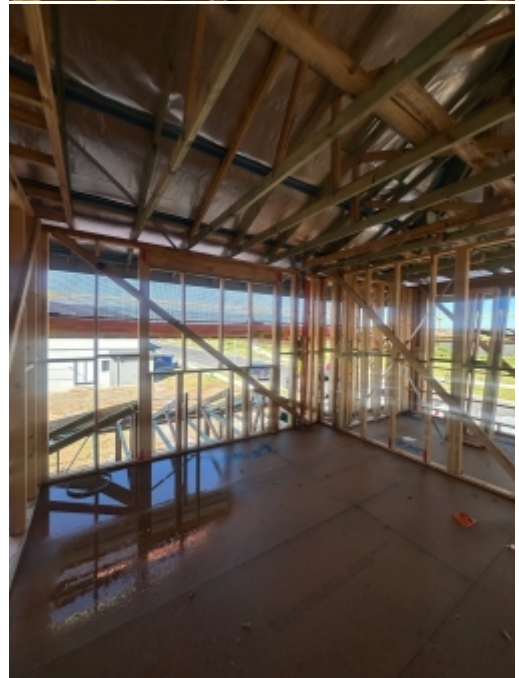
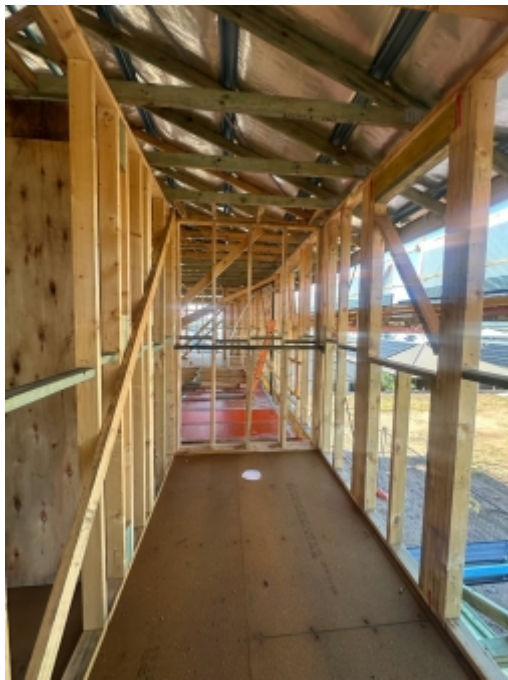
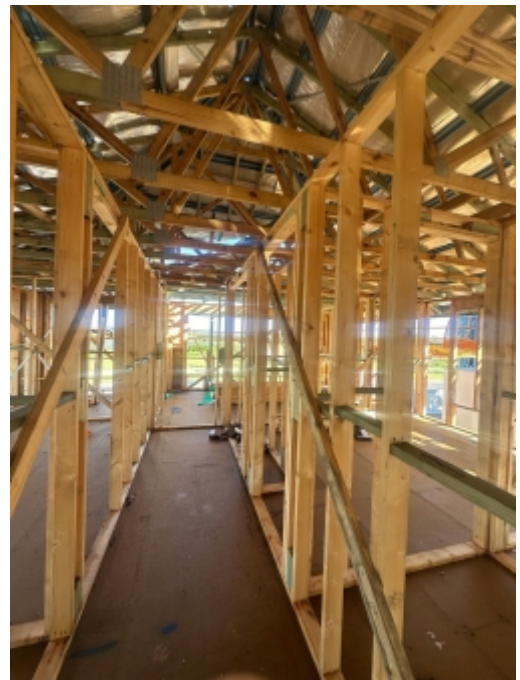
Showing a general view of the framing at the time of the inspection
