Builders Defects Warranty Report

Builders Defects Warranty Inspection - Articon Standard Property Report

55 Liberty Drive Flagstone 4124 Queensland Australia

Report number:	ABI-03039
Inspection Date:	04 Mar 2026
Property Address	55 Liberty Drive Flagstone 4124 Queensland Australia
Special conditions or instructions	
Special conditions or instructions	There are no special conditions or instructions.
The parties	
Name of Client:	Brad wells

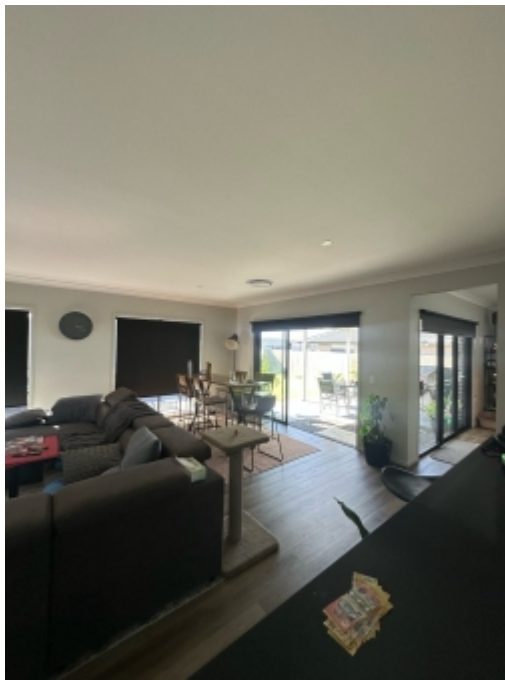
Photo of Obstruction

Showing an example of furniture, floor covering, stored goods, walls, and ceiling linings

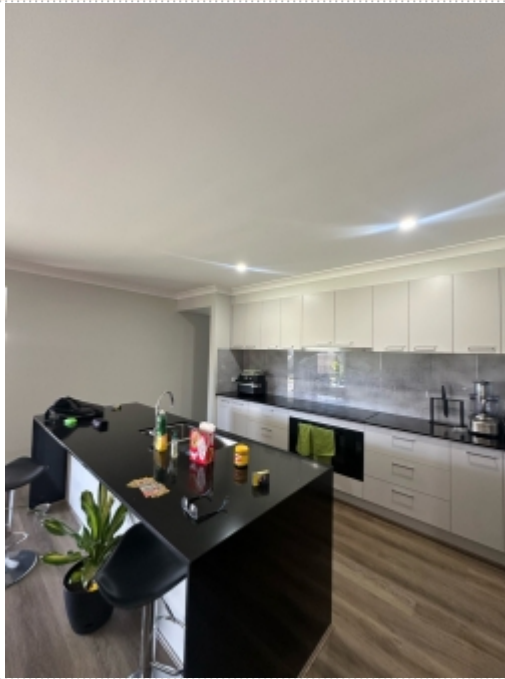
Photo of Obstruction

Showing an example of cabinetry

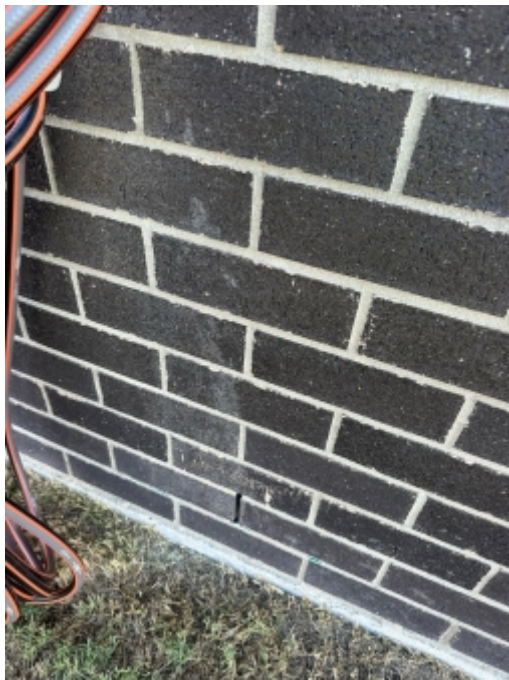
Showing Examples Photo(s) of Defects

Examples of minor defects are shown only, and not all possible minor defects are shown in every situation. It is recommended to engage the appropriate trades to assess and complete the necessary repairs
