Builders Defects Warranty Report

Builders Defects Warranty Inspection - Articon Standard Property Report

55 Liberty Drive Flagstone 4124 Queensland Australia

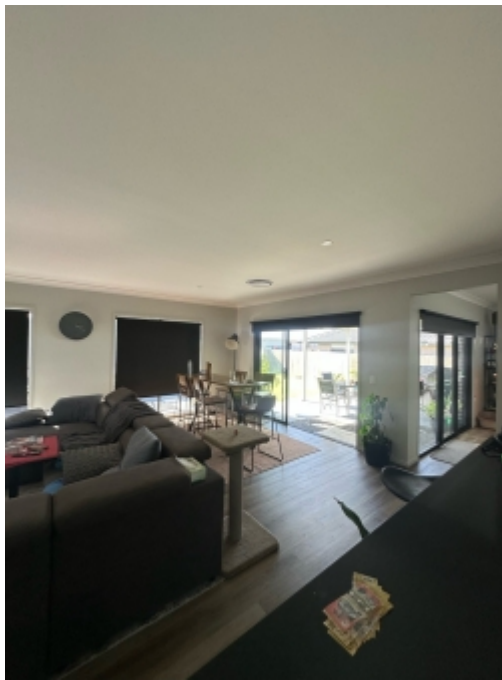
Photo of Obstruction

Showing an example of furniture, floor covering, stored goods, walls, and ceiling linings

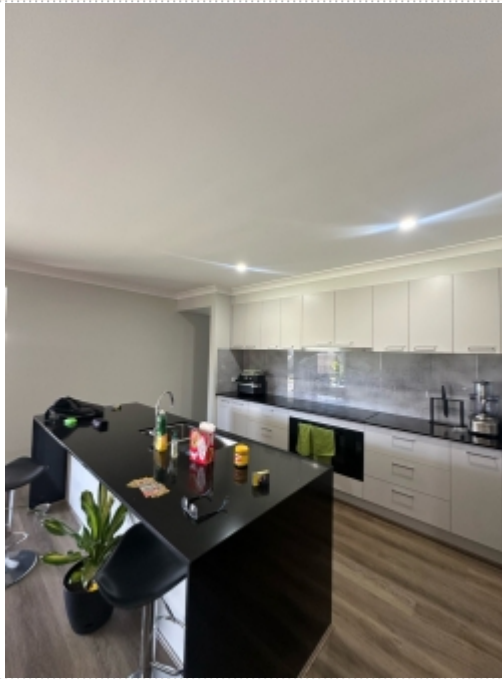
Photo of Obstruction

Showing an example of cabinetry

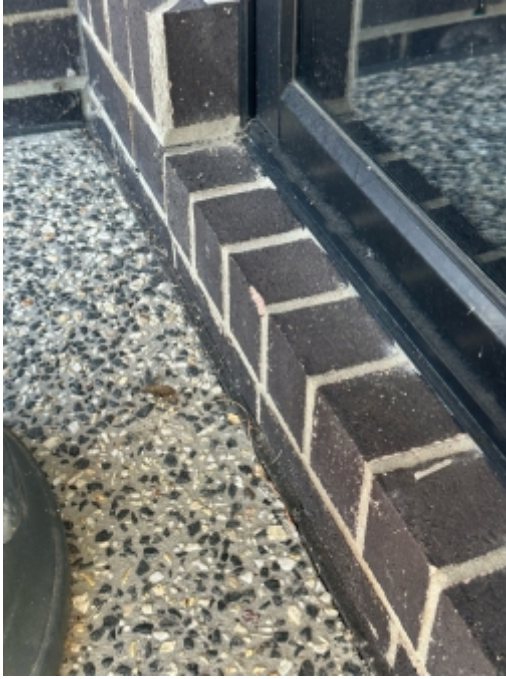
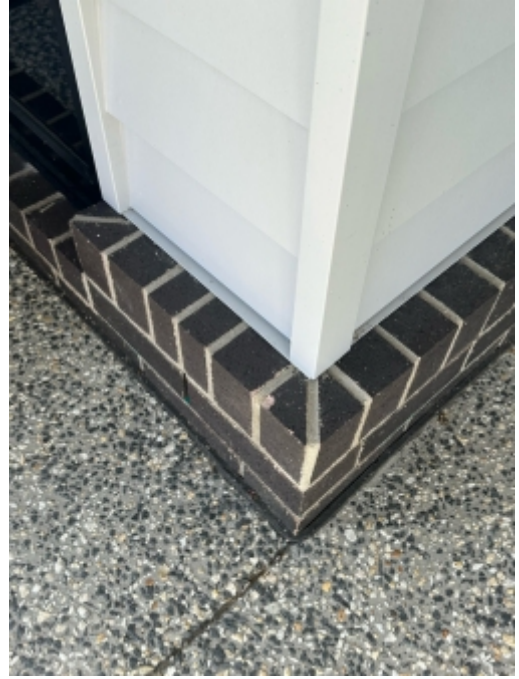
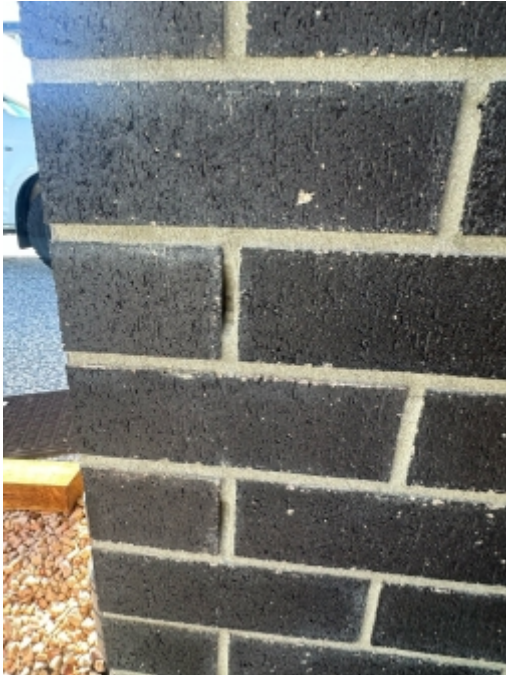
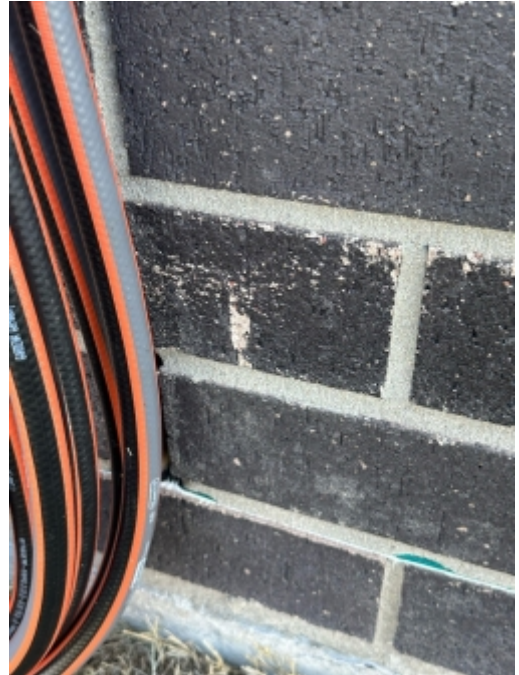
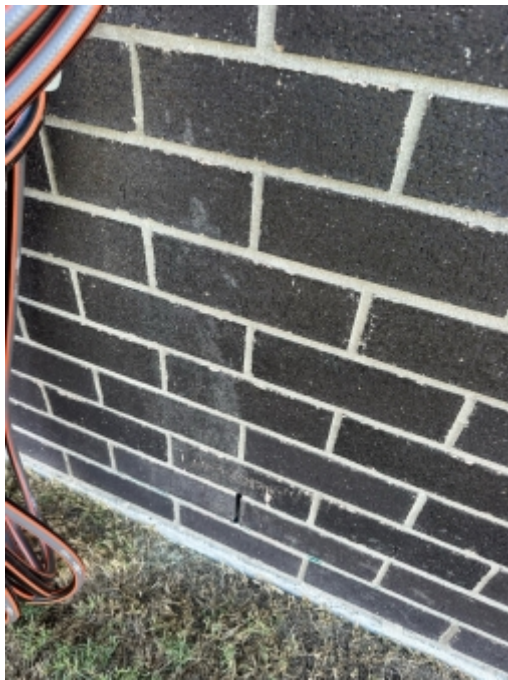
Showing Examples Photo(s) of Defects

Examples of minor defects are shown only, and not all possible minor defects are shown in every situation. It is recommended to engage the appropriate trades to assess and complete the necessary repairs
