Frame Stage Inspection Report

77 Guroman Drive, Greenbank, Queensland, 4124 Australia

Frame Stage Inspection Report - SDA STAGE - Frame Stage Inspection Report 22 Apr 2025

Email address:	info@articon.com.au
Report Number:	ABI-02472
Inspection Date:	22 Apr 2025
Address of the Property Inspected:	77 Guroman Drive, Greenbank, Queensland, 4124 Australia

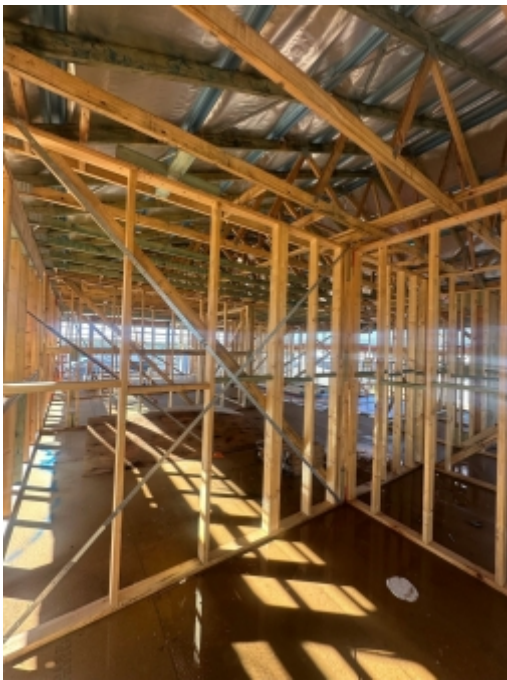
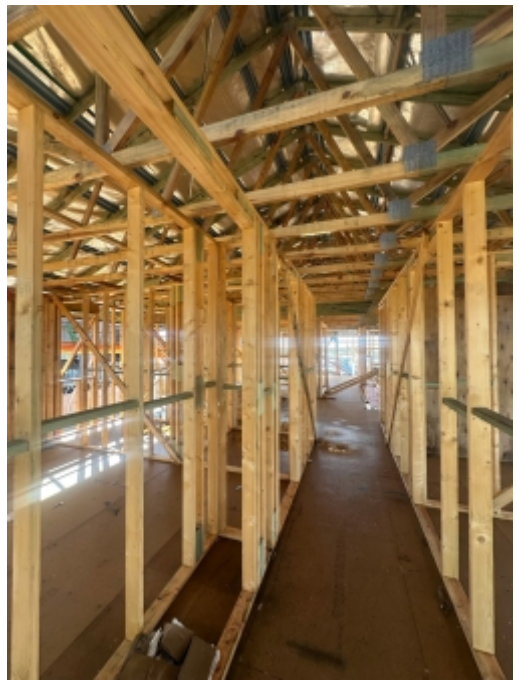
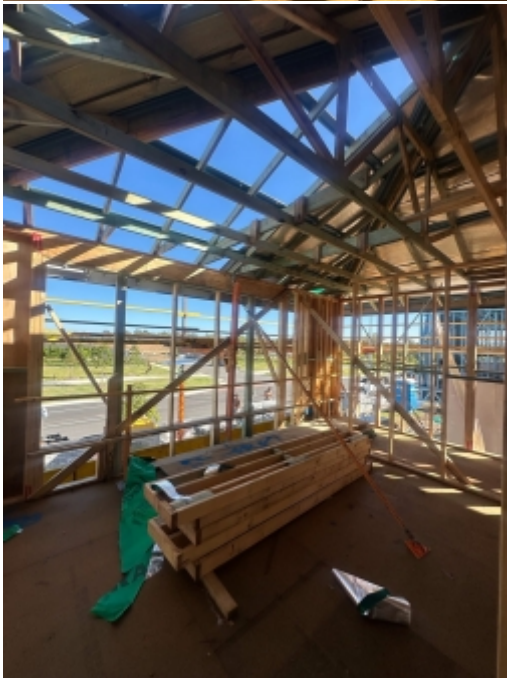
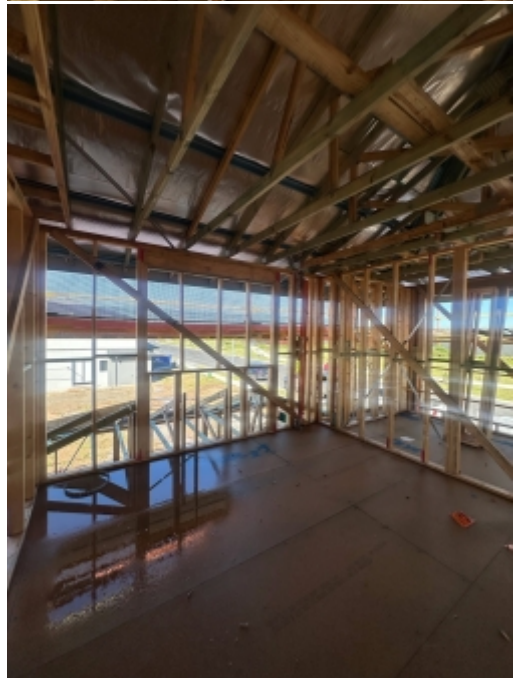
Showing a general view of the framing at the time of the inspection
