PCI (Practical Completion Inspection) Report

lot 4308/30 Peach Avenue Greenbank 4124 Queensland Australia

Report number:	ABI-03079
Inspection Date:	01 Apr 2026
Property Address	lot 4308/30 Peach Avenue Greenbank 4124 Queensland Australia
Special conditions or instructions	
Special conditions or instructions	There are no special conditions or instructions.
The parties	
Name of Client:	Shane Chand

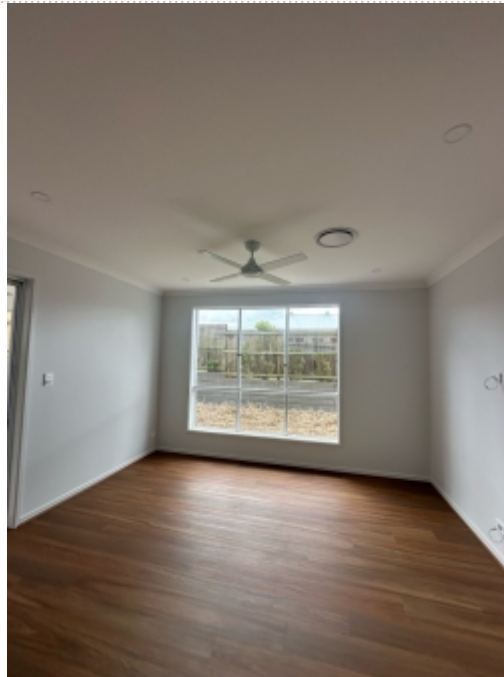
Photo of Obstruction

Showing an example of floor covering, walls and ceiling linings

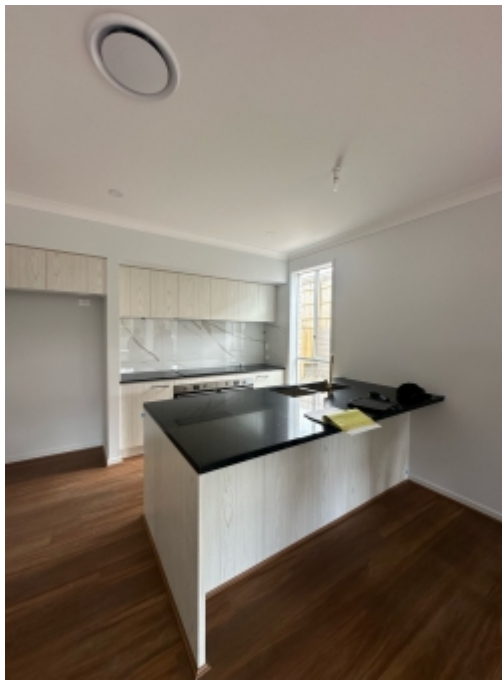
Photo of Obstruction

Comments of Obstructions: Showing an example of cabinetry

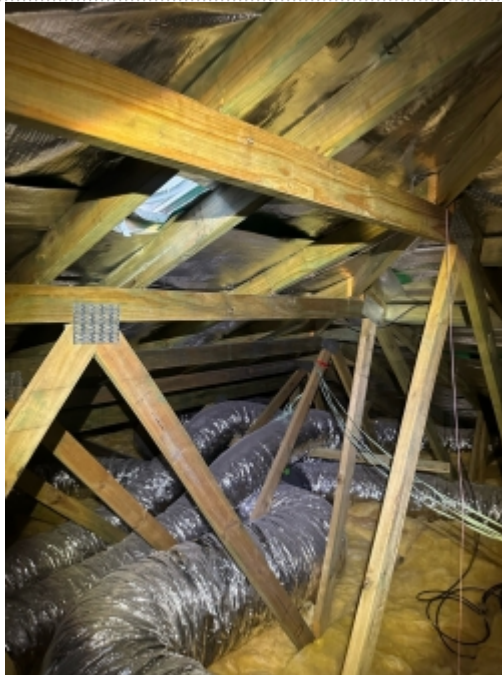
Photo of Obstruction

Comments of Obstructions: Showing an example of ducted AC and insulation

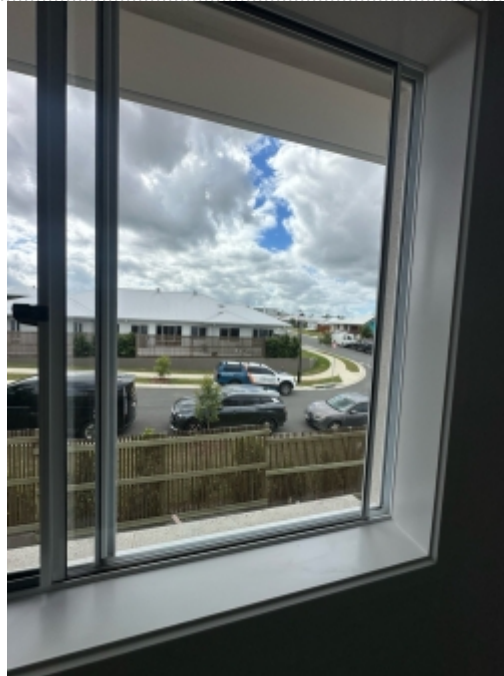
Photo of Hazard

Upper floor windows with no fall prevention. Recommend engaging a builder/glazier to rectify to reduce the risk of people falling out of the windows.

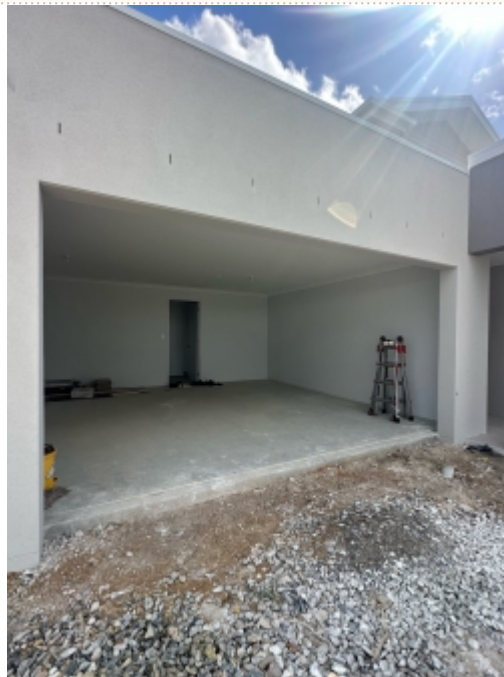
Photo(s) of Defect

The garage door was not installed at the time of the inspection.

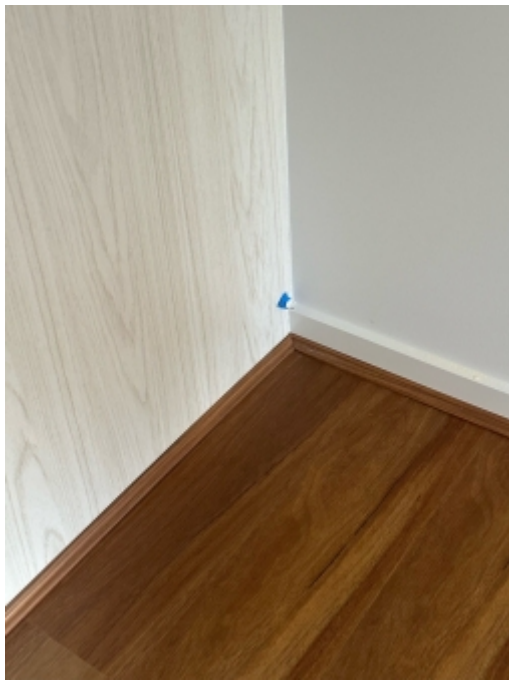
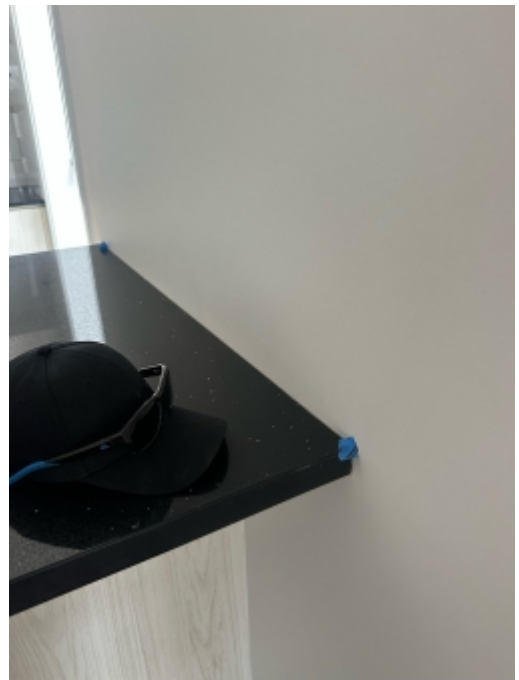
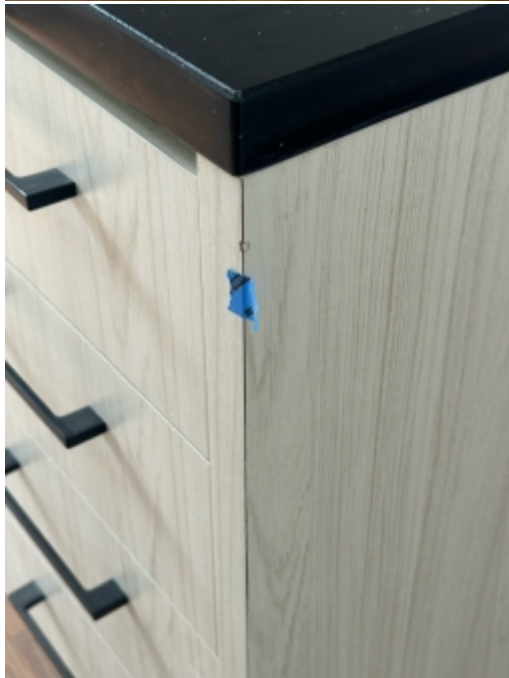
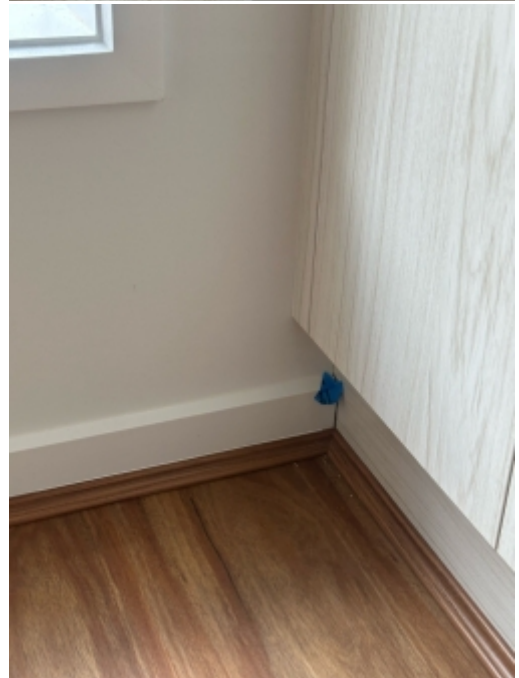
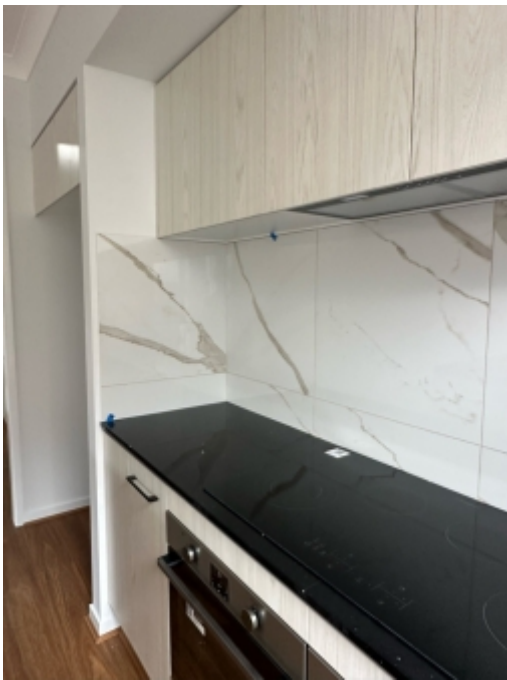
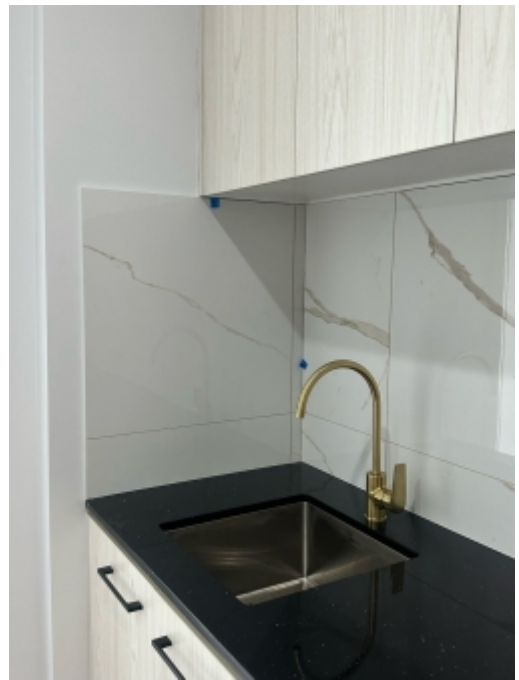
Showing Examples Photo(s) or Detects

Showing examples of missing screws to the hinges.

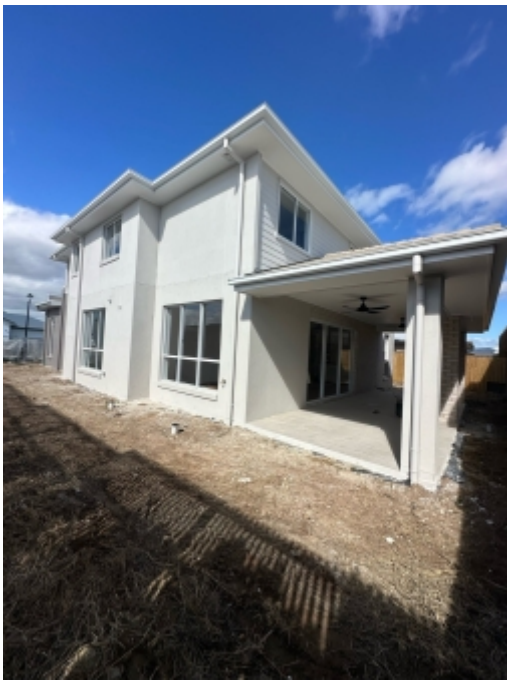
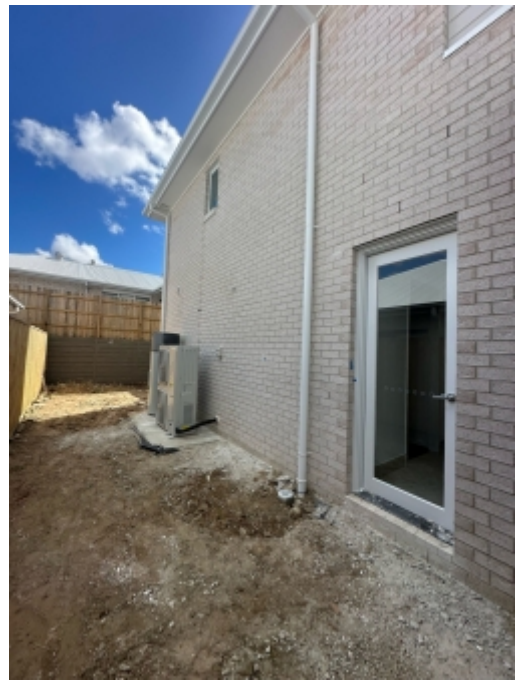
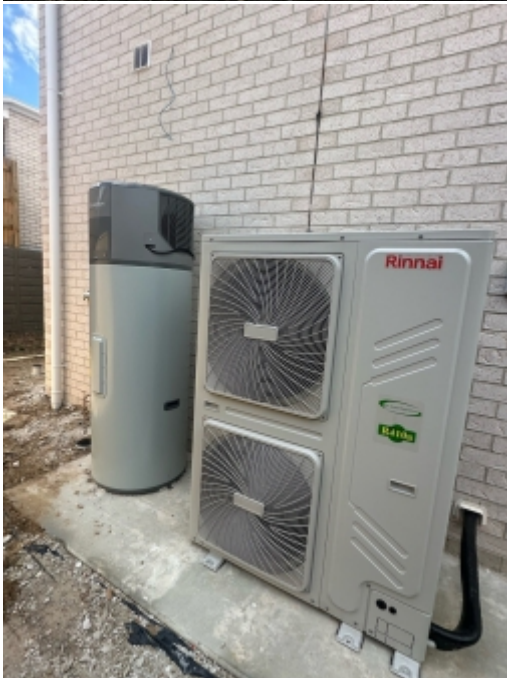
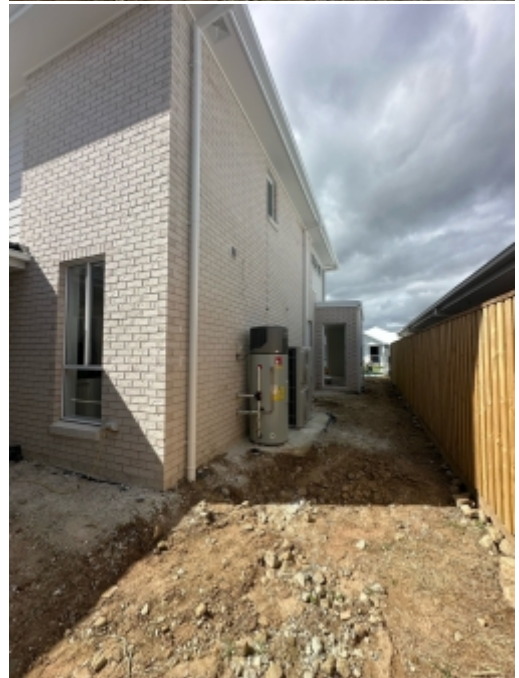
Showing a general view of the House External at the time of the inspection
