Pre-Purchase Standard Property & Timber Pest Combined Report

43 Clausen Street Mount Gravatt East 4122 Queensland Australia

Report number:	ABI-03083
Inspection Date:	03 Apr 2026
Property Address	43 Clausen Street Mount Gravatt East 4122 Queensland Australia

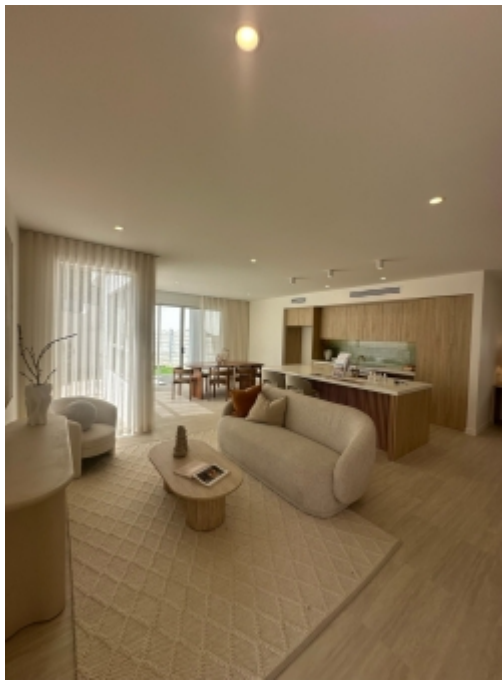
Photo of Obstruction	
----------------------	--

Comments on Obstructions:

Showing an example of furniture, floor covering, stored goods, walls, and ceiling linings

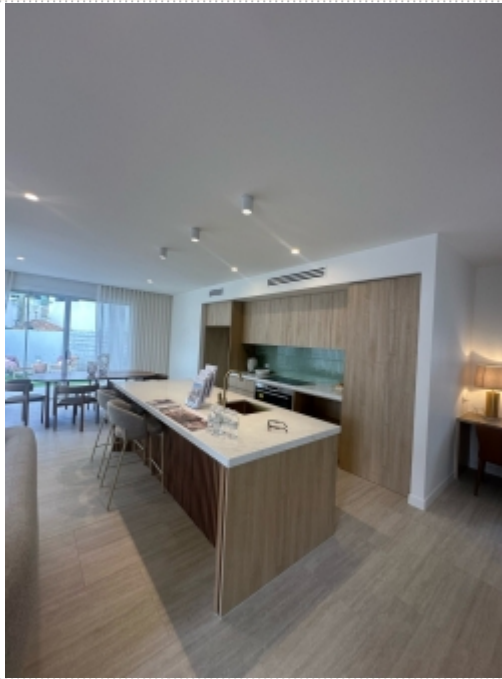
Photo of Obstruction

Comments on Obstructions:

Showing an example of cabinetry

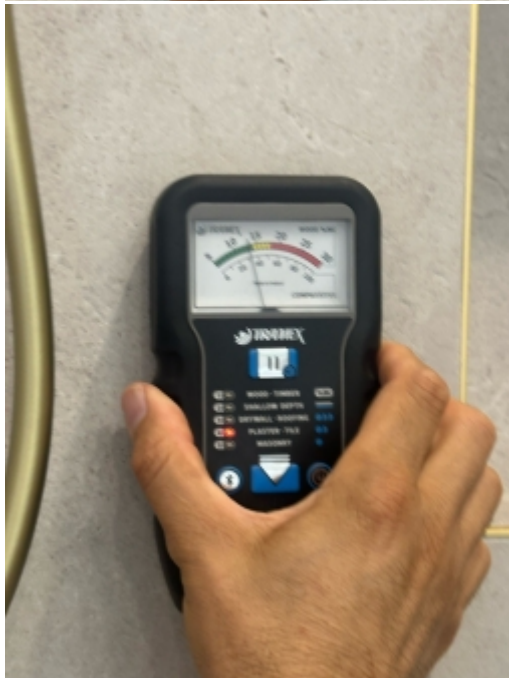
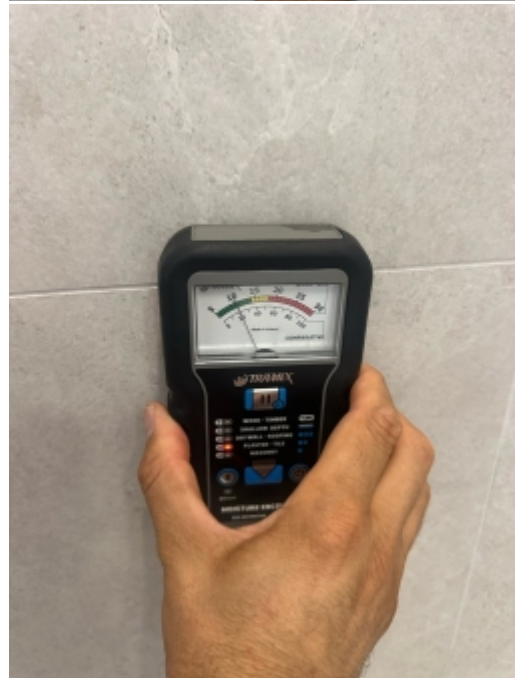
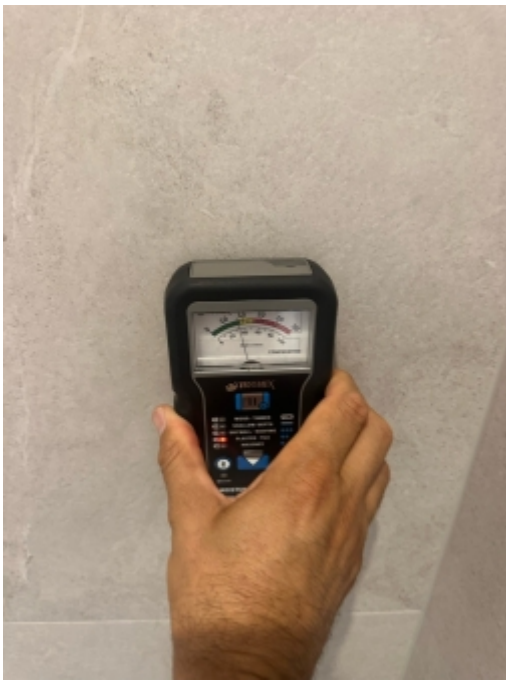
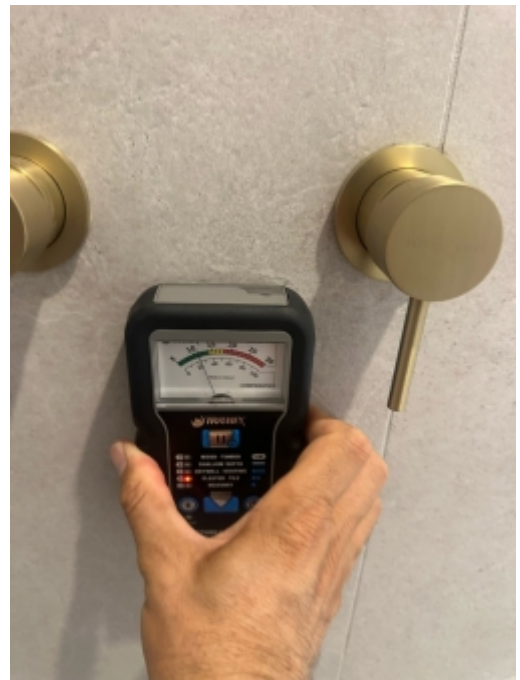
Showing a general view of the House Internal at the time of the inspection
